National Transportation Safety Board

Marine Accident Brief

Fire Aboard Containership *Gunde Maersk*

Accident no.	DCA16FM009
Vessel name	<i>Gunde Maersk</i>
Accident type	Fire
Location	Seattle, Washington
Date	December 8, 2015
Time	0509 Pacific standard time (coordinated universal time – 8 hours)
Injuries	None
Property damage	\$380,000
Environmental damage	None
Weather	Light rain, visibility 4 miles, ¹ winds south-southeast at 8.1 mph, air temperature 52°F
Waterway information	Elliott Bay, also known as the Port of Seattle, is a deep water port within Puget Sound

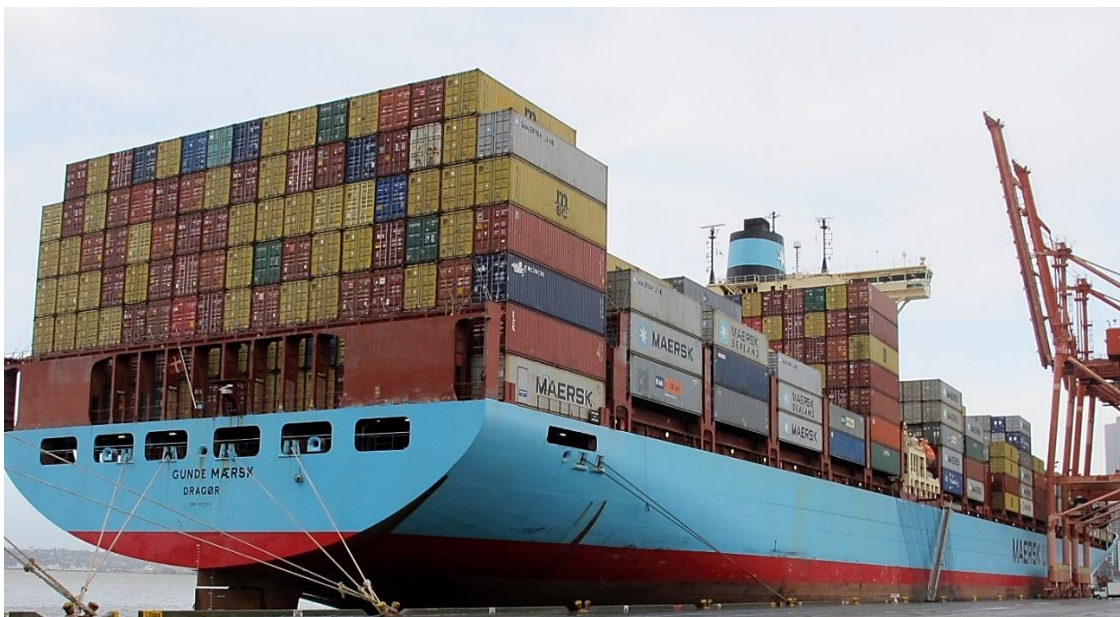
The 9,700 TEU *Gunde Maersk* at berth 37 in Seattle, Washington, on December 10, 2015.²

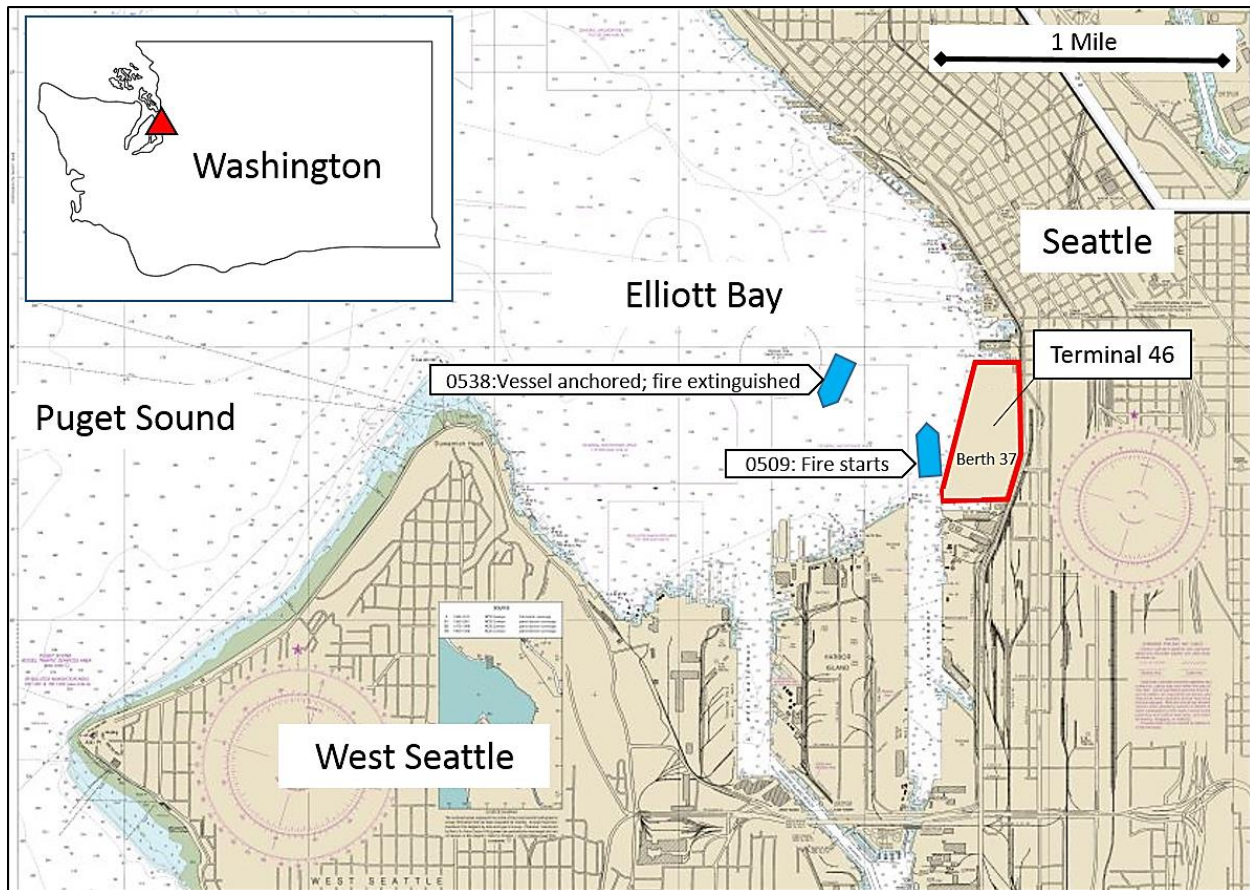
Chart showing the location of *Gunde Maersk* at the start of the fire and when the vessel anchored (vessel, shown in blue, not to scale). Inset shows the State of Washington with the accident site indicated by a red triangle. (Background NOAA Chart 18450)
