National Transportation Safety Board

Marine Accident Brief

Fire Aboard Towing Vessel *San Gabriel*

Accident no.	DCA16FM027
Vessel name	<i>San Gabriel</i>
Accident type	Fire
Location	LyondellBasell refinery dock "D," Houston, Texas; 29°43'23"N, 95°14'06"W.
Date	February 26, 2016
Time	About 2220 central standard time (coordinated universal time – 6 hours)
Injuries	None
Property damage	\$875,000 est.
Environmental damage	None
Weather	Clear night, visibility 10 miles, north winds about 15 mph, air temperature 50°F
Waterway information	Houston Ship Channel between Simms Bayou and Light 162, about 2 miles* east of Interstate 610.

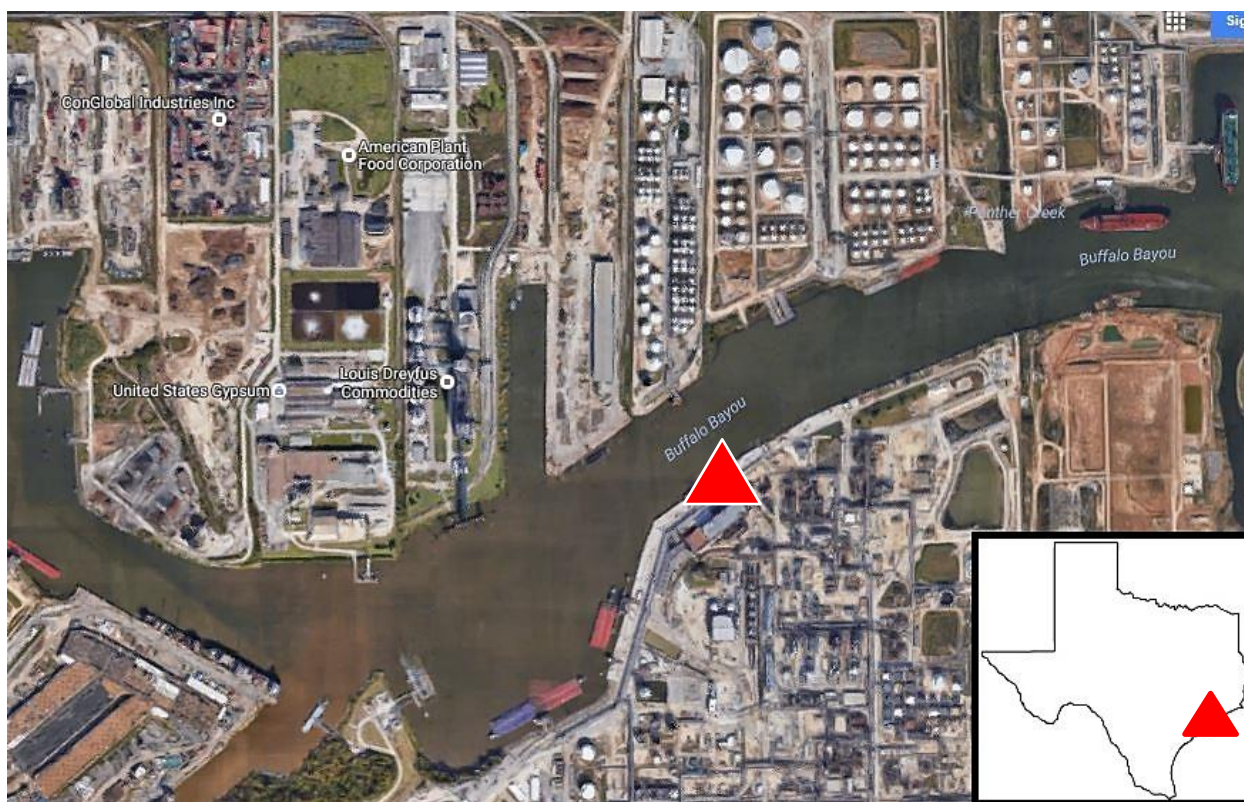
Aerial view of LyondellBasell refinery where *San Gabriel* was docked during the fire. The accident location is labeled with a red triangle.
