# **National Transportation Safety Board**

# **Marine Accident Brief**

# Allision of Passenger Vessel *Carnival Pride* with Pier and Passenger Walkway

Accident no.	DCA16FM038
Vessel name	Carnival Pride
Accident type	Allision
Location	Cruise Maryland Terminal, South Locust Point, Baltimore Harbor, Maryland 39°15.8' N, 076°35.8' W
Date	May 8, 2016
Time	0800 eastern daylight time (coordinated universal time – 4 hours)
Injuries	None
Property damage	\$2,085,000 est.
Environmental damage	None
Weather	Scattered clouds, clear visibility at 10 miles, air temperature 57°F, winds west- southwest at 4–6 knots
Waterway information	The Port of Baltimore, also known as Baltimore Harbor, is at the head of tidewater navigation on the Patapsco River in Chesapeake Bay. It is one of the major ports on the east coast of the United States. Currents in the harbor are 0.8 knot on the flood and ebb, with a mean range of tides at only 1.1 feet. <sup>1</sup>

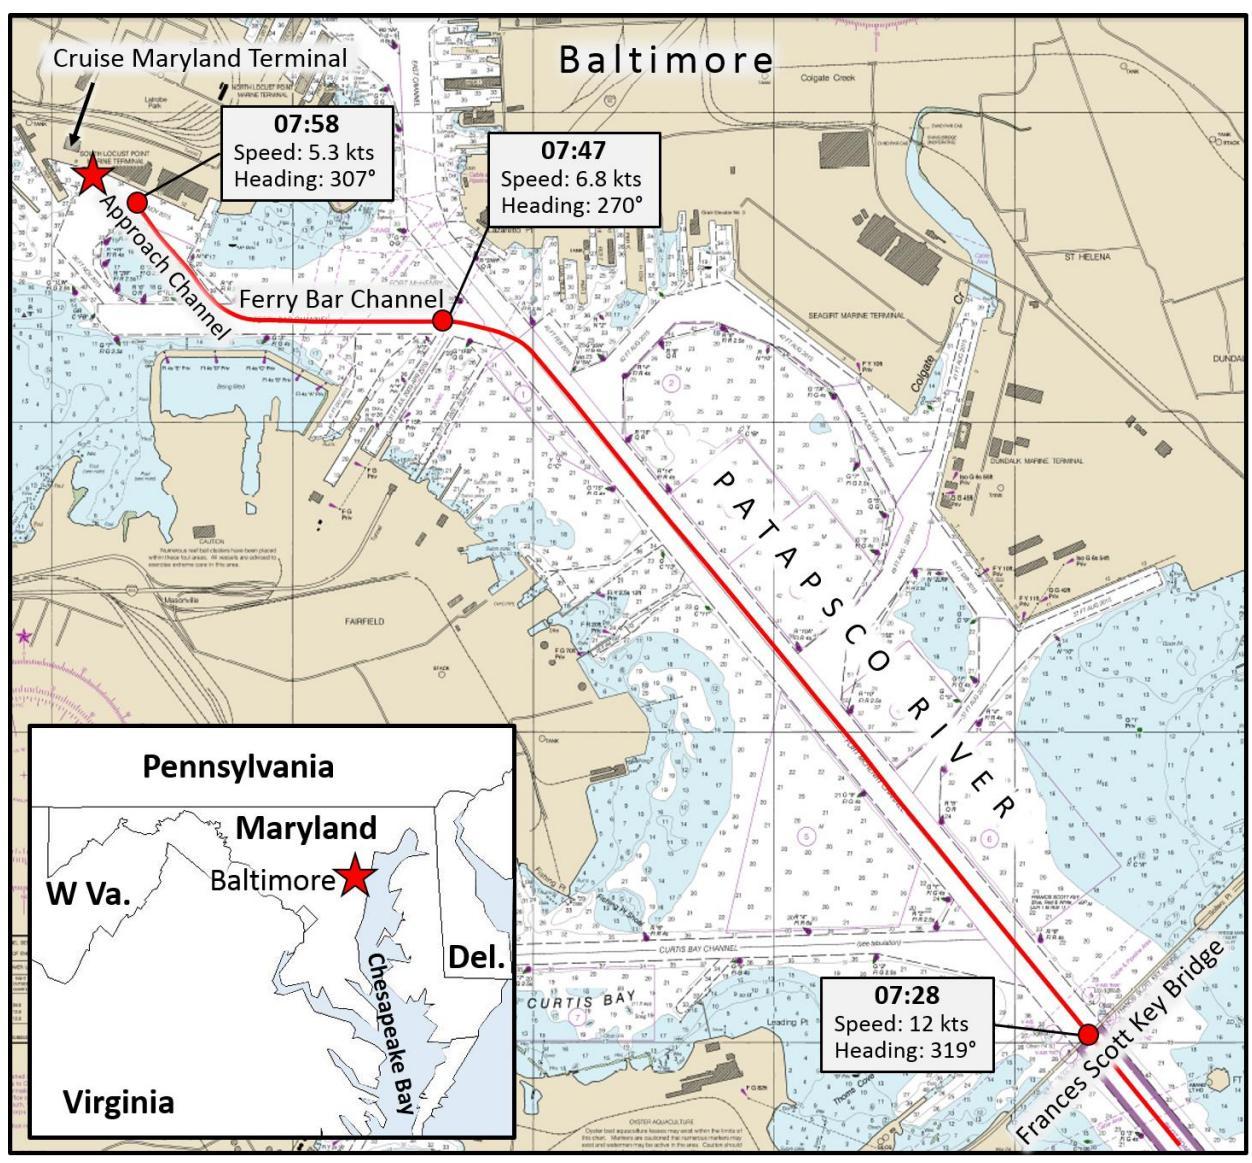
Excerpt from National Oceanic and Atmospheric Administration (NOAA) chart 12281 showing approach to cruise terminal via Patapsco River in Baltimore Harbor. The red star denotes the accident location and the red line shows the track of the *Carnival Pride* as it proceeded to the berth.
