National Transportation Safety Board

Marine Accident Brief

Allision of *Amy Frances* Tow with Natchez–Vidalia Highway 84 Bridge

Accident no.	DCA16FM020
Vessel names	<i>Amy Frances</i> , MM-46
Accident type	Allision
Location	Lower Mississippi River at mile marker 363.3 at Natchez, Mississippi 31°33.6' N, 091°25.2' W
Date	January 21, 2016
Time	1247 central standard time (coordinated universal time – 6 hours)
Injuries	None
Property damage	>\$542,000 est.
Environmental damage	24,654 gallons of catalytic cracked clarified oil
Weather	Visibility 10 miles, winds south at 10 mph, air temperature 71°F
Waterway information	The Lower Mississippi River near mile marker 363.3 was under an extreme high-water safety advisory from the US Coast Guard Captain of the Port due to “hazardous conditions associated with strong currents, severe outdrafts, [and] missing/off-station aids to navigation and diving buoys.”

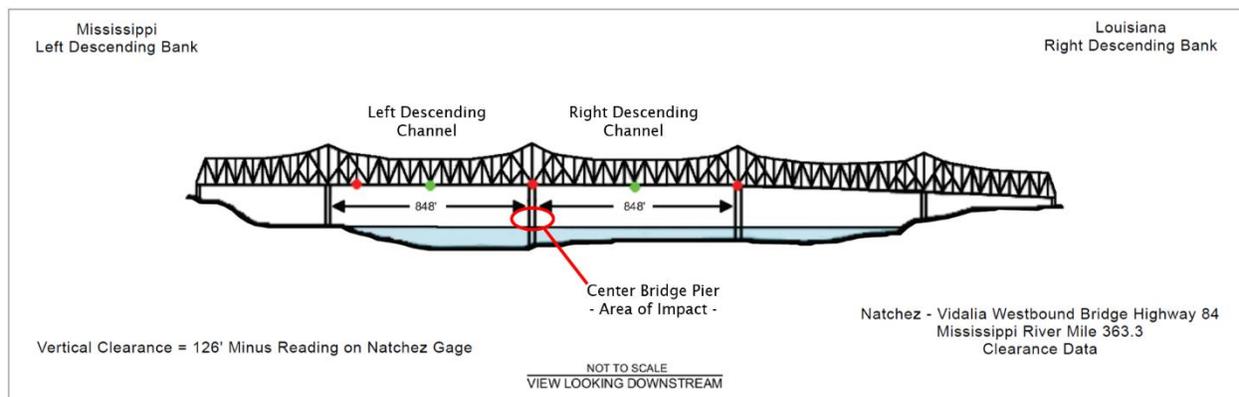
Natchez–Vidalia Highway 84 Bridge. (Diagram by US Army Corps of Engineers)

The Natchez–Vidalia Highway 84 Bridge has twin cantilever-style bridges that connect the cities of Natchez, Mississippi, and Vidalia, Louisiana. The upriver span is for westbound vehicular traffic and the downriver span for eastbound traffic. Both spans have six concrete piers—structures designed to support the spans—as pictured above. Three of the piers on each span form two main channels for vessels to navigate, the left descending channel and the right descending channel. The Army Corps of Engineers chart for the Lower Mississippi River lists the horizontal distance between the main channel piers as 848 feet, while the Coast Guard Light List states the distance
