National Transportation Safety Board

Marine Accident Brief

Collision of Tugboat Cerro Santiago with US Coast Guard Cutter Tampa

| Accident no. | DCA17PM011 |

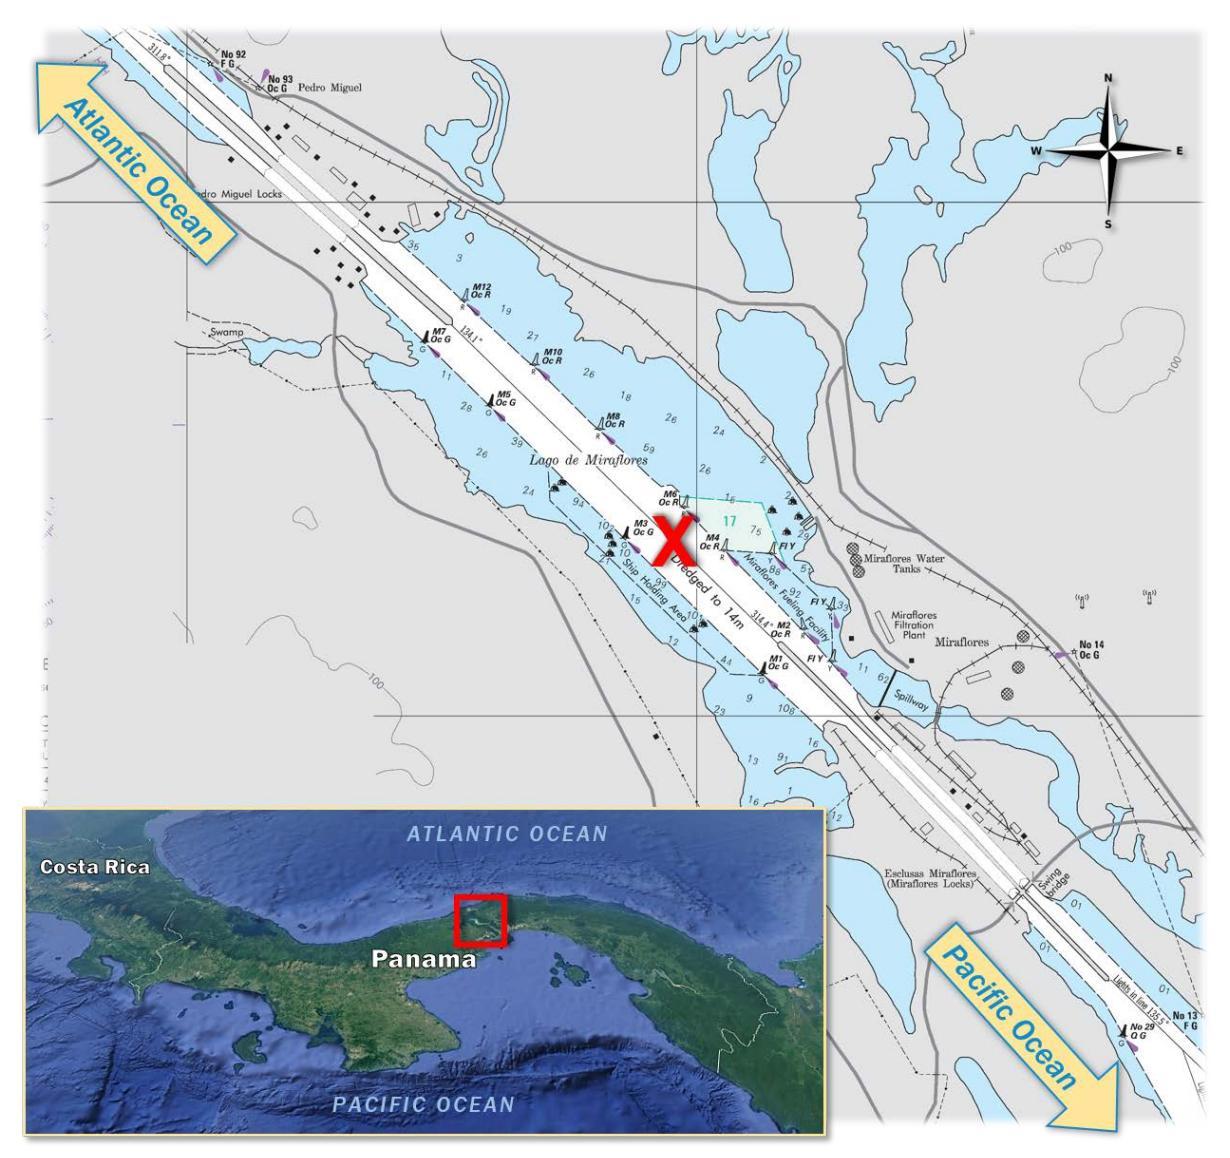
The accident area in Miraflores Lake, Panama Canal. (National Geospatial-Intelligence Agency chart 21602)
