National Transportation Safety Board

Marine Accident Brief

Grounding of Articulated Tug and Barge *Nathan E Stewart/DBL 55*

Accident no.	DCA17RM001
Vessel name	<i>Nathan E Stewart/DBL 55</i>
Accident type	Grounding
Location	Edge Reef, off Athlone Island in Seaforth Channel, northwest of Bella Bella, British Columbia, Canada
Date	October 13, 2016
Time	0108 Pacific daylight time (coordinated universal time – 7 hours)
Injuries	None reported
Damage	\$12 million est.
Environmental damage	Approximately 29,000 gallons of fuel and lube oil released
Weather	Light rain, visibility 6–10 miles, winds east 10–20 knots, gusts to 25 knots, seas 3 feet, air temperature 48°F*
Waterway information	The Seaforth Channel is part of the Inside Passage between Seattle, Washington, and Juneau, Alaska. The bottom and shoreline in that area is predominantly rocky.

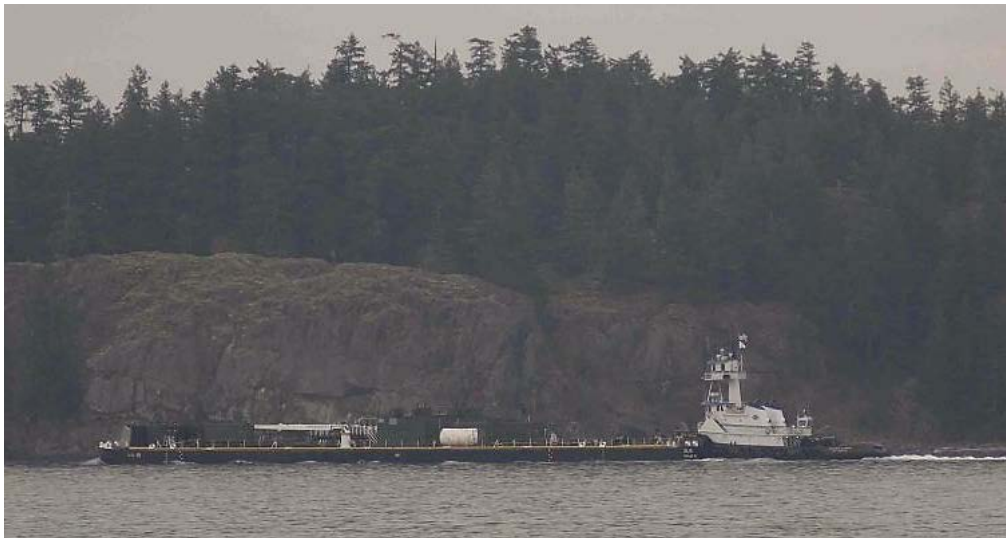
Nathan E Stewart/DBL 55 near Quadra Island, British Columbia, in November 2013. (Photo by Dirk Septer)

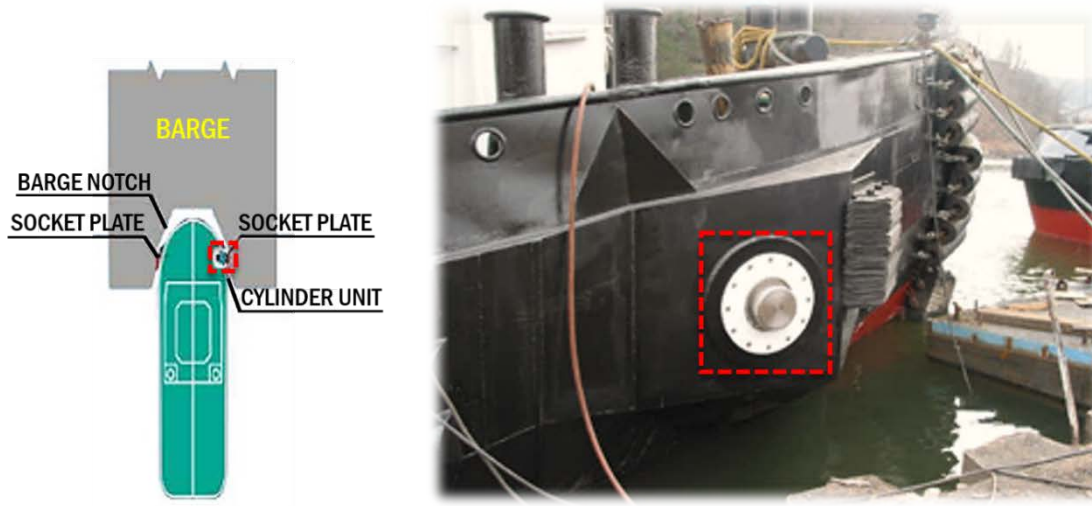
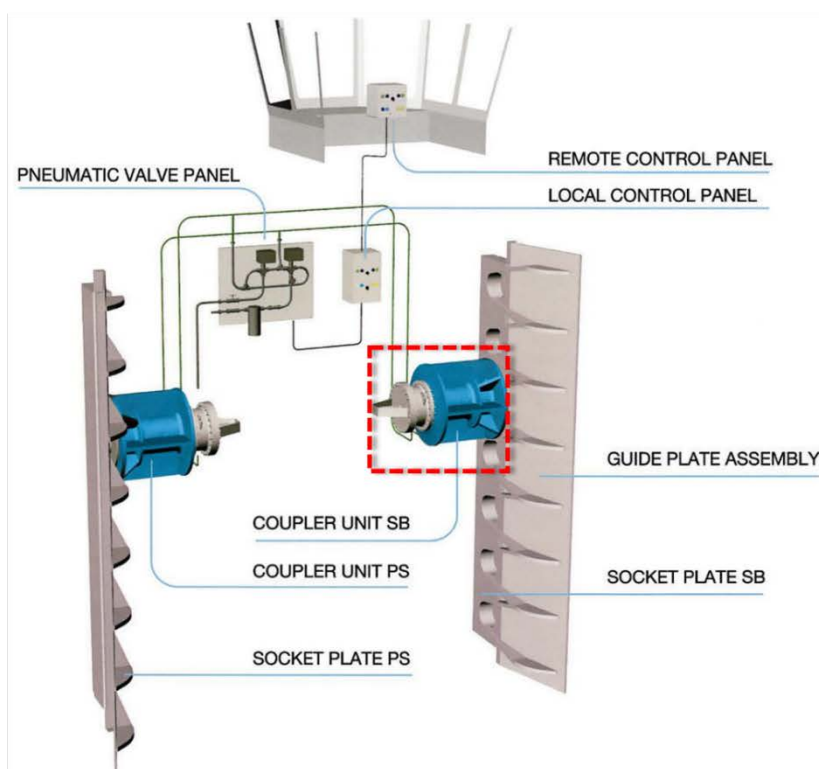
Pneumatically actuated pin on an unidentified tugboat and graphics detailing components of the JAK coupling system. (Images courtesy of Beacon Finland)
