National Transportation Safety Board

Marine Accident Brief

Allision of *Marguerite L. Terral* Tow with Krotz Springs Railroad Bridge

| Accident no. | DCA17FM017 |

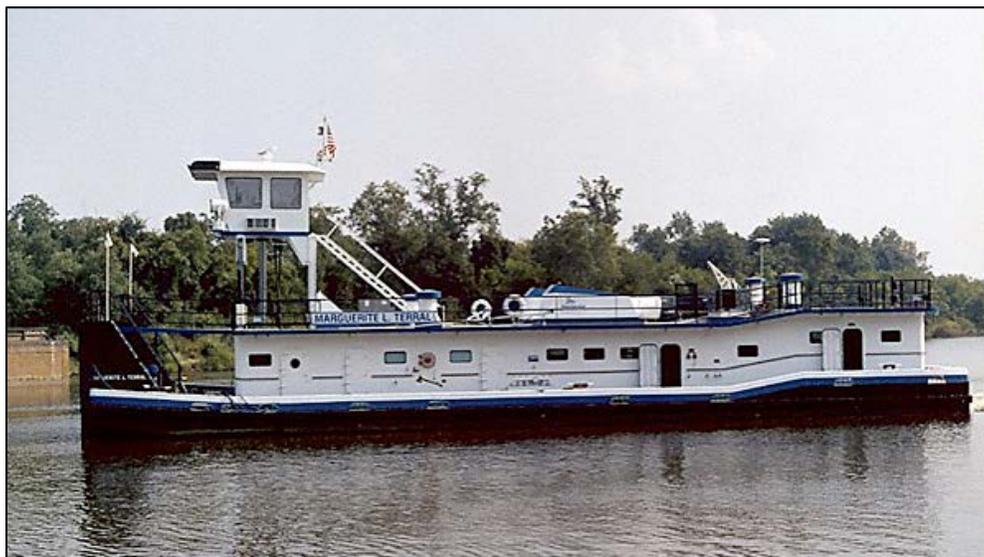
Marguerite L. Terral under way before the accident. (Photo courtesy of Terral River Service)

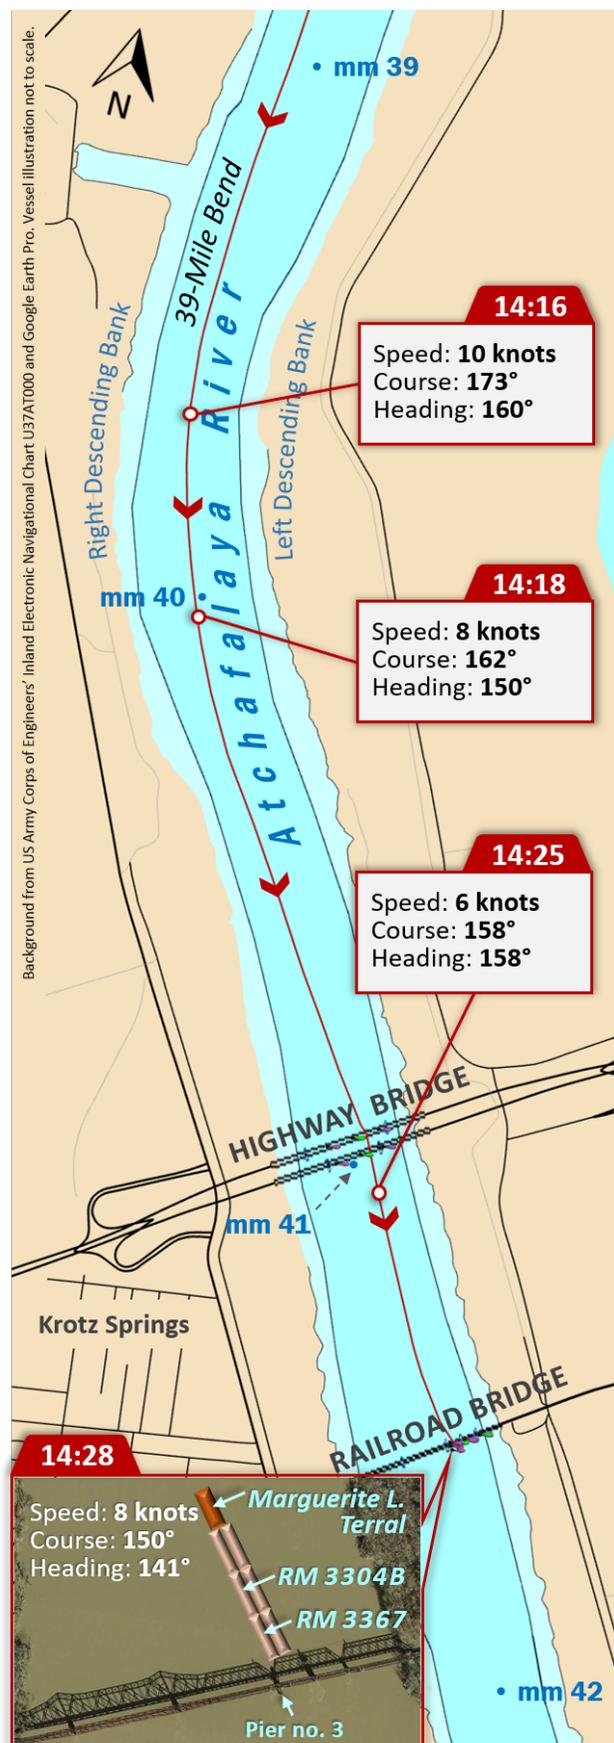
The force of the impact also caused pier no. 3, which supported the western portion of the fixed-bridge structure, to shift horizontally. Multiple large-diameter positioning pins and bolts attaching the northern and southern truss-mounting plates to the caisson were sheered. The fixed portion of the bridge truss on the western side shifted horizontally as well, causing a misalignment of the lift rail with the fixed and rider rails. The total damage resulting from the allision exceeded \$4 million.
