# National Transportation Safety Board

## Marine Accident Brief

### Grounding and Sinking of Towing Vessel *Eric Haney*

<b>Accident no.</b>	DCA17FM020
<b>Vessel name</b>	<i>Eric Haney</i>
<b>Accident type</b>	Grounding and sinking
<b>Location</b>	Upper Mississippi River, mile marker 13.4, near Cairo, Illinois 37°05.479' N, 89°16.263' W
<b>Date</b>	July 8, 2017
<b>Time</b>	2342 central daylight time (coordinated universal time – 5 hours)
<b>Injuries</b>	None
<b>Property damage</b>	\$4.3 million est.
<b>Environmental damage</b>	Oil sheen observed
<b>Weather</b>	Visibility 10 miles or greater, sky conditions clear, winds south at 5 knots (5.8 mph), air temperature 77°F, no precipitation reported in previous 24 hours
<b>Waterway information</b>	The Upper Mississippi River measured 27.7 feet high on the river gauge (at Cape Girardeau). The current was estimated at 3 mph.

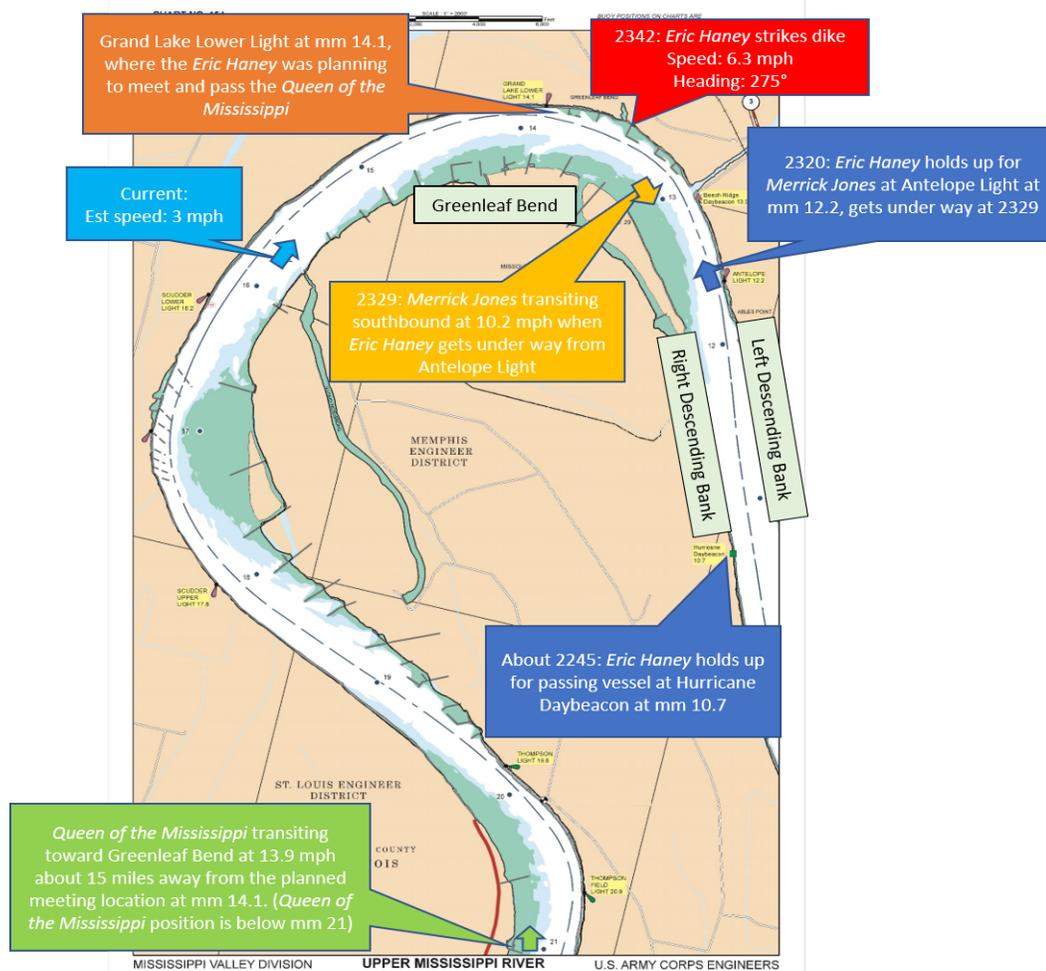
**Chart of Greenleaf Bend area. Accident location identified by red callout box. (Map from US Army Corps of Engineers)**
