National Transportation Safety Board

Marine Accident Brief

Flooding and Sinking of Fishing Vessel *Lady Damaris*

Accident no.	DCA17FM019
Vessel name	<i>Lady Damaris</i>
Accident type	Flooding
Location	Gulf of Mexico, about 32 miles* southeast of Galveston, Texas 28° 52.72' N, 094° 24.78' W
Date	June 22, 2017
Time	About 1140 central daylight time (coordinated universal time – 5 hours)
Injuries	None reported
Property damage	\$210,000 est.
Environmental damage	About 5,000 gallons of diesel fuel and lube oil resulting in oil sheen on water
Weather	Tropical storm Cindy, overcast, visibility 8 miles; winds southwest at 18 knots gusting to 24 knots, seas about 6 ft, air temperature 79°F
Waterway information	Open waters of the Gulf of Mexico; water depth about 70 feet at accident site

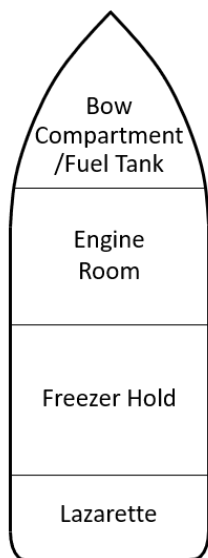
General layout of *Lady Demaris* below main deck, with primary bulkheads. (Dimensions and bulkhead locations not to scale.)

to a freezer hold and the lazarette. Below the main deck, the vessel had three bulkheads. Although the forward engine room bulkhead was originally designed to be watertight, the captain stated that the door on the bulkhead that led to the bow compartment was not watertight. He also said that there may have been small openings around wire and piping runs passing through the bulkhead between the engine room and freezer hold.

Water leaking into the vessel entered the engine room through a 2.5-inch drain pipe from the freezer hold. Although there was a valve in the drain line that could have isolated the engine room from the leak in the hold, the captain told investigators that he kept the valve open so that water coming in through the hull would flow into the engine room to the two fixed bilge pumps. The crew did not close the valve in the freezer hold drain line during the entire voyage.

The pipe between the freezer hold and the engine room, a common feature in shrimping vessels, was designed to drain melted ice and seawater into the engine room, where the water could be pumped out by the bilge pumps. This pipe was fitted with a valve accessible from the engine room. Crewmembers stated that the valve was not shut throughout the voyage. The crew left the valve open in order to remove water using the two pumps in the engine room, rather than solely relying on the portable pump that they had placed in the freezer. Had the valve been shut once the pumps in the engine room failed, progressive flooding into the engine room would have been slowed.
