National Transportation Safety Board

Marine Accident Brief

Pipeline Breach and Subsequent Fire aboard Cutter Suction Dredge *Jonathon King Boyd* and Towboat *Bayou Chevron*

Accident type	Fire/Explosion	No. DCA18FM021
Vessel names	<i>Jonathon King Boyd</i> (dredge), <i>Bayou Chevron</i> (towboat)	
Location	Matagorda Bay, Texas, 28°27.54'N 96°23.02'W	
Date	April 17, 2018	
Time	2014 central daylight time (coordinated universal time – 5 hours)	
Injuries	None	
Property damage	Total of about \$7.3 million est.	
Environmental damage	3,458 barrels of condensate and 12,680 MSCF of natural gas released, est. ¹	
Weather	Clear, visibility 8 miles, winds south-southeast at 8–10 mph, less than 1-foot waves, air temperature 72°F, water temperature 71°F ²	
Waterway information	Matagorda Bay is a large estuary on the Texas coast, about 80 miles northeast of Corpus Christi. The Gulf Intracoastal Waterway channel at the intersection with Matagorda Ship Channel has a controlling depth of 10 feet.

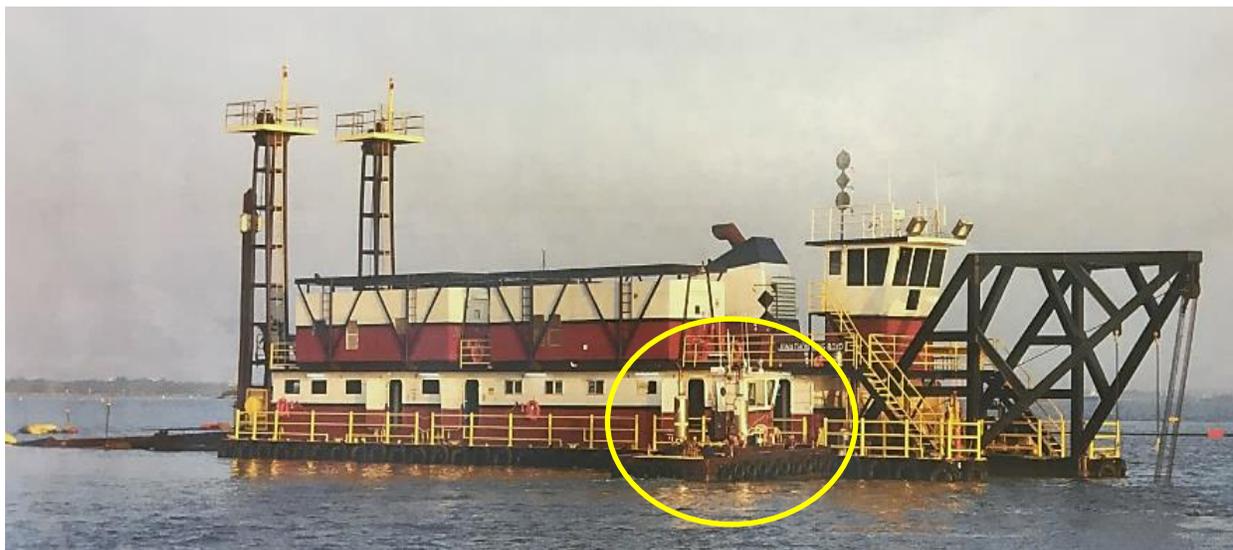
Jonathon King Boyd in Port Lavaca, Texas, before the accident. In this photo, towboat *Bayou Chevron* (marked by a yellow circle) is positioned on the dredge's starboard side. (Photo by RLB Contracting Inc.)
