National Transportation Safety Board

Marine Accident Brief

Flooding and Sinking of Hopper Barge *PTC 598*

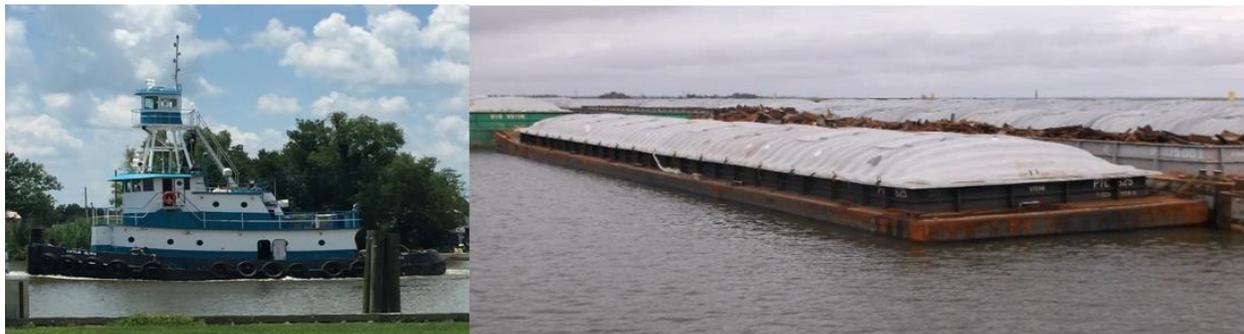
Left, towing vessel *Kaitlin Olivia*. Right, barge *PTC 625* (same class as the *PTC 598*) with its fiberglass cargo covers closed. (Photos courtesy of LA Carriers and Parker Towing Company)

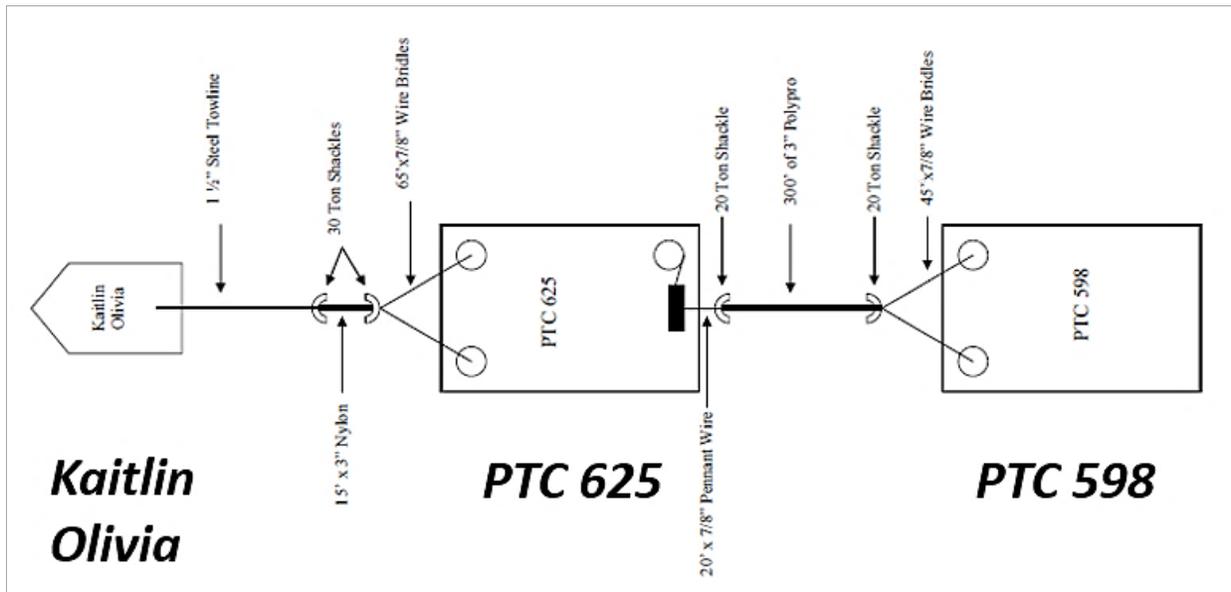
Tow diagram of the *Kaitlin Olivia* and the two barges on the accident voyage. (Source: LA Carriers)

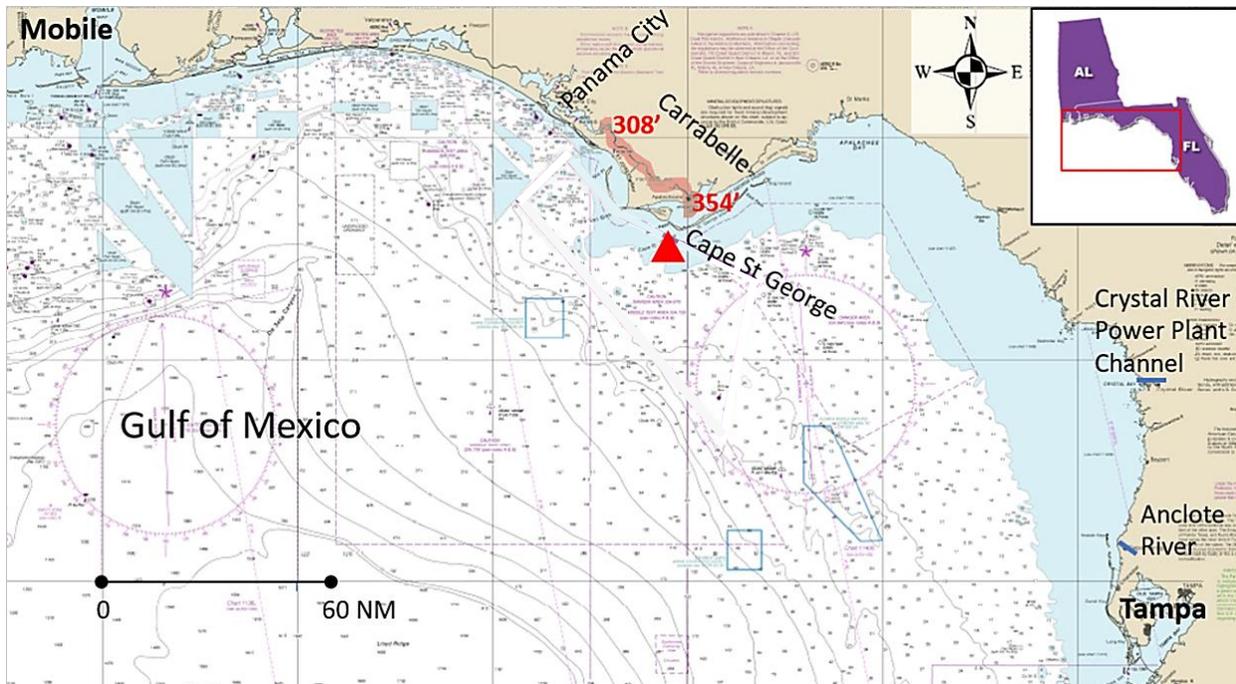
The coastline from Tampa to Mobile. The red triangle marks the position where barge *PTC 598* sank. The 140-mile stretch of the Intracoastal Waterway (ICW) between Anclote River and Carrabelle, Florida, is not protected. Shaded in red near the top center of the image is the ICW between miles 308 and 354, where shoaling was reported. (NOAA Chart 11006)
