# National Transportation Safety Board

## Marine Accident Brief

### Contact of *Bettye M. Jenkins* Tow with Bunge Grain Facility

<b>Accident type</b>	Contact	<b>No.</b> DCA19FM018
<b>Vessel names</b>	<i>Bettye M. Jenkins</i> and barge <i>T9353</i>	
<b>Location</b>	Lower Mississippi River, mile 361, near Vidalia, Louisiana 31°32.95' N, 091°26.43' W	
<b>Date</b>	February 15, 2019	
<b>Time</b>	0130 central standard time (coordinated universal time – 6 hours)	
<b>Injuries</b>	None	
<b>Property damage</b>	\$3.3 million est.	
<b>Environmental damage</b>	None	
<b>Weather</b>	Visibility 10 miles, partly cloudy, winds south 4 knots, air temperature 60°F	
<b>Waterway information</b>	The Lower Mississippi River near mile marker 361 is 0.6 mile wide with a maintained channel depth of 9 feet. At the time of the accident, the river near mile marker 361 was at flood stage, and a high-water safety advisory was in effect. The river stage near Vidalia, at Natchez, Mississippi, was 49.1 feet.

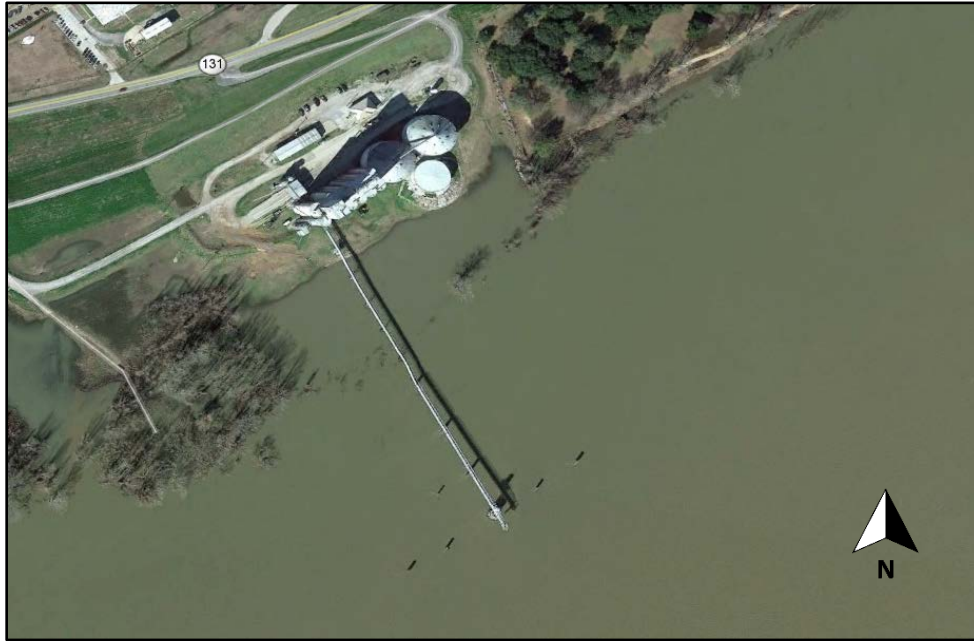
The Bunge grain facility, located 2 miles downriver of the Natchez Bridge (US Route 84), handled corn, wheat, and soybeans. The facility included storage silos connected by a conveyor belt that was supported by trusses and extended approximately 700 feet out into the river. The loading cell at the end of the structure was marked by a green light. Four mooring dolphins were installed parallel with the shore on either side of the loading cell (2 upriver and 2 downriver). The northernmost and southernmost dolphins were marked by lights.

The Bunge facility, including silos, conveyor, and mooring pilings. (Source: Google Earth)
