National Transportation Safety Board

Marine Accident Brief

Contact of Cruise Ship *Norwegian Epic* with San Juan Cruise Port Pier 3

Accident type	Contact	No. DCA19FM016
Vessel name	<i>Norwegian Epic</i>	
Location	Pier 3 east, Old San Juan Cruise Port, San Juan, Puerto Rico 18°27.58' N, 066°06.67' W	
Date	February 12, 2019	
Time	1724 Atlantic time (coordinated universal time – 4 hours)	
Injuries	None	
Property damage	\$3.7 million est.	
Environmental damage	None	
Weather	Visibility 10 miles, partly cloudy, winds easterly at 11 knots, gusts 21 knots; easterly waves at 2–3 feet, current setting west at 1 knot, air temperature 79°F, water temperature 78°F ¹	
Waterway information	San Juan harbor generally runs in an east to west direction after entering from the Atlantic. The cruise ship piers of Old San Juan are situated at the northern part of the harbor.

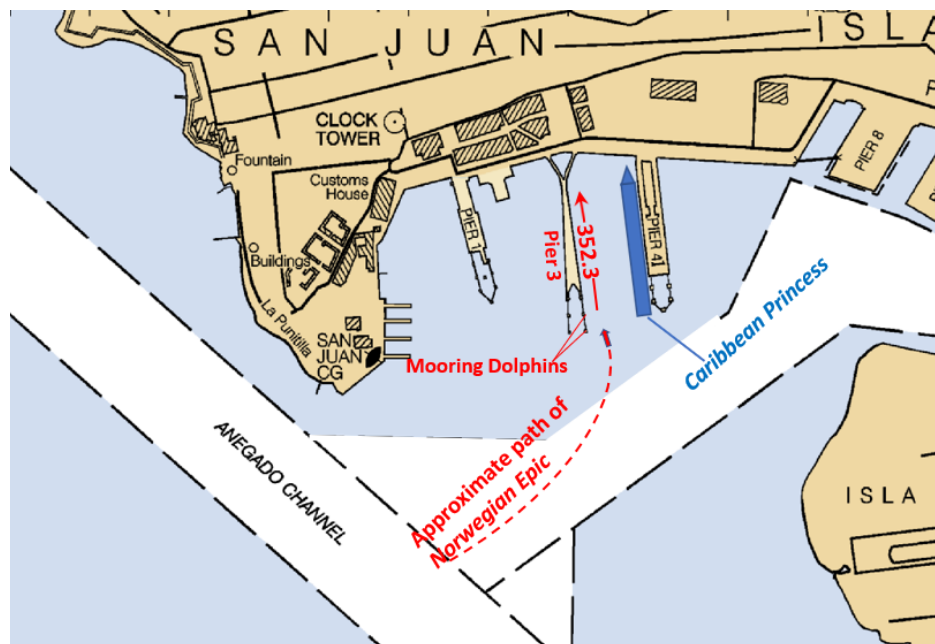
Berthing area and approximate path of the *Norwegian Epic*. The *Caribbean Princess* is not to scale. (Background source: NOAA chart 25670)
