National Transportation Safety Board

Marine Accident Brief

Collision Between *Miss Dixie* Tow and *D. & R. Boney* Tow

Accident type	Collision	No. DCA19FM017
Vessel names	<i>Miss Dixie</i> , <i>D. & R. Boney</i> , and barges <i>AEP 7235</i> , <i>005024</i> , <i>005028</i> , <i>005492</i> , and <i>005495</i>	
Location	Lower Mississippi River, Mile 104, New Orleans, Louisiana 29°56.91' N, 90°8.44' W	
Date	February 13, 2019	
Time	1917 central standard time (coordinated universal time – 6 hours)	
Injuries	None	
Property damage	\$294,530 for barges <i>AEP 7235</i> , <i>005024</i> , <i>005028</i> , <i>005495</i>	
Environmental damage	None	
Weather	Visibility 15 miles, clear, winds from the south at 5 miles per hour (mph), air temperature 51°F	
Waterway information	Carrollton Bend at mile 104 near Nine Mile Point in the Lower Mississippi River, approximately 2 miles downriver from Huey P. Long Bridge. ¹ Current estimated at 4–5 mph. The Carrollton river gage was 13.6 feet.

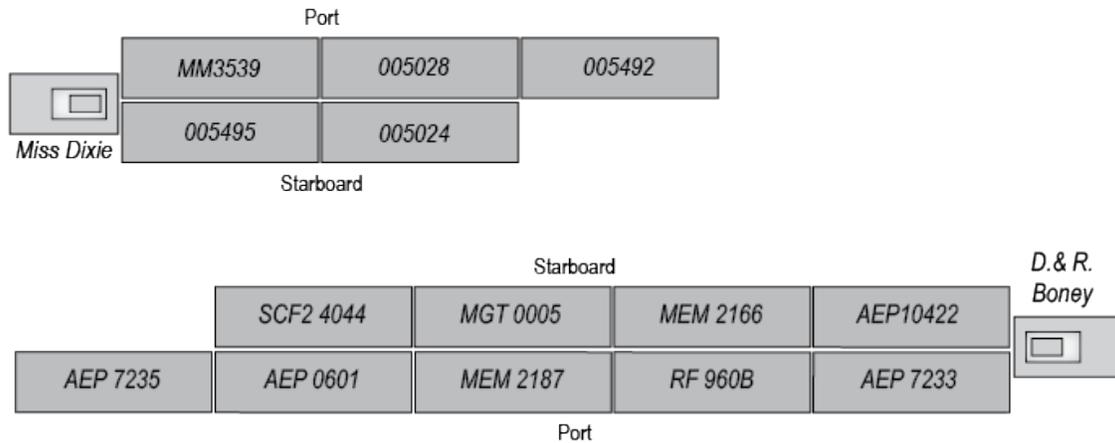
Simplified towing arrangements of the *Miss Dixie* and the *D. & R. Boney* on the evening of the accident (not to scale).

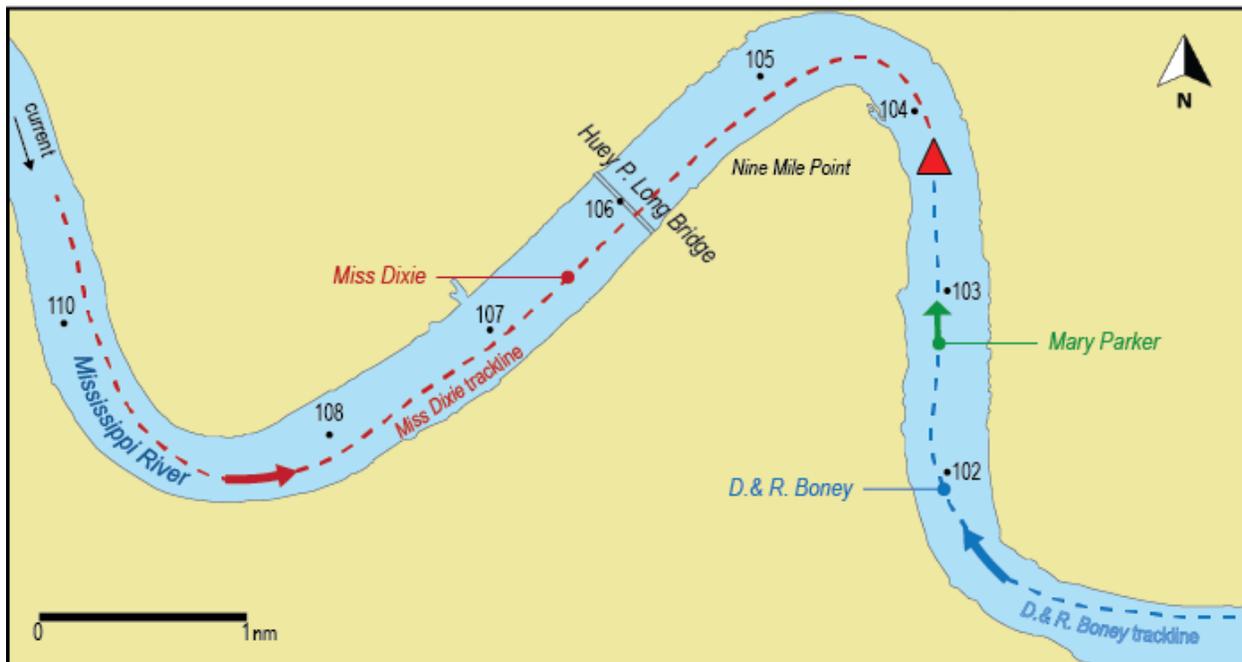
Location of the *Miss Dixie*, *D. & R. Boney*, and *Mary Parker* at 1900 and approximate tracklines of the *Miss Dixie* and the *D. & R. Boney*, with the accident location marked with a red triangle. (Source: US Coast Guard Vessel Traffic Service [VTS])

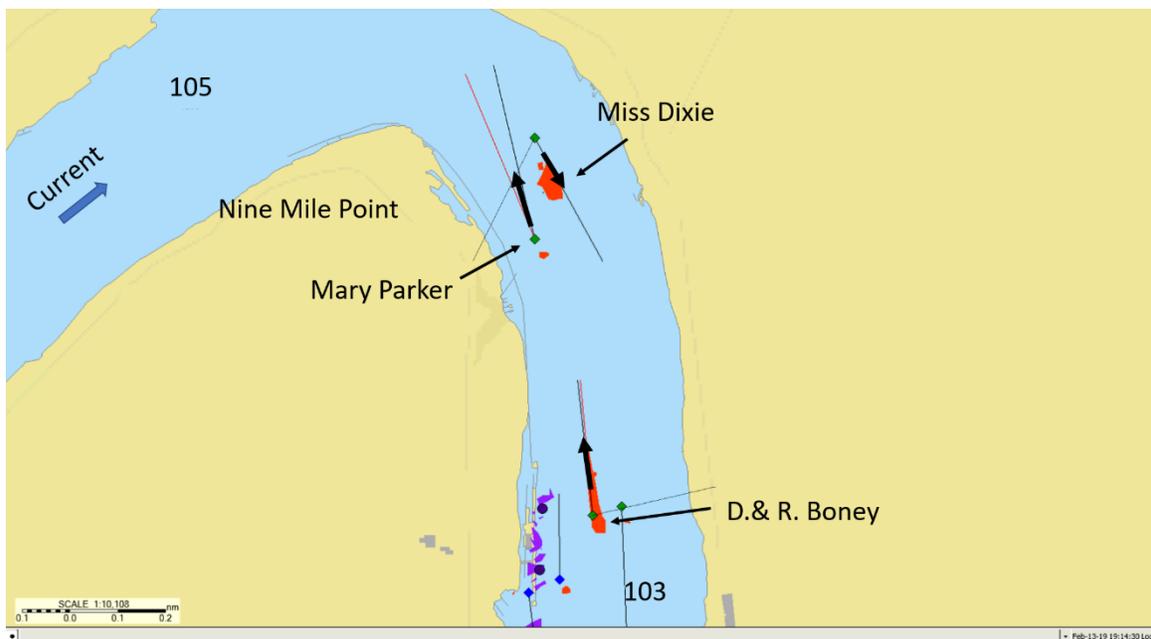
Location of the *Miss Dixie* and *D. & R. Boney* at 1914:30. (Coast Guard VTS)
