National Transportation Safety Board

Marine Accident Brief

Contact of Towing Vessel *DeJeanne Maria* with Submerged Dredge Pipe

Accident type	Contact	No. DCA19FM030
Vessel name	<i>DeJeanne Maria</i>	
Location	Lower Mississippi River, mile 0, Head of Passes, near Pilottown, Louisiana 29°09.26' N, 089°14.86' W	
Date	April 15, 2019	
Time	0044 central daylight time (coordinated universal time – 5 hours)	
Injuries	None	
Property damage	\$650,000 est.	
Environmental damage	Oil sheen (diesel oil, estimated volume released 70 gallons)	
Weather	Visibility 10 miles, clear, winds north at 10 knots; air temperature 56°F, water temperature 75°F	
Waterway information	Mississippi River close to where it empties into the Gulf of Mexico where the river splits into three larger passes: Southwest Pass, South Pass, and Pass A Loutre. This area of large and smaller passes, taken together, form the delta of the river.

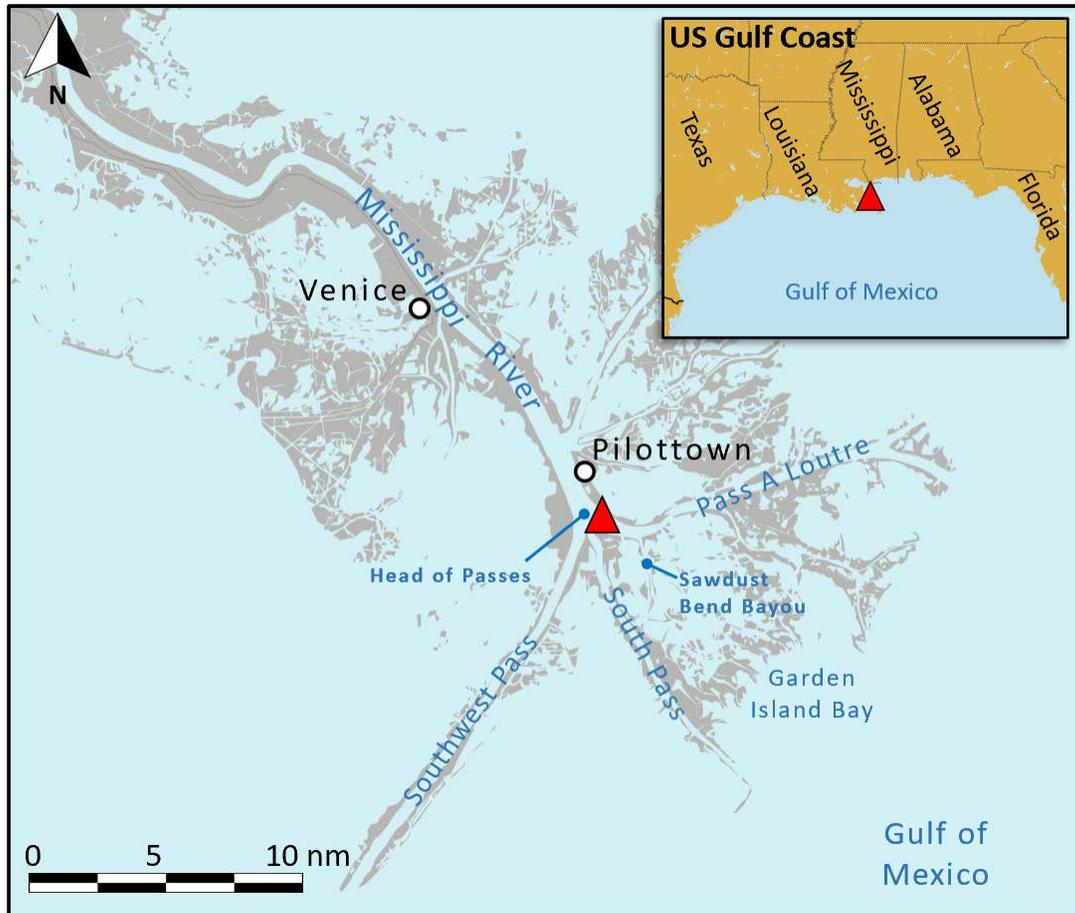
Area of accident where the *DeJeanne Maria* struck the submerged dredge pipe indicated by the red triangle. (Background source: Google Maps)
