National Transportation Safety Board

Marine Accident Brief

Contact of *Dewey R* Tow with CSX Railroad Bridge Protection Cell

Accident type	Contact	No. DCA19FM031
Vessel name	<i>Dewey R</i> and <i>ATC 3404</i>	
Location	Chicago Sanitary and Ship Canal, CSX Railroad Bridge, mile 312.3, Summit, Illinois 41°46.98' N; 87°49.58' W	
Date	April 13, 2019	
Time	0123 central daylight time (coordinated universal time – 5 hours)	
Injuries	None	
Property damage	\$162,104 to barge <i>ATC 3404</i> , est. \$813,980 in damage to bridge protection cell	
Environmental damage	None	
Weather	Temperature 38°F, winds from the northwest about 25 mph, clear visibility	
Waterway information	The Chicago Sanitary and Ship Canal is a waterway linking the south branch of the Chicago River with the Des Planes River at Lockport, Illinois. The canal is 30 miles long and has a minimum width of 160 feet, a minimum depth of 9 feet, and 2 locks.

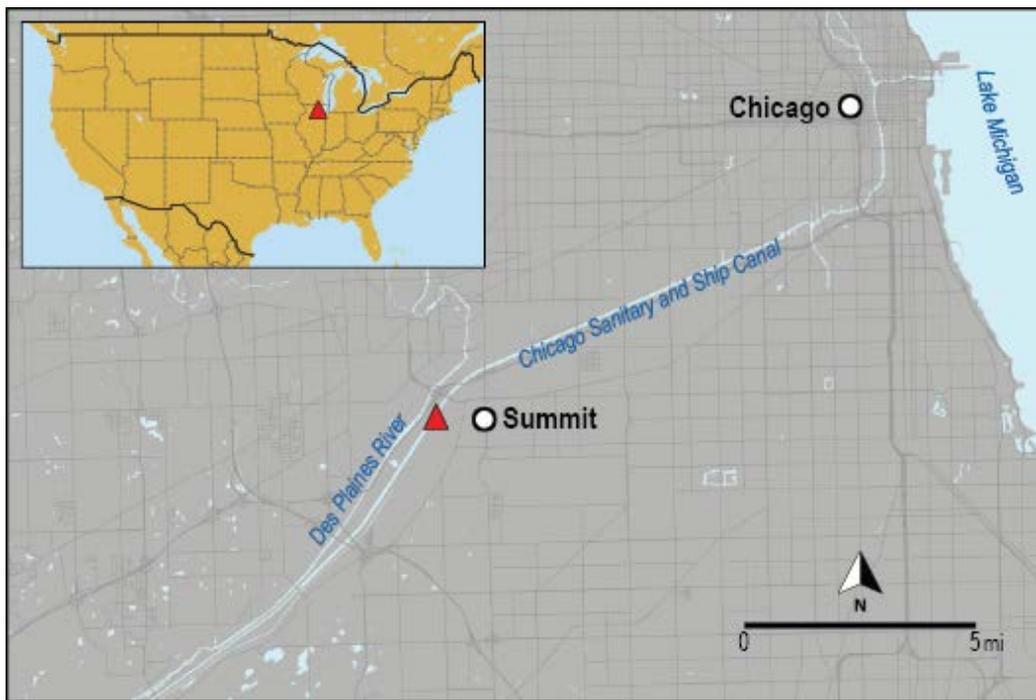
Location of the *Dewey R* when the tow struck the CSX Railroad Bridge protection cell. (Background source: Google Maps)

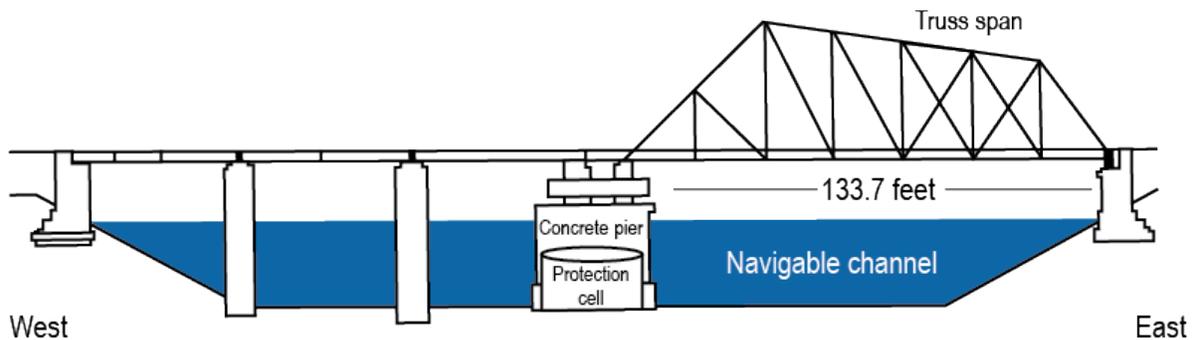
Graphic of CSX Railroad Bridge, as seen from the south, showing the navigable channel on the right side. (Background source: US Army Corps of Engineers)
