National Transportation Safety Board

Marine Accident Brief

Contact of Crane Barge *Mr Ervin*, Pushed by Towing Vessel *Kristin Alexis*, with Sunshine Bridge

Accident type	Contact	No. DCA19FM003
Vessel name	<i>Kristin Alexis</i>	
Location	Lower Mississippi River, mile 167.4, St. James Parish, about 30 miles downriver of Baton Rouge, Louisiana ¹ 30°05.86' N, 90°54.81' W	
Date	October 12, 2018	
Time	0141 central daylight time (coordinated universal time – 5 hours)	
Injuries	None	
Property damage	\$7 million est.	
Environmental damage	None	
Weather	Clear skies with visibility at 10 miles, winds north-northeast at 6 mph; air temperature 62°F, water temperature 77.5°F	
Waterway information	The Mississippi River at the Sunshine Bridge is about 2,550 feet wide, bank to bank. At the time of the accident, the river gage at Donaldsonville was at 18.37 feet, and the current was about 3 mph. (Flood stage was in effect at 27 feet.)

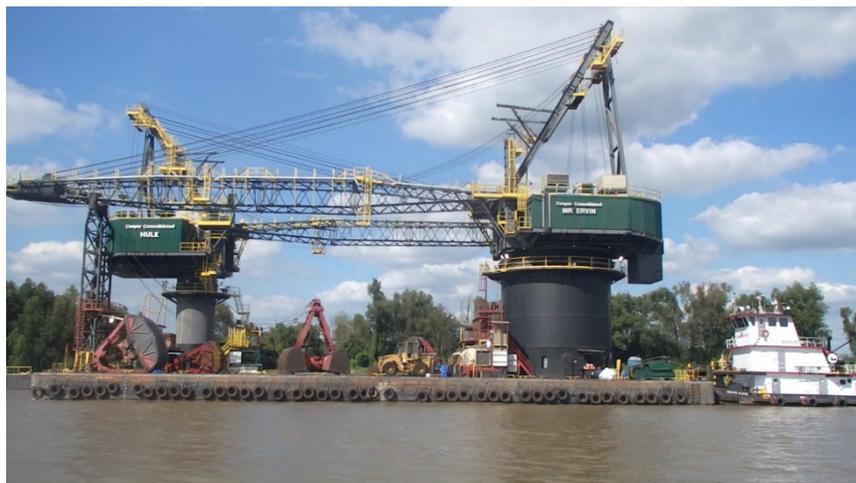
Figure 1. The *Kristin Alexis* and crane barge *Mr Ervin* configuration. (Source: US Coast Guard)

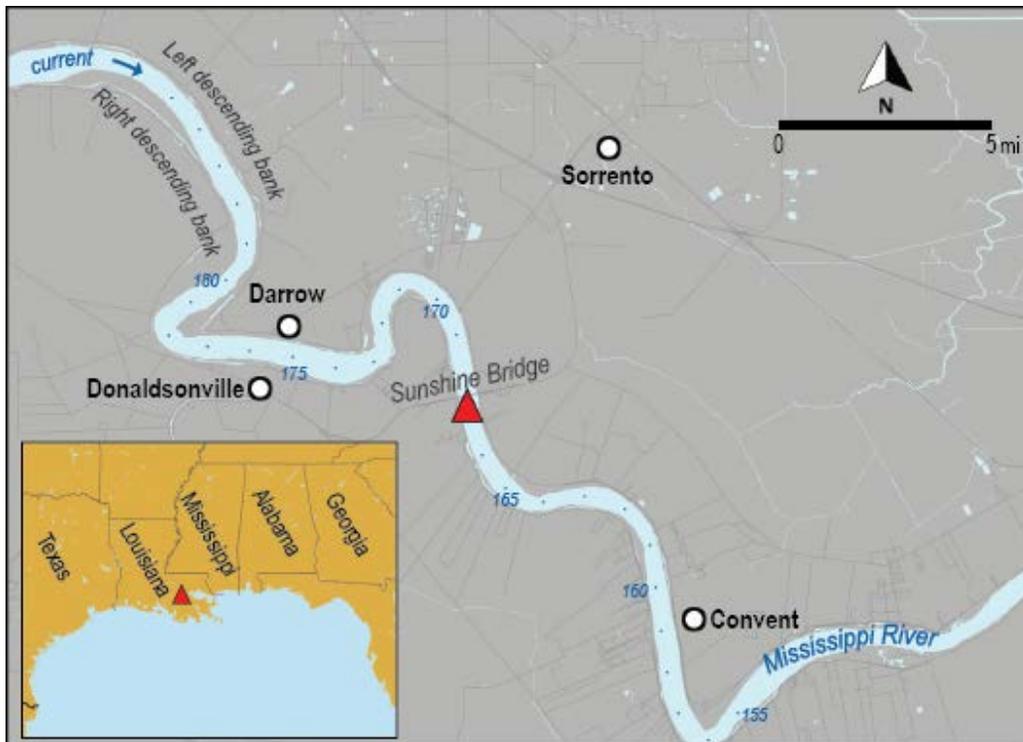
Figure 2. Location where the *Kristin Alexis/Mr Ervin* struck the Sunshine Bridge, marked by the red triangle. (Background source: Google Earth)
