National Transportation Safety Board

Marine Accident Brief

Flooding and Sinking of Towing Vessel *Mangilao* Towed by *Chamorro*

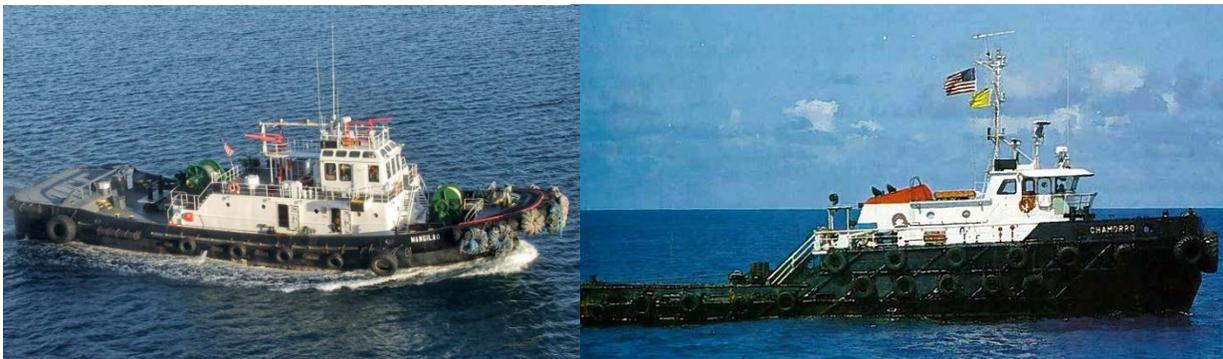
Mangilao (on left) and *Chamorro* (on right) under way prior to the accident voyage. (Source: Cabras Marine Corporation)
