National Transportation Safety Board

Marine Accident Brief

Contact of Bulk Carrier *Atlantic Huron* with the Soo Locks West Center Pier

Accident type	Contact	No. DCA20FM023
Vessel name	<i>Atlantic Huron</i>	
Location	Soo Locks, Saint Marys River, Sault Sainte Marie, Michigan 46°30.16' N, 84°22.09' W	
Date	July 5, 2020	
Time	0250 eastern daylight time (coordinated universal time – 4 hours)	
Injuries	None	
Property damage	\$2.2 million est.	
Environmental damage	None	
Weather	Visibility 6 miles, scattered clouds, winds from southeast at 1.7 knots, calm water, air temperature 63°F, water temperature 67°F ¹	
Waterway information	The 77-mile St. Marys River flows in a general southeast direction and connects Lake Superior to Lake Huron. The Soo Locks, located in Sault Sainte Marie, Michigan, allow vessels to navigate a 21-foot elevation difference in the river. The water depth at the locks is about 28 feet.

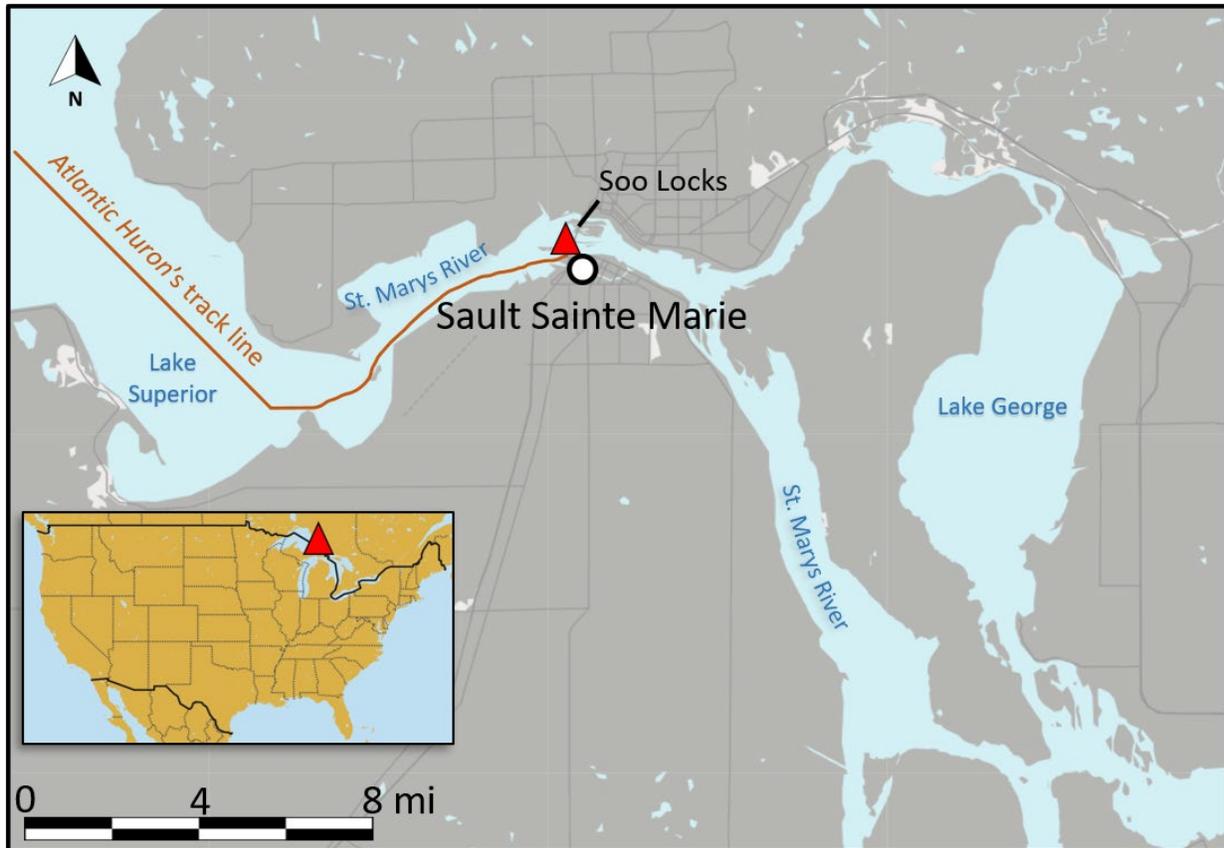
Area of accident where the *Atlantic Huron* contacted the west center pier, as indicated by the red triangle. (Background source: Google Maps)
