Issued November 10, 2021

MAB-21/24

Contact of Tanker *Atina* with Oil and Gas Production Platform SP-57B

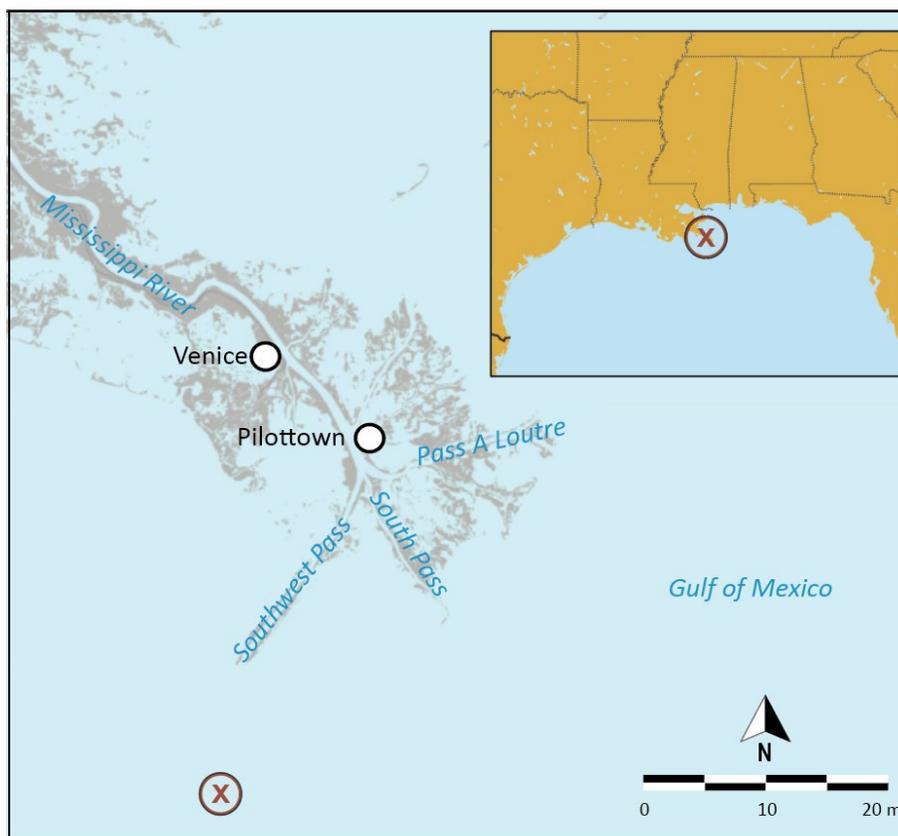
Figure 2. Area of accident where the *Atina* struck platform SP-57B, as indicated by the red circle. (Background source: Google Maps)
