Grounding of U.S. Passenger Vessel  
*Empress of the North*  
Intersection of Lynn Canal and Icy Strait  
Southeast Alaska  
May 14, 2007

ACCIDENT REPORT

NTSB/MAR-08/02  
PB2008-916402

# Marine Accident Report

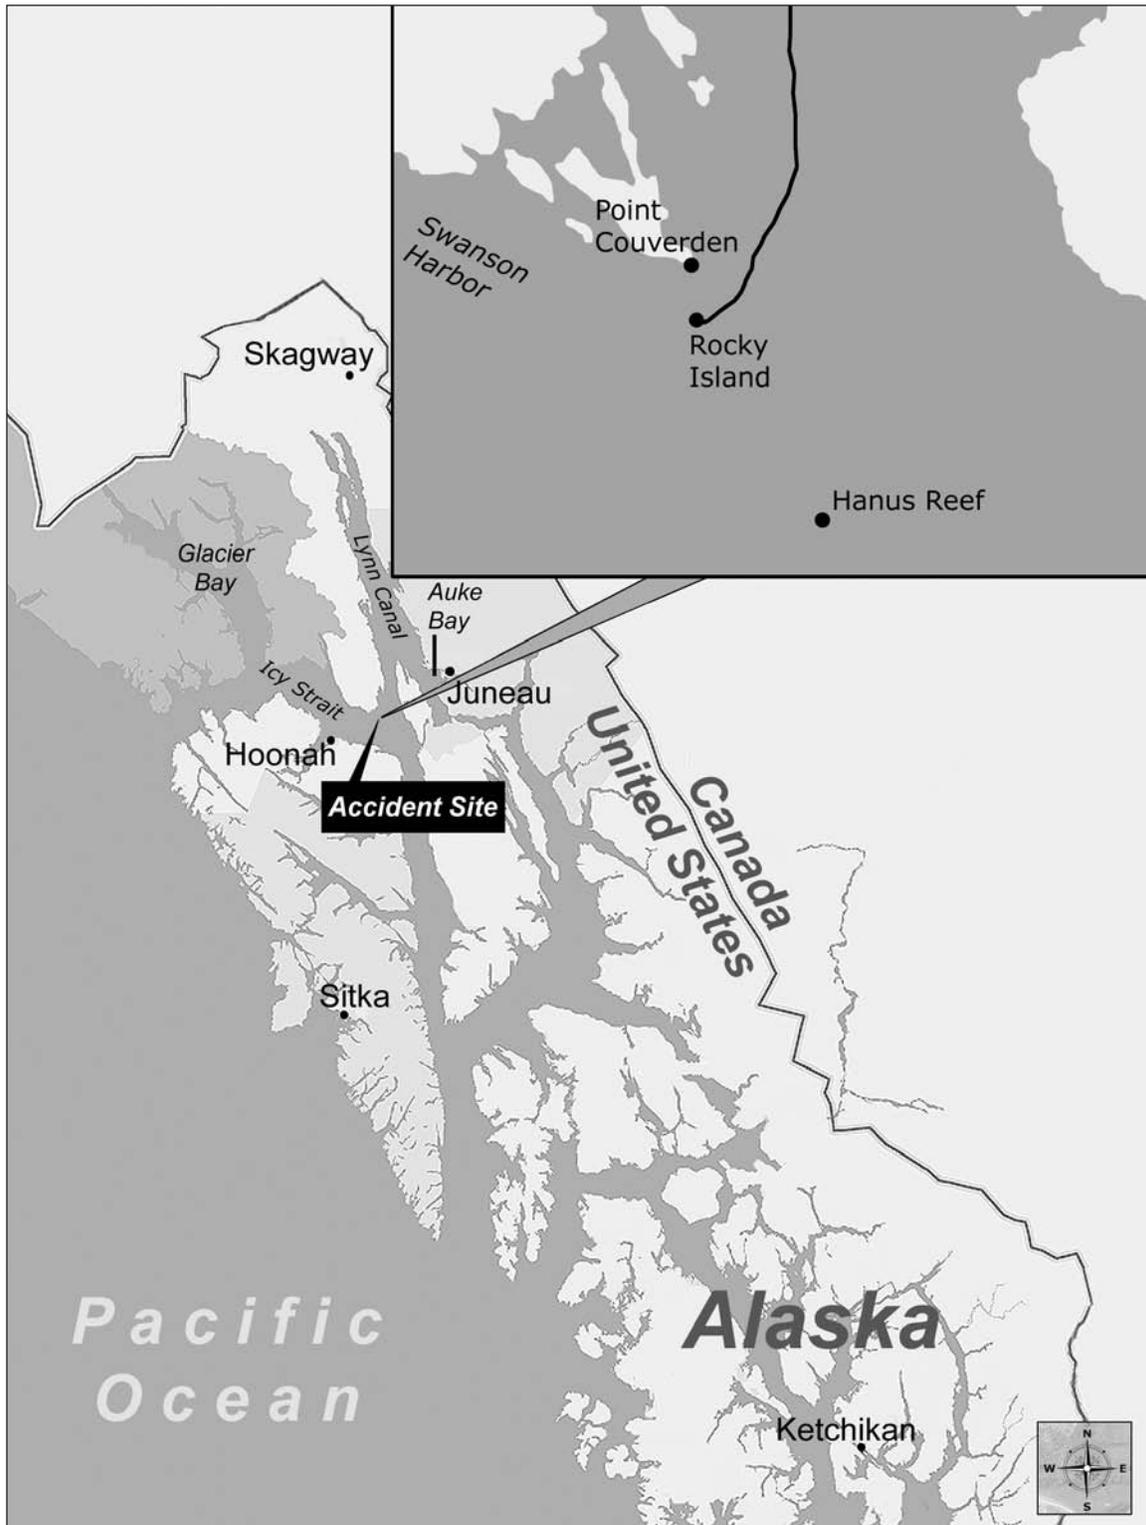
**Figure 2.** *Empress of the North* accident site and other southeast Alaska locations referenced in the report. Inset shows the vessel's path to its grounding on Rocky Island.

The grounding occurred in the Inland Passage of southeast Alaska off Point Couverden, which is at the southernmost end of an isthmus that extends into the junction of the east end of Icy Strait (running northwest to southeast) and Lynn Canal (running roughly north and south). The ship grounded on the southeastern shoals of Rocky Island (58° 10.6' N and 135° 03.1' W). (Refer to figure 2.)

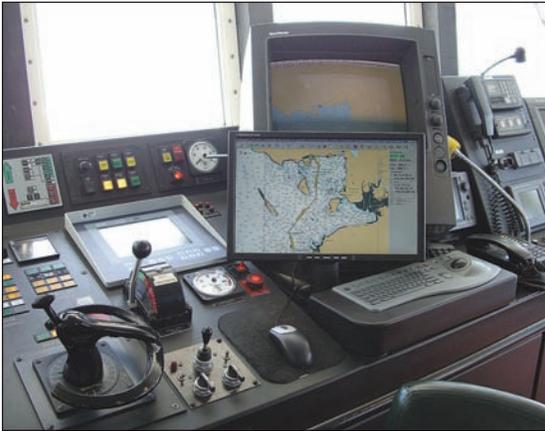
The monitors for the two electronic navigation charts were next to the helmsman's station (figure 4). The Nobeltec showed a trackline going between Rocky Island and Point Couverden, the ECDIS showed a trackline going south of Rocky Island, and the paper chart showed tracklines both north and south of Rocky Island. The paper chart was used to mark navigation fixes (vessel positions), but the Nobeltec was used for navigation purposes, according to Majestic America Line.

**Figure 4a.** View of bridge showing location of monitors for Nobeltec (front) and ECDIS (rear) at helmsman's post.

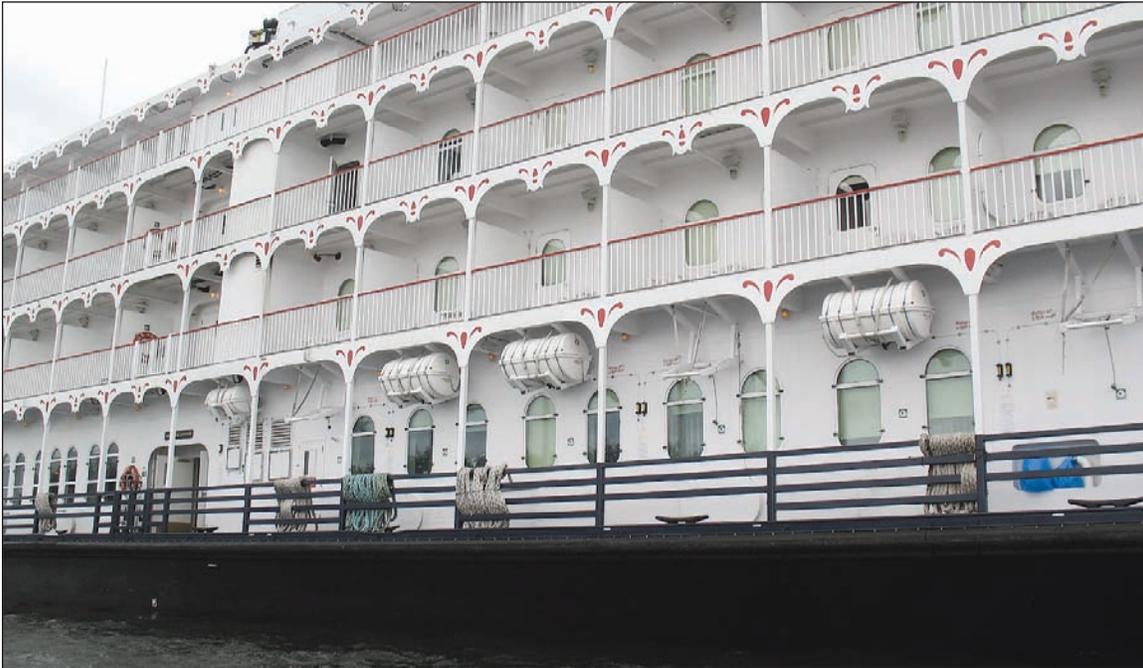
The *Empress of the North* carried two types of inflatable survival craft for use if the vessel had to be abandoned, plus inflatable slides for escaping from the vessel into the survival craft. Twenty inflatable liferafts, which held 50 people each, were kept in overhead cradles along the main outer deck, 10 on either side of the vessel (figure 5).

**Figure 5.** Liferrafts mounted in overhead cradles above the main deck of the *Empress of the North*.

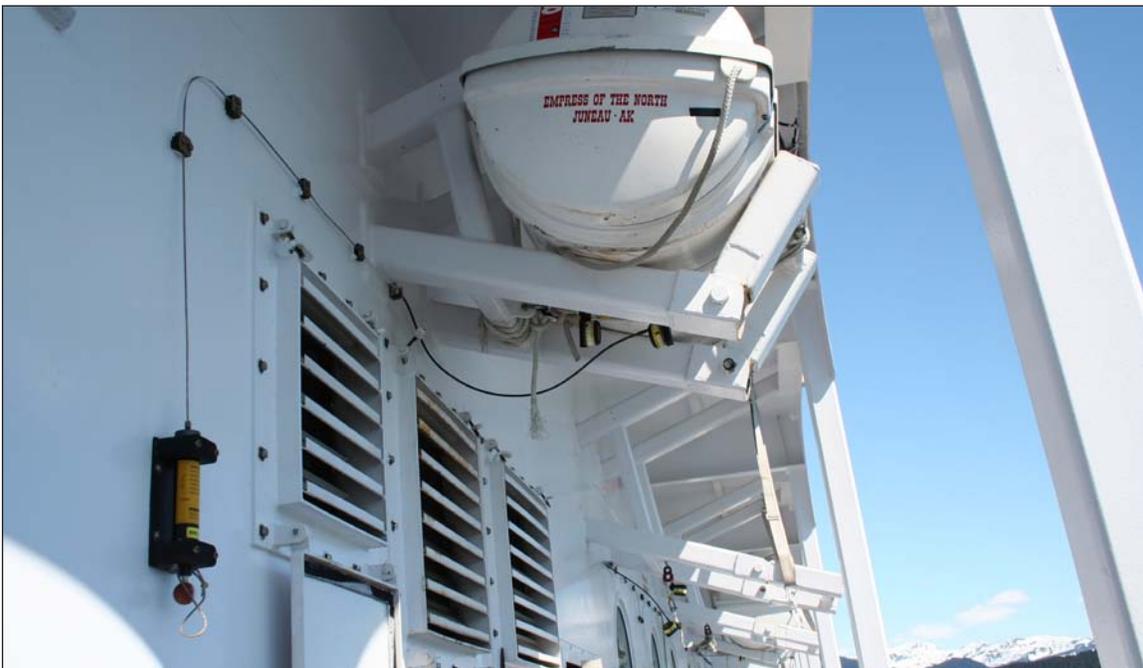
Each liferaft had two remote-release units, model H20 manufactured by Hammar, that would free the raft from its cradle. If the vessel sank, the liferafts would be launched automatically by a unit that, when submerged to a predetermined depth, would sever the line securing the raft. Manually releasing a liferaft required the use of a hydrostatic hand pump located on the vessel bulkhead, next to the rafts (figure 6).

**Figure 6.** Liferaft remote-release unit mounted on a bulkhead near one of the liferafts.

Activating the pump would sever the line, freeing the liferaft from its cradle and allowing it to drop into the water alongside the vessel. A placard posted below each pump directed, "Pump plunger two to six times until the raft releases." The release units were disposable, to be replaced after 2 years of use. All release units on the vessel had expiration dates of February 2009.

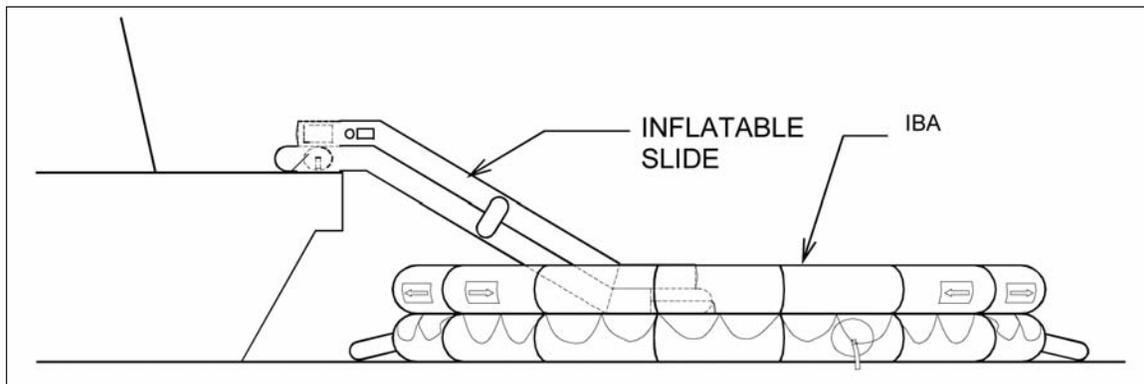
Also not part of its required lifesaving apparatus, the *Empress of the North* carried two Coast Guard-approved model SL32 inflatable marine evacuation slides manufactured in December 2002 by DBC Marine Safety Systems, Ltd., of Richmond (Vancouver), British Columbia. When inflated, the evacuation slides would create an escape route from the vessel into an IBA (figure 7), from which evacuees could easily enter the liferafts.

**Figure 7.** Drawing showing inflatable evacuation slide leading from ship's deck into an IBA.

The evaluation slides were packed in fabric valises and stored separately in a locker on the main deck. Arrows were stenciled on the outside of the valises to indicate whether an end should face inboard or outboard and also where to find the pull-cord that would inflate the slide. The chief mate told investigators that the valises were brought out during drills and installed in their launching position for practice; the crew did not inflate or repack the slides during the drills.
