Allision of Liberia-Registered Fruit Juice Carrier M/V *Orange Sun*  
with U.S.-Registered Dredge *New York*  
Newark Bay, New Jersey  
January 24, 2008

**Accident Report**

NTSB/MAR-09/03  
PB2009-916403

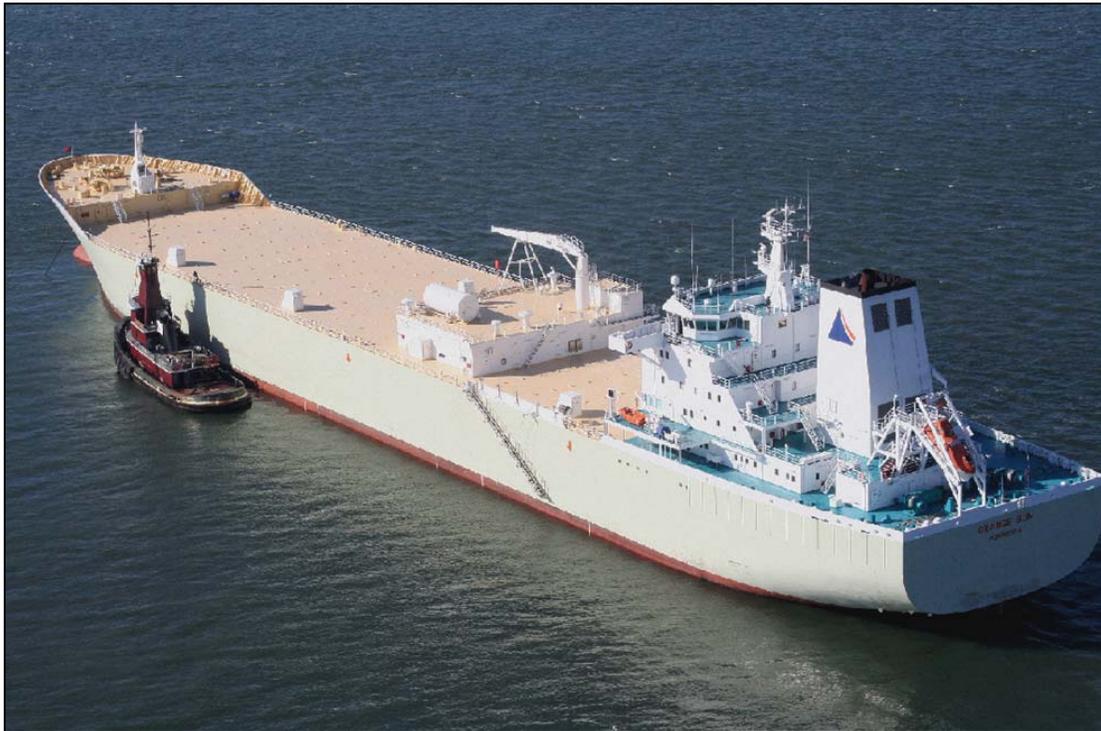
**Figure 1.** The *Orange Sun*. Photo by the U.S. Coast Guard.

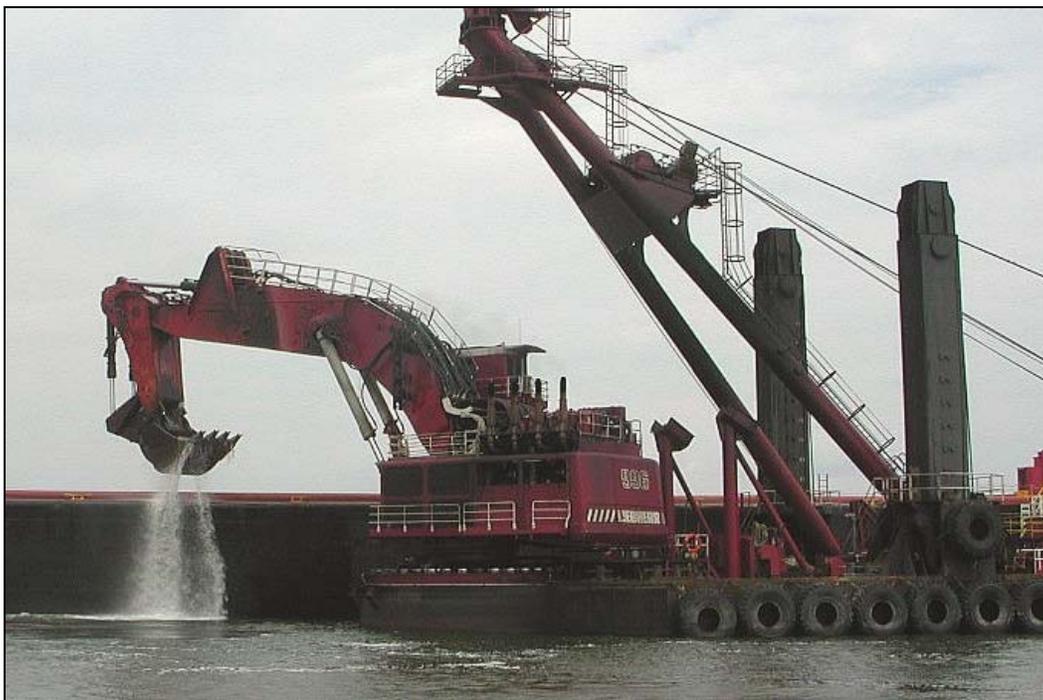
**Figure 2.** The *New York* during dredging operations. Photo by Fred Wehner for Tug44.org.

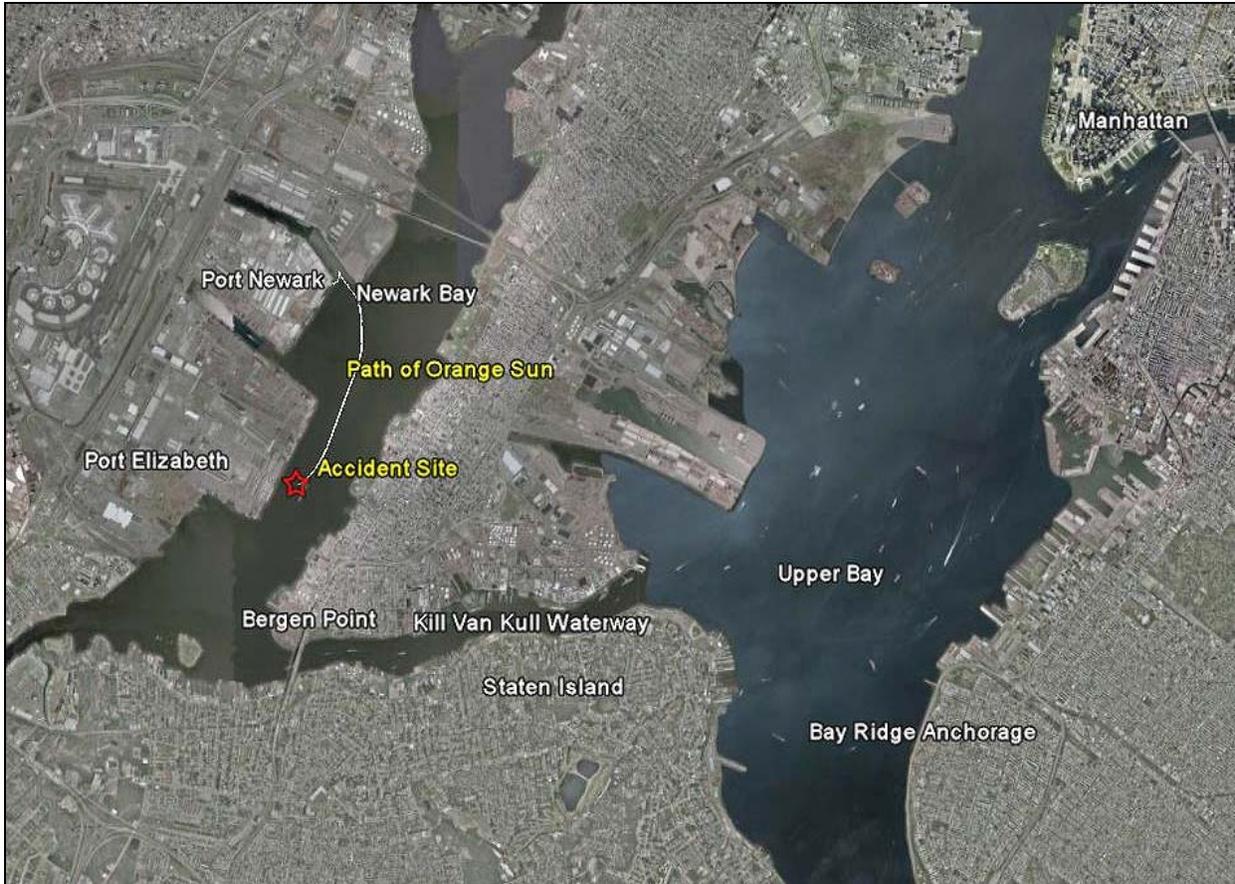
**Figure 3.** Aerial view of Newark Bay and Upper New York Bay. The line down Newark Bay shows the path of the *Orange Sun* leading up to the allision from the berth at Port Newark and southbound through the main shipping channel.

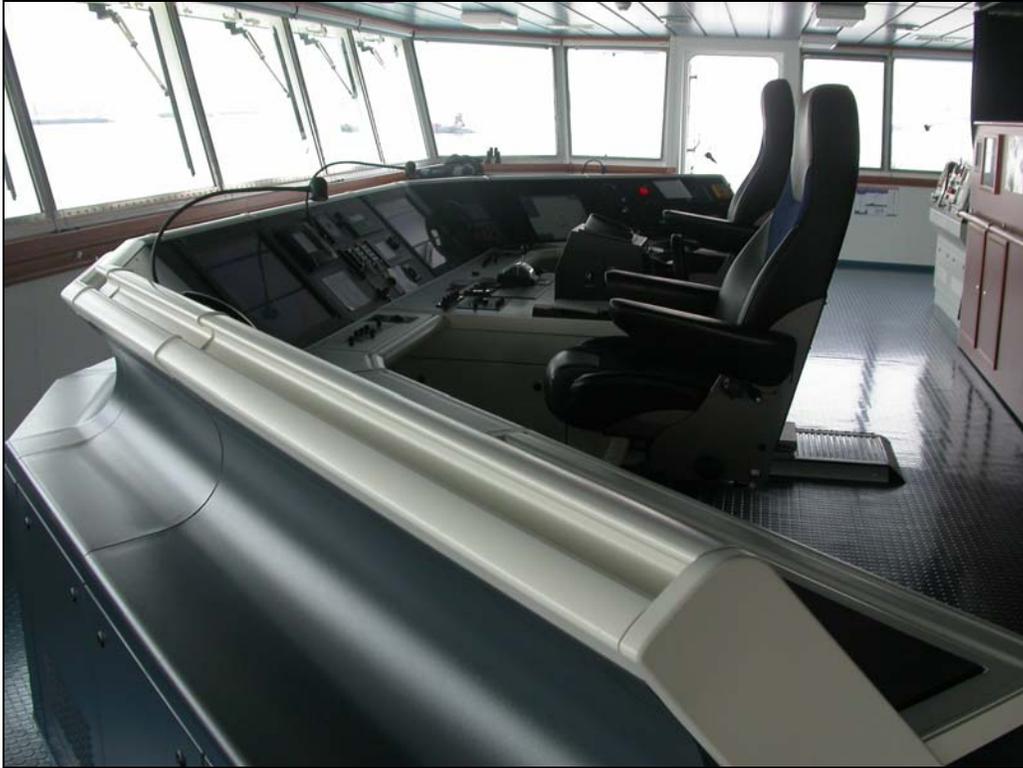
As is often the case on ships, it was not possible for the pilot on board the *Orange Sun* to observe the wheel inputs applied by the helmsman from the pilot position forward of the bridge console (figure 4). Therefore, the pilot would from time to time monitor the vessel's rudder angle indicator, located on the overhead forward of the main navigation console (figure 5).

**Figure 4.** The bridge console on board the *Orange Sun*. The pilot was positioned forward of the console, piloting by visual cues looking out the bridge windows.

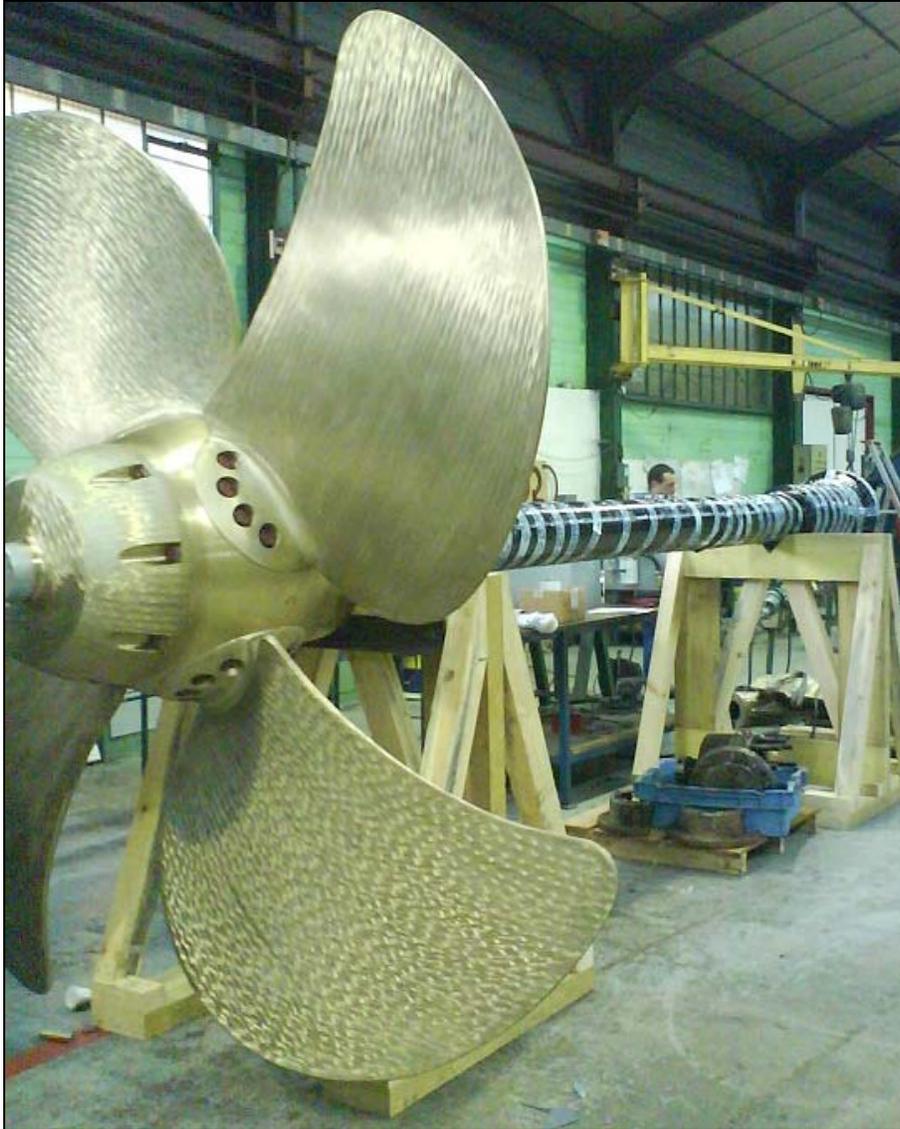
The *Orange Sun* was fitted with a controllable pitch propeller (figure 11) for propulsion. In the marine industry, controllable pitch propellers are less common than fixed pitch, conventional propellers; however, their installation and use is becoming more frequent, and ship masters and pilots are increasingly experienced with them. Because of the ability to adjust the pitch, or angle, of the propeller blades, controllable pitch propellers enable quicker changes in ship speed and direction than do conventional propellers. This is an advantage over conventional propellers which alter speed by changing the revolutions per minute (RPM) of the propeller shaft. Controllable pitch propellers are especially advantageous in port or in confined waterways.

**Figure 11.** Controllable pitch propeller with adjustable-angle blades and main rotating shaft, similar to the one on the *Orange Sun*. Photo by Masson Marine.

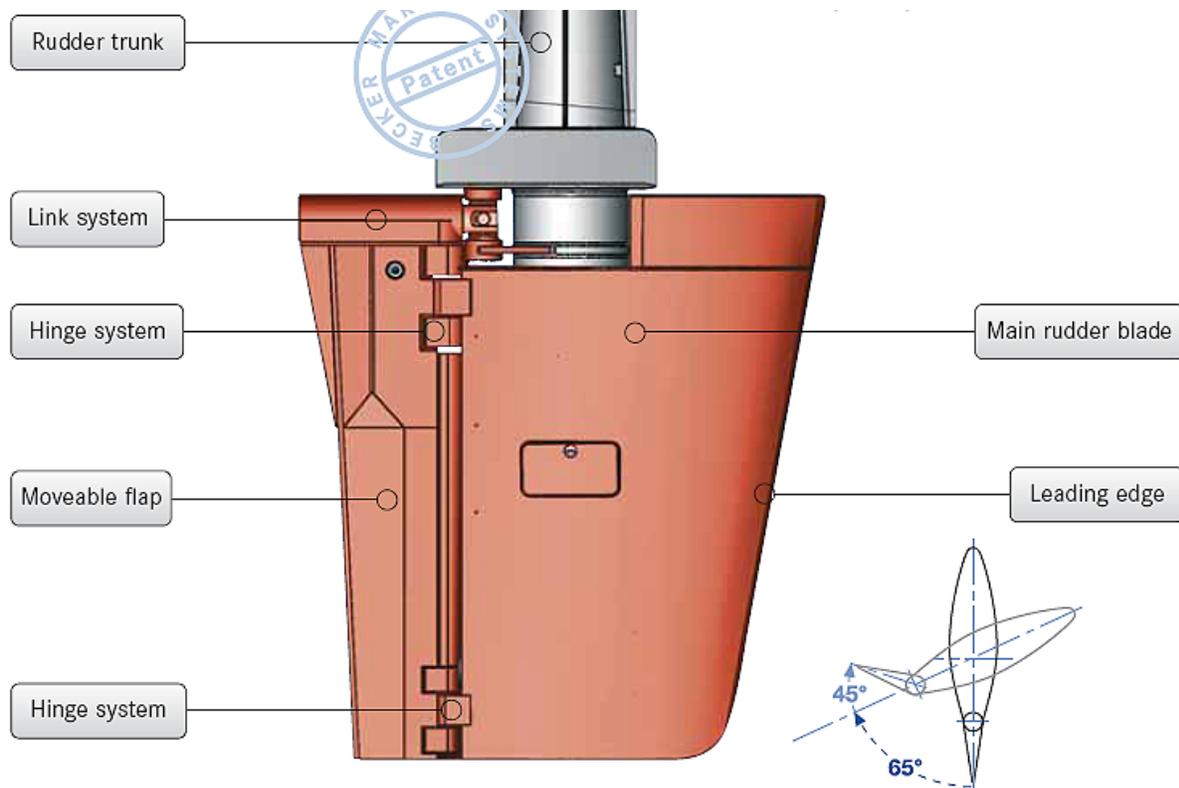
Flap-type rudders such as the Becker rudder (figure 12) enable more responsive steering capability on vessels under way. In port, flap-type rudders are effective as stern thrusters; by increasing the angle of the rudder to about  $70^\circ$ , thrust from the propeller can be directed outward at nearly  $90^\circ$  from the center line of the ship, allowing the operator to “push” the stern of the vessel away from or toward the dock. Flap-type rudders are considered “high performance,” and enable improved fuel economy and handling.

**Figure 12.** Becker rudder, a flap-type rudder sometimes used on single-screw, long-route ships. The rudder may be turned to very large angles (45° to 70°) and can be used as a stern thruster. Several different manufacturers make flap-type rudders. Graphic by Becker Marine Systems. (Further information about the Becker rudder can be found in Appendix B.)

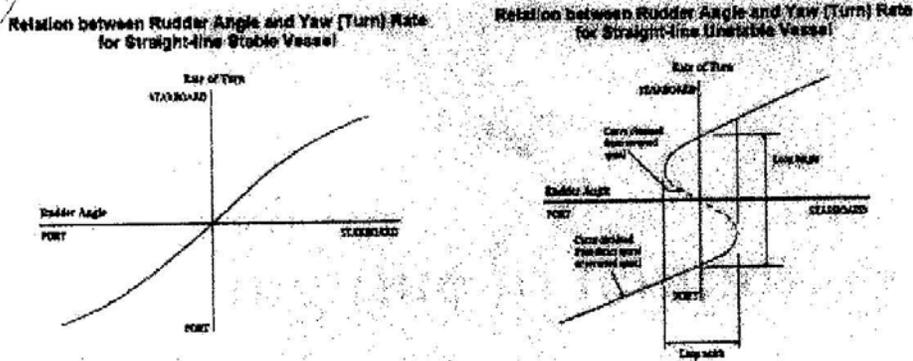
Fig. 2: Relationship between rudder angle and yaw (turn) rate for straight-line stable/unstable vessel.

tend to turn either P or S when no rudder is applied), see Fig. 2, no rudder angle is needed to initiate a turn, while a large rudder angle is needed to check a turn (ref. the right figure below showing the relationship between rudder angle and yaw rate (ROT) for an unstable vessel). As larger rudder angles are needed to check a turn there is less "reserve rudder" available if the rudder force should be reduced.

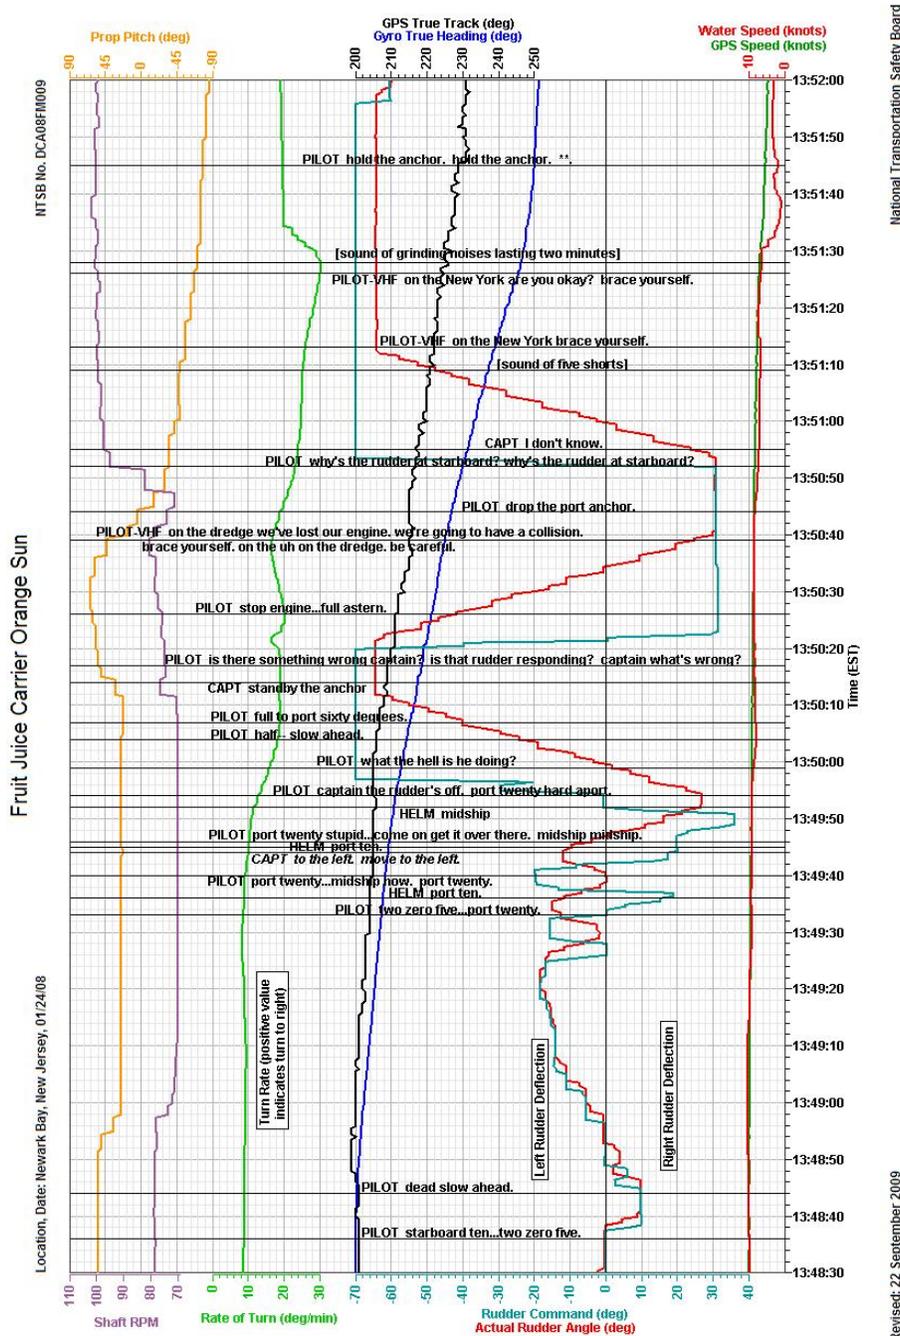
## Readout of VDR Data from the Moments Before the Allision

The text in this graph reflects key events and select, relevant comments uttered by the bridge team leading up to the allision.
