Allision of Passenger Ferry *Andrew J. Barberi*  
With St. George Terminal  
Staten Island, New York  
May 8, 2010

NTSB/MAR-12/01  
PB2012-916401

Allision of Passenger Ferry *Andrew J. Barberi*  
With St. George Terminal, Staten Island, New York  
May 8, 2010

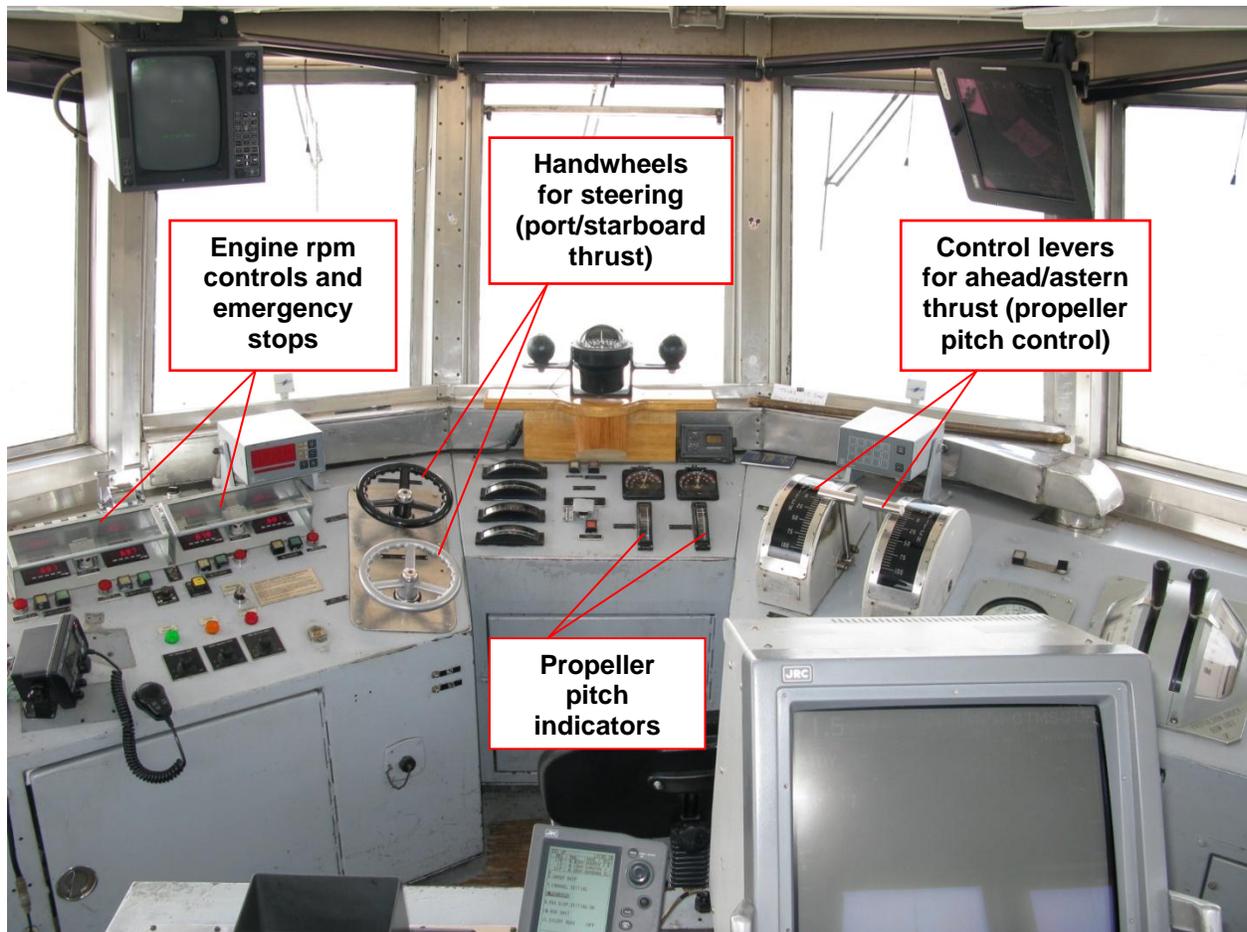
The first two roundtrips that day had been uneventful, with all systems performing normally. About 0916, near the end of its third return to Staten Island, the *Andrew J. Barberi* passed the Kill Van Kull (KV) buoy about 1,000 yards from the St. George terminal. This was the point where vessel crews customarily began preparing for arrival at Staten Island. Accordingly, the mate in the pilothouse made a routine radio call to the engineering crew in the engine control room (ECR) to stand by for docking. A video camera in the pilothouse—one of several onboard cameras in the vessel’s closed-circuit television (CCTV) security system—was recording the pilothouse control station from a fixed vantage position. It recorded the assistant captain reducing engine rpm and pulling back on the levers that controlled propeller pitch to decrease speed in preparation for docking. (On vessels with cycloidal propulsion, like the *Andrew J. Barberi*, adjusting the pitch of the propeller blades changes the magnitude and direction of thrust. More detail is provided in section “1.7.2 Vessel Information; Propulsion System.”)

**Figure 3.** The control station in the Staten Island-end pilothouse.

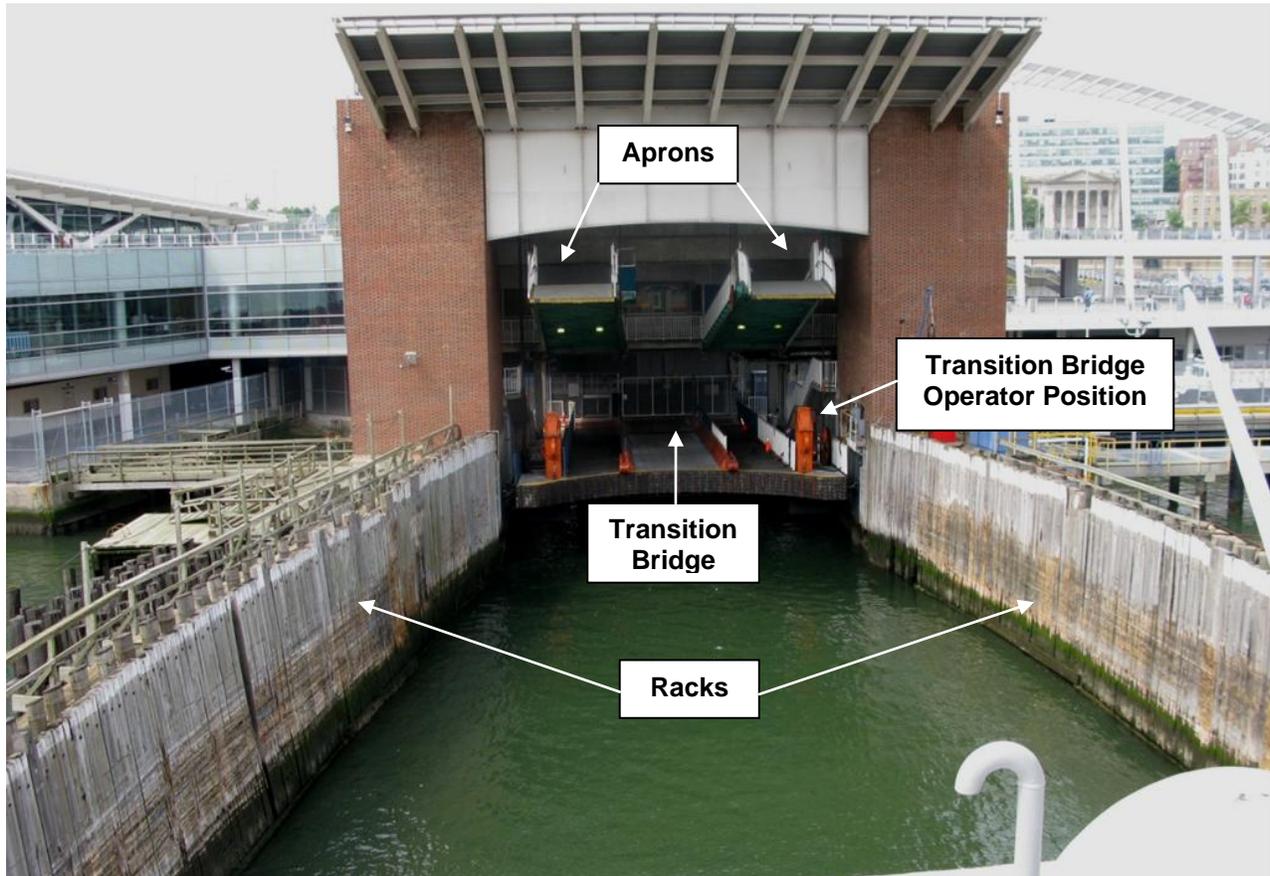
In the pilothouse, the captain reached for the whistle and sounded the danger signal.<sup>4</sup> The mate announced “brace, brace, brace” on the public address system. After the assistant captain steered the vessel to avoid striking the outer point of the slip’s portside rack, the vessel made lateral contact with the starboard-side rack (figure 4) about 9 seconds before the allision.

**Figure 4.** Slip at the St. George terminal on Staten Island. At the end of the slip, nearest to the terminal, is the adjustable height transition bridge, which abutted to the main deck of the ferry, and which passengers normally used to embark and disembark. The two retractable aprons, located above the transition bridge, were also normally used for embarkation and disembarkation.

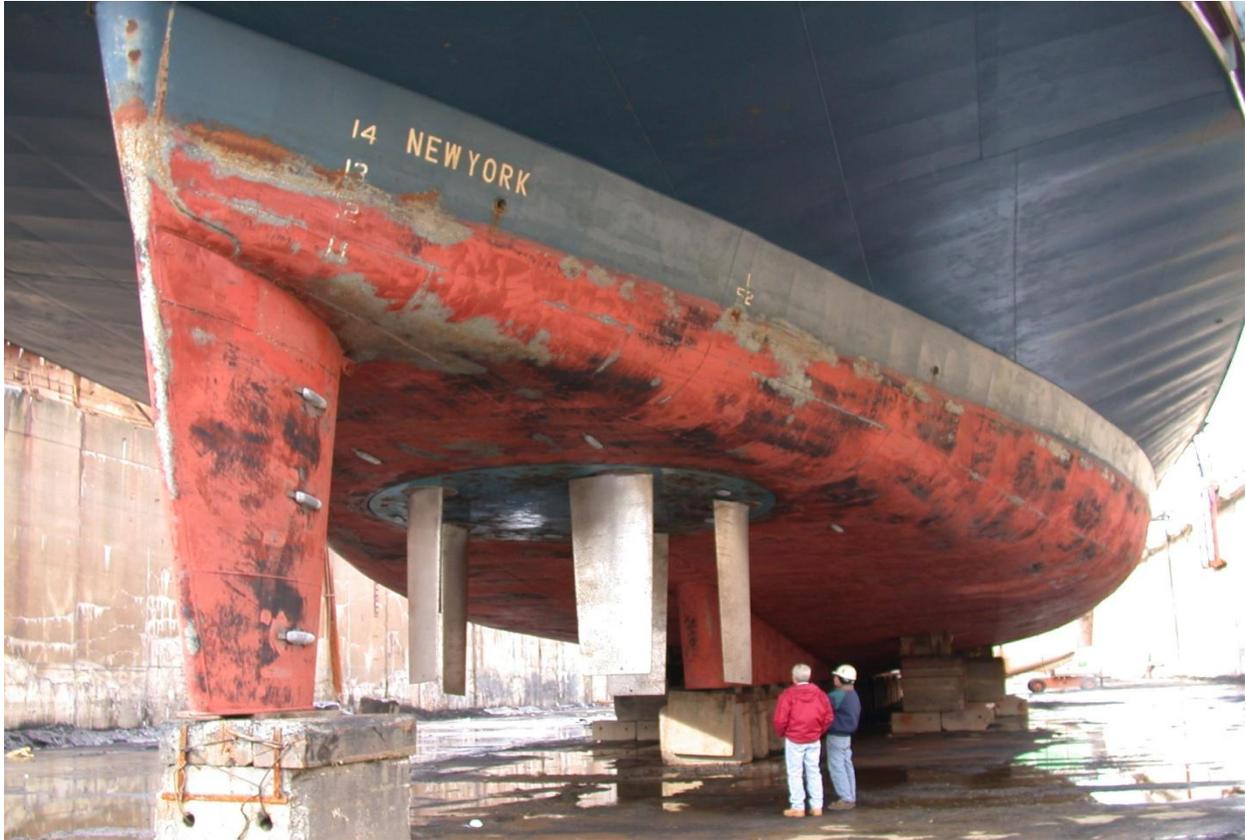
**Figure 9.** One of the two cycloidal propellers on the *Andrew J. Barberi*.

The *Andrew J. Barberi* was equipped with two Voith Turbo cycloidal propulsion units, one at each end of the vessel (figure 9).

Cycloidal propulsion allows quick and precise control of a vessel's direction and speed. Cycloidal propulsion is similar to controllable pitch propulsion<sup>13</sup> in that the angle, or pitch, of the propeller blades can be changed to control the magnitude and direction of thrust. However, unlike a controllable pitch propeller, which can thrust only along its shaft axis, a cycloidal propeller can thrust in any direction, thereby allowing operators to both steer and propel the vessel. Further, a cycloidal propeller is mounted on a vertical, as opposed to horizontal, shaft.

Each of the *Andrew J. Barberi*'s propulsion units had five stainless steel propeller blades mounted vertically on a large circular plate below the hull. Each propulsion unit was driven by two General Motors diesel engines rated at 1,700 horsepower each (3,400 horsepower per propulsion unit). The two pilothouses on the *Andrew J. Barberi* could operate both propulsion units; so could the ECR (figure 10 shows the ECR propulsion control station).

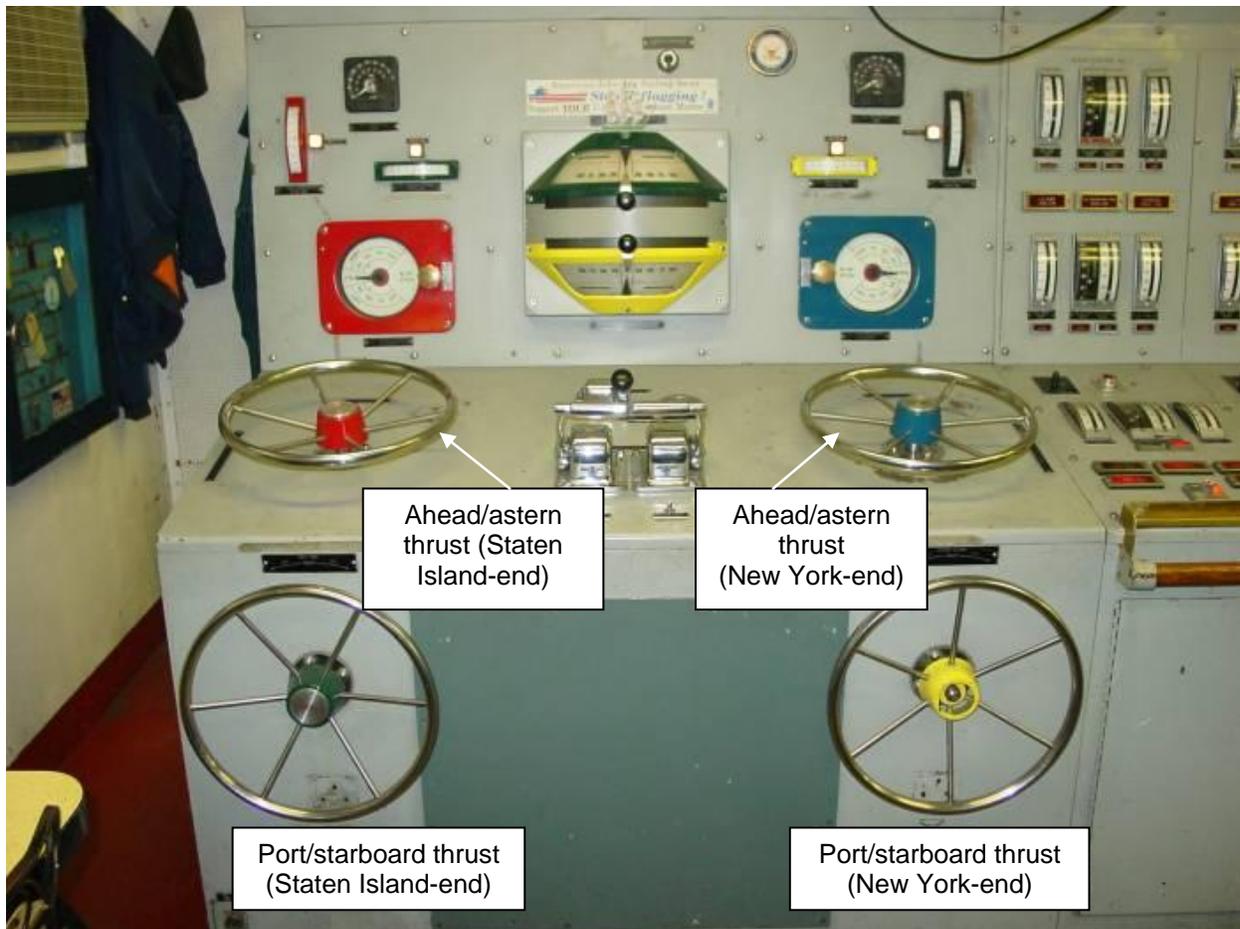
**Figure 10.** ECR propulsion control station.

The two pilothouses controlled the propulsion units through an electro-hydraulic system. To control the pitch of the propeller blades, the pilothouse crew would transmit an electrical signal from the pilothouse control levers and handwheels to solenoids<sup>14</sup> on the hydraulic control panels, located at the propulsion units (see figure 11 on page 18). The ECR controlled the propulsion units through an independent, direct linkage to hydraulic pumps located behind the control console. This method disabled the solenoids on the hydraulic control panels and allowed the crew to adjust the propeller pitch using the ECR control handwheels.
