Collision of the Tankship *Elka Apollon*
With the Containership *MSC Nederland*
Houston Ship Channel, Upper Galveston Bay, Texas
October 29, 2011

NTSB/MAR-12/02
PB2012-916402

Marine Accident Report

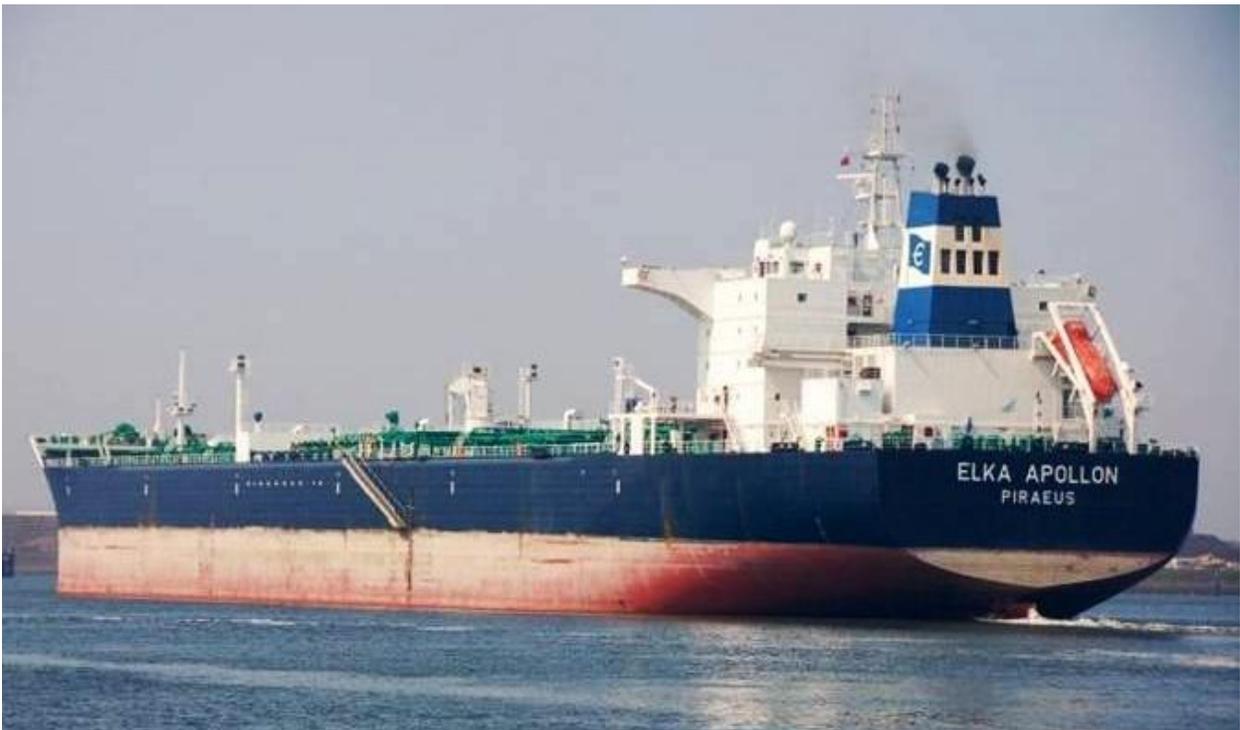
Figure 1. *Elka Apollon*. (Photo www.worldmaritimeneews.com, October 31, 2011.)

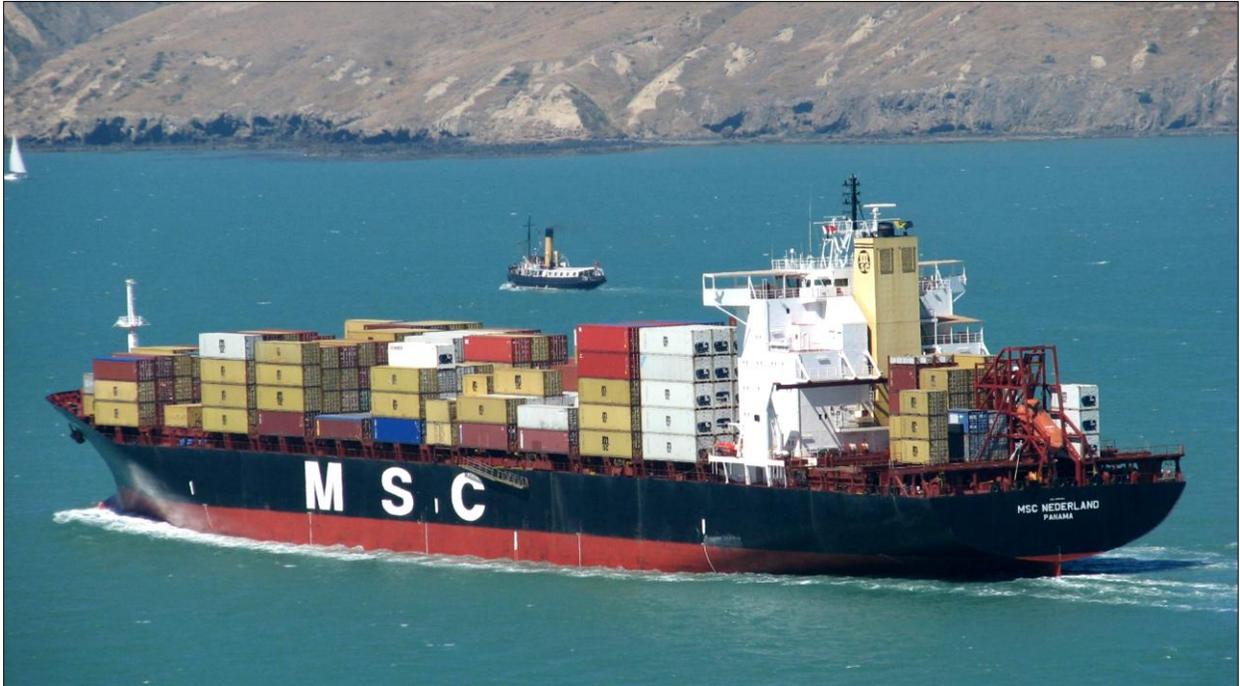
Figure 3. *MSC Nederland*. (Photograph by Wayne A'Court, www.marinetraffic.com)

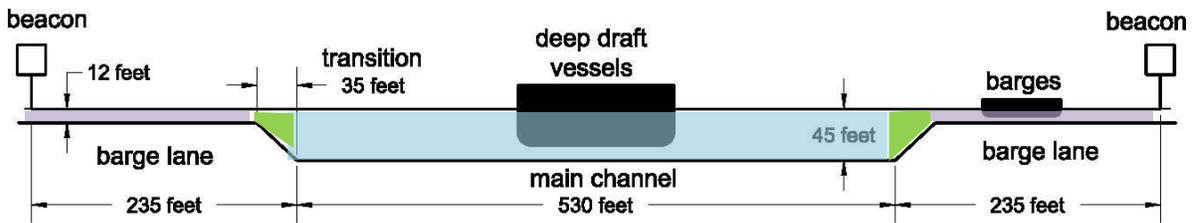
The U.S. Army Corps of Engineers completed a major widening of the channel in 2005, and the collision occurred in an area included in this project. The widening project added dedicated barge lanes for towing vessels and deepened as well as widened the channel. The main Houston Ship Channel in the area of the accident is 530 feet wide with a depth of 45 feet. The barge lanes located along both sides of the main channel are 235 feet wide and 12 feet deep (see figure 8).¹⁸ With specified barge lanes alongside a major shipping channel—together with the high volume of marine traffic, relatively narrow main channel, and designation of 14 Coast Guard precautionary areas along the length of the channel—the Houston Ship Channel is a unique waterway in the United States.

Figure 8. Dimensions of the main Houston Ship Channel, barge lanes, and transition zones following U.S. Army Corps of Engineers deepening and widening project.

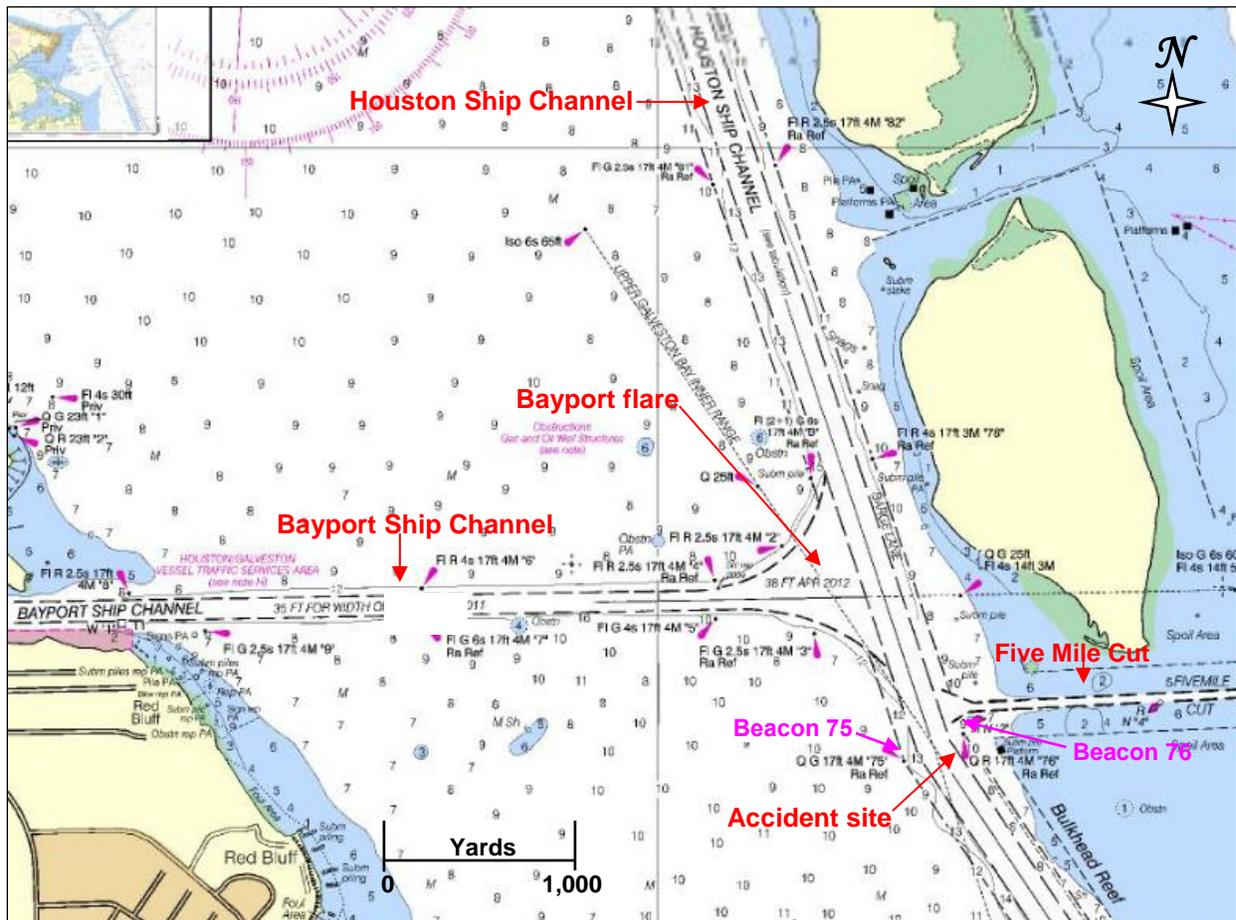
In the vicinity where the accident occurred, the Houston channel makes a 15-degree bend, changing from a course of 161 degrees to 146 degrees (see figure 9). This turn is located at navigation beacons 75 and 76, slightly south of Five Mile Cut. Five Mile Cut allows smaller vessels with a draft of 6 feet or less to transit between the Houston Ship Channel and the shallower portion of Galveston Bay located to the east.

Figure 9. Houston Ship Channel and Bayport flare, as shown in an excerpt from National Oceanic and Atmospheric Administration (NOAA) nautical chart 11327. Along each side of the main Houston channel are the barge lanes, indicated by dashed lines.

The Bayport Ship Channel meets the Houston Ship Channel about 0.3 nautical mile¹⁹ (nm) northwest of Five Mile Cut and the 15-degree turn in the Houston channel. The Bayport channel runs east and west and can accommodate deep-draft vessels along with tug and tow traffic. The channel is 300 feet wide and 35 feet deep, according to the latest edition of NOAA chart 11327. The Bayport flare, near the accident location, is at the junction of the Bayport and Houston channels where the Bayport channel widens to the north and south to smooth the turn for vessels entering and exiting the waterway.
