Collision between Bulk Carrier *Conti Peridot* and Tanker *Carla Maersk*
Houston Ship Channel near Morgan's Point, Texas
March 9, 2015

Marine Accident Report

NTSB/MAR-16/01
PB2016-103277

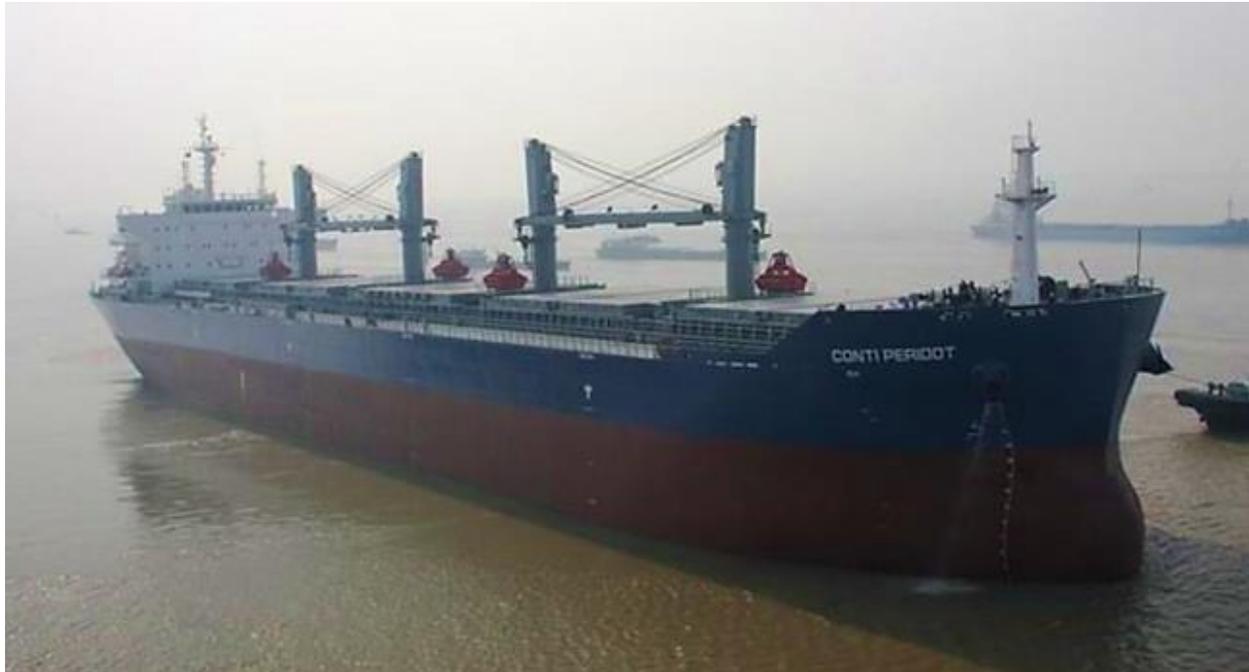
Figure 1. Bulk carrier *Conti Peridot*. (Photo by G. Dorofeyev, www.marinetraffic.com)

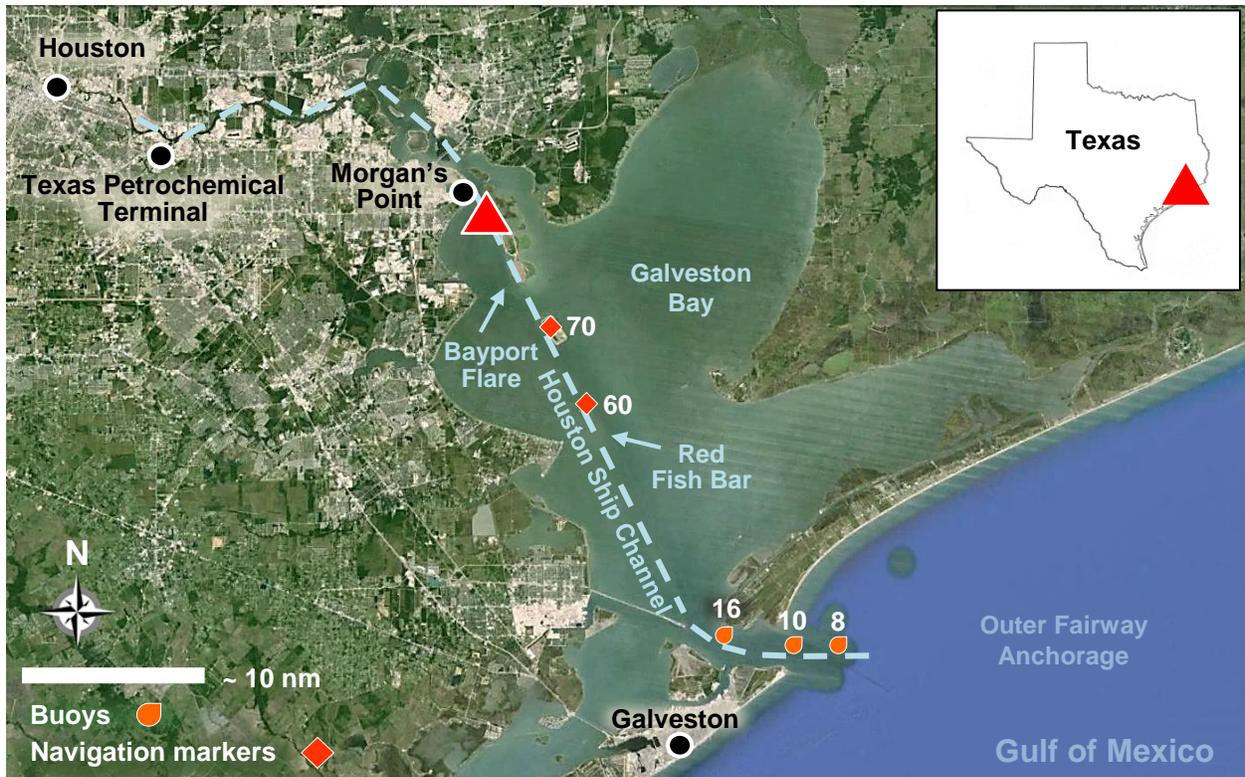
Figure 2. Satellite image of the Houston Ship Channel. The overlaid red triangle denotes the collision site. (Background by Google Earth)

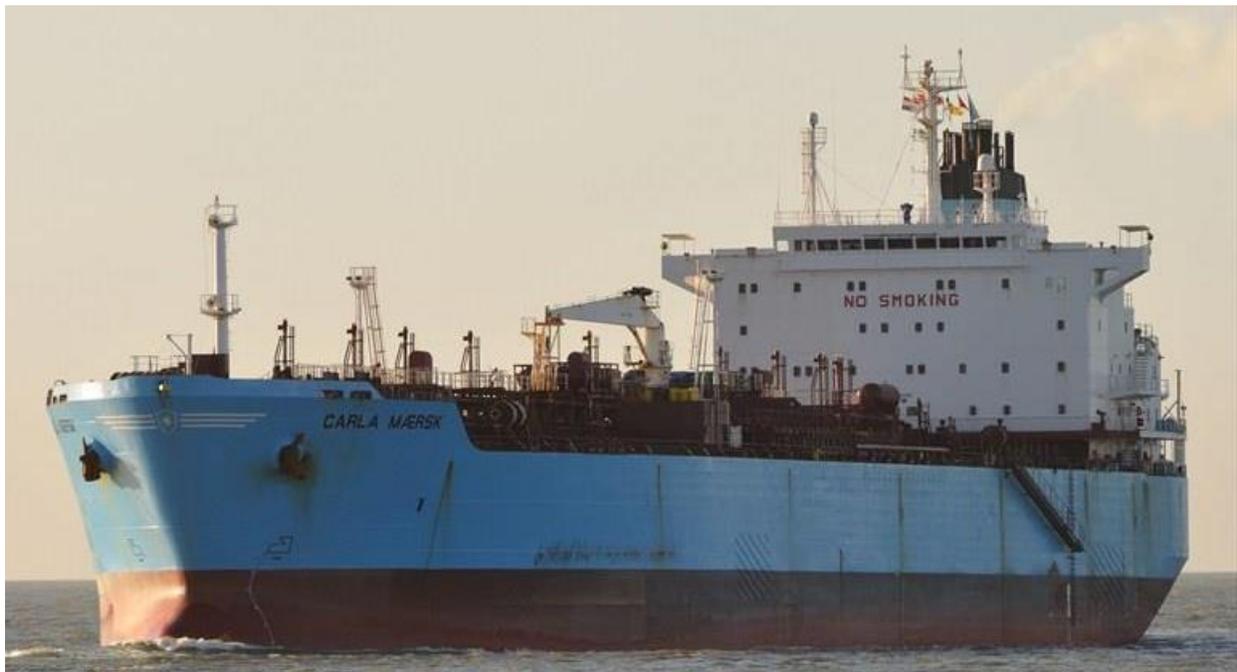
Figure 3. Chemical tanker *Carla Maersk*. (Photo by Roland Delhaxhe, www.marinetraffic.com)

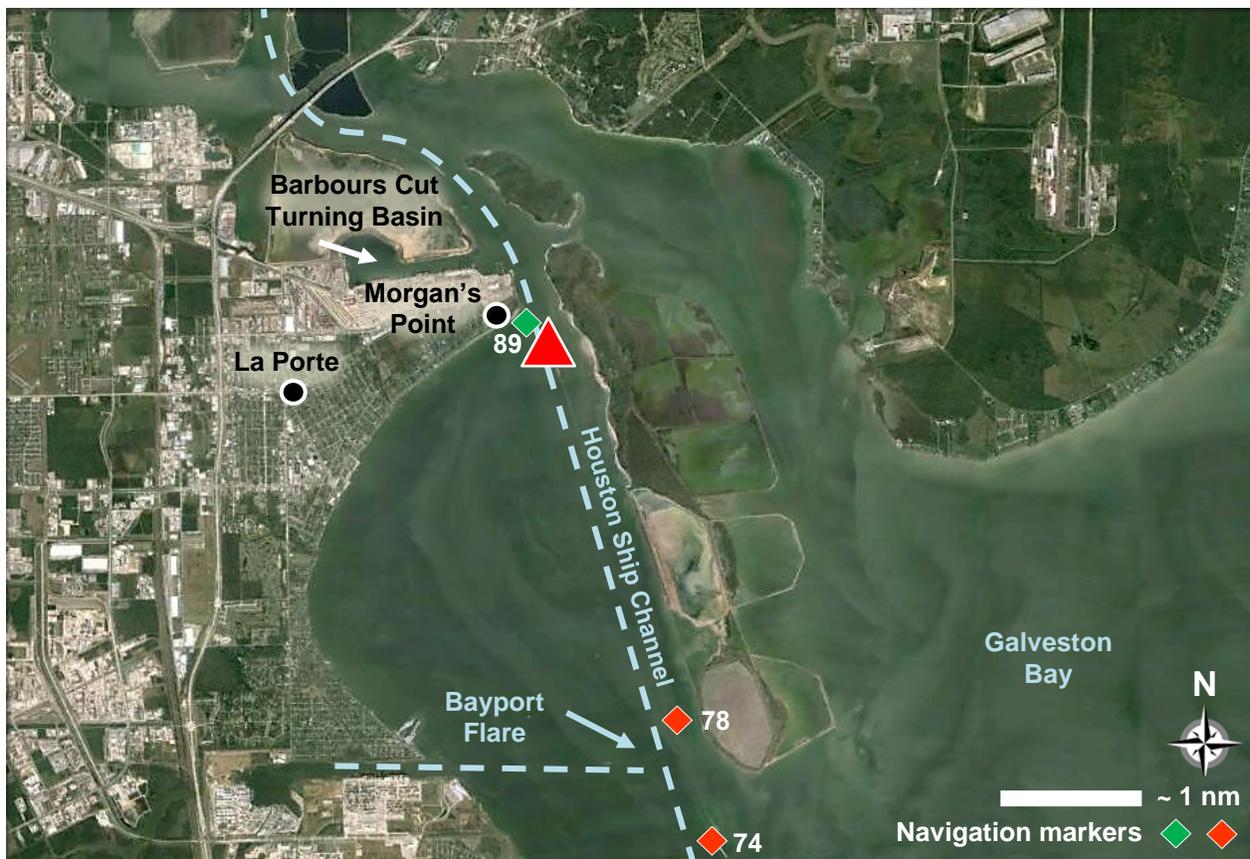
Figure 5. Satellite image of the area near Morgan's Point, including the Barbours Cut turning basin and the city of La Porte. The collision site near navigation marker 89 is overlaid by a red triangle.

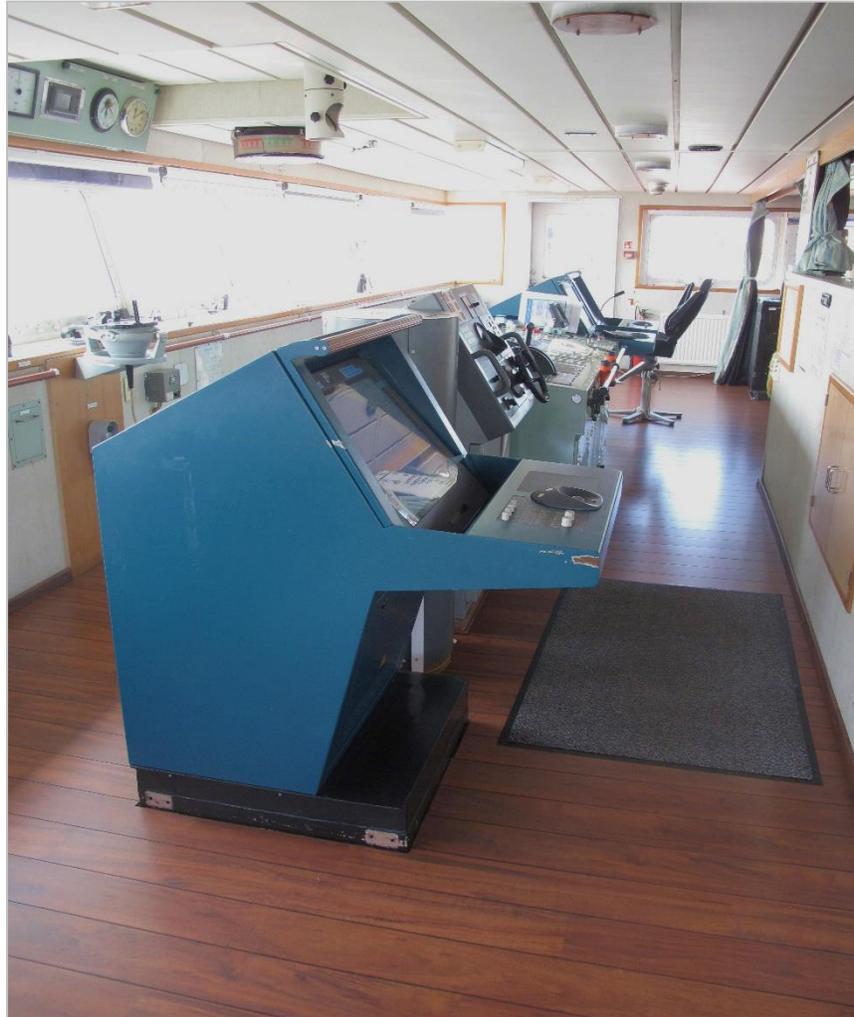
Given the increasing fog, the *Carla Maersk* bridge team added an additional bow lookout from the crew.¹⁷ The pilot also asked the mate to change the radar scale from 3 miles to 1.5 miles for greater detail. The pilot then repositioned himself on the bridge, away from the front windows and aft to the radar (figure 6), placing his PPU next to it. The bridge team also began sounding the fog signal on the *Carla Maersk*.

Figure 6. The *Carla Maersk* navigation bridge, shown from port to starboard. Consoles are equipped with radars, electronic chart display and information system (ECDIS), steering controls, and engine telegraph and communications equipment.

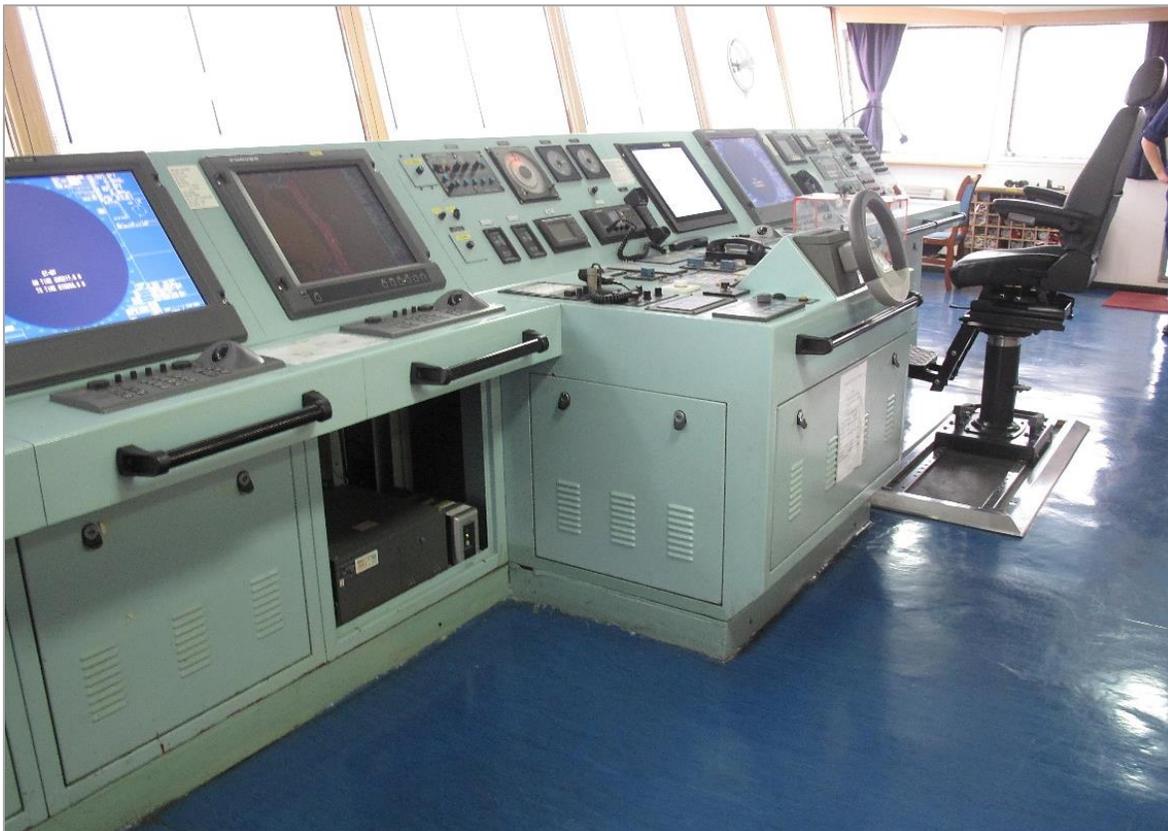
passing the *Gaia Leader* and sensing that vessel's large displacement of water, the *Conti Peridot*, as expected, "[dove] into the void" behind the vehicle carrier (similar to what happened with the *Stolt Span* about 1 hour earlier). The pilot said that the *Conti Peridot* was then "off to the races," describing the bulk carrier's uncontrolled motion from bank to bank. He did not communicate the continued handling difficulty to the bridge crew nor anyone else. When investigators asked the pilot what the *Conti Peridot* master was doing during this time, the pilot said that he did not think the master (or bridge crew) knew what was happening. The pilot said that the master and bridge crew "didn't know we were going bank to bank" and that no one questioned him as to what was going on with the vessel (figure 7).

Figure 7. The *Conti Peridot* navigation bridge, shown from port to starboard. Consoles are equipped with radars, ECDIS, steering controls, and engine telegraph and communications equipment.

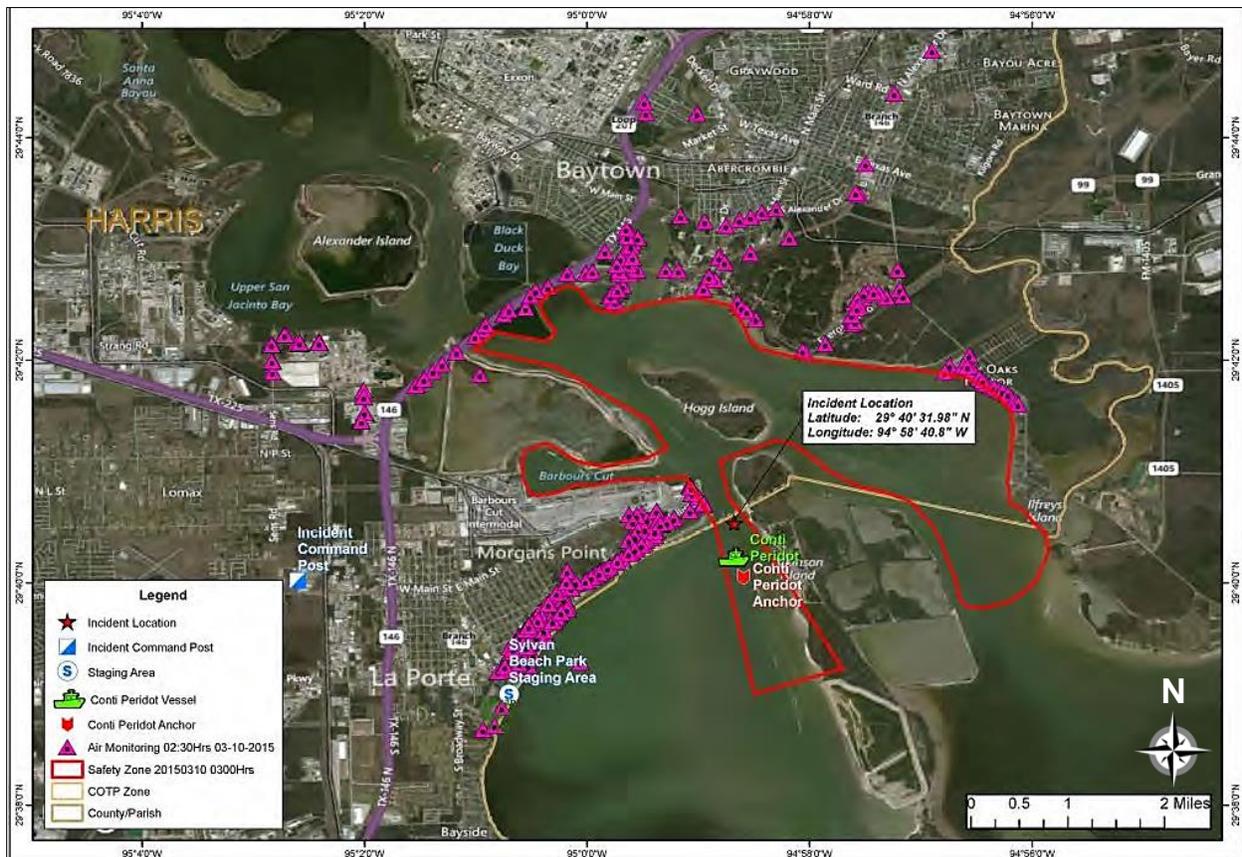
The emergency response guidance for MTBE advises responders to isolate the spill for at least 1,000 feet in all directions, which responders did. Air monitoring stations were promptly established (figure 14). A fireboat, dispatched by the Port of Houston Authority Fire Department and carrying an assistant fire chief, was on scene next to the *Carla Maersk* within 25 minutes of the collision. The *Carla Maersk* crew was also monitoring the air in several locations inside the ship. Initial readings detected high levels of volatile organic chemical vapor, both on board and near the ship. Personnel were wearing appropriate personal protective equipment while conducting air monitoring. About 1309, due to increasing reports of odor, a modified shelter-in-place order was put into effect for the Barbours Cut terminal; the order was subsequently extended to include the city of Morgan's Point. About 1415, the local fire department ordered that the Barbours Cut terminal be evacuated. About 1500, some 2.5 hours after the collision, a unified command was established at the La Porte Emergency Operations Center, near Morgan's Point.²⁵ About 1600 that same afternoon, the shelter-in-place order was

Figure 14. Map of the safety zone and air monitoring stations on the morning after the collision.

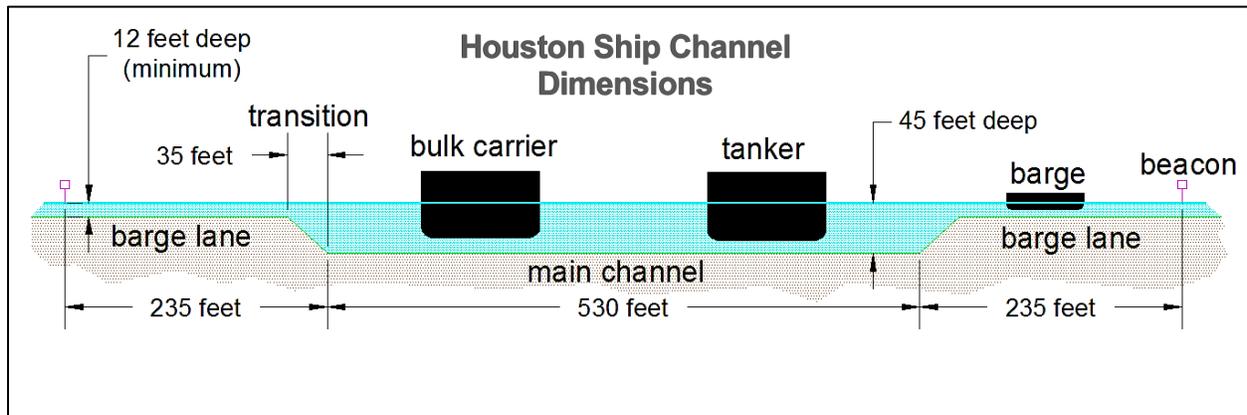
The Houston Ship Channel is about 55 nautical miles in length from the sea buoy offshore from Galveston (where pilots usually board inbound deep-draft vessels) to the turning basin at the Port of Houston. In 2005, the US Army Corps of Engineers completed a major upgrade of the Houston Ship Channel, which included adding dedicated barge lanes for towing vessels and deepening and widening the main channel. The main Houston Ship Channel in the area of the accident is 530 feet wide with a project depth of 45 feet. The barge lanes located on both sides of the main channel are each 235 feet wide with a project depth of 12 feet (figure 15).

Figure 15. Cross-sectional view of the Houston Ship Channel in the accident area. (Modified image; original provided by the Houston Pilots Association)

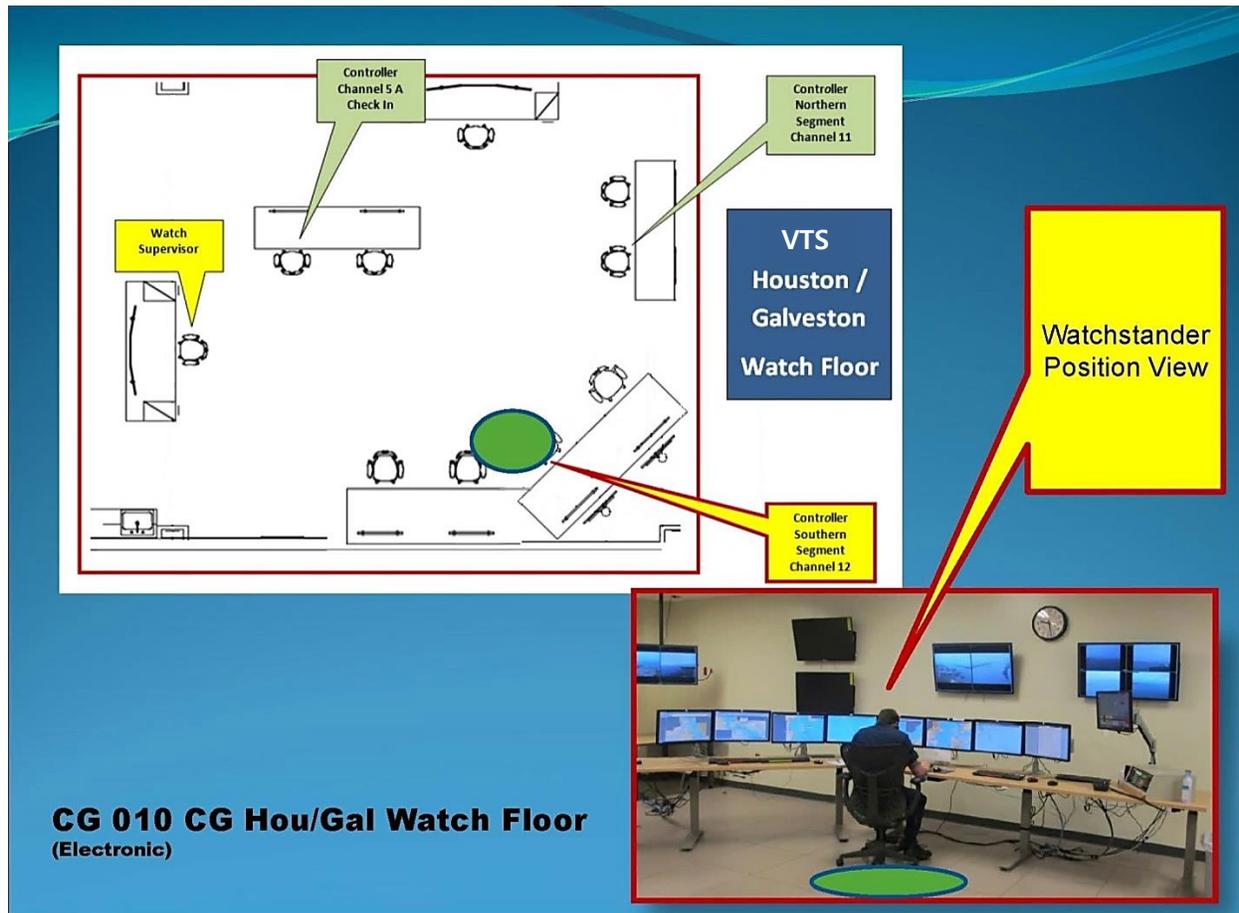
At the VTS watch desk for Sector I & II (figure 16) in which the accident occurred, an active-duty watchstander took the watch at 1030 that morning, beginning a 2-hour shift. When asked by investigators about his preferred display settings, the watchstander said that he did not like using the track history setting on the display (a function that displays a vessel's course over ground on the screen for a defined period of time), because he felt that this setting "just clutters up the screen."³⁶ He did use the track vector setting, a function that displays both a

Figure 16. The top drawing shows the layout of VTS Houston/Galveston's vessel traffic center. The bottom photo shows a watchstander monitoring the displays for southern Sector I & II.
