Sinking of Amphibious Passenger Vessel
Stretch Duck 7
Table Rock Lake, near Branson, Missouri
July 19, 2018

Marine Accident Report

NTSB/MAR-20/01
PB2020-101002

National
Transportation
Safety Board

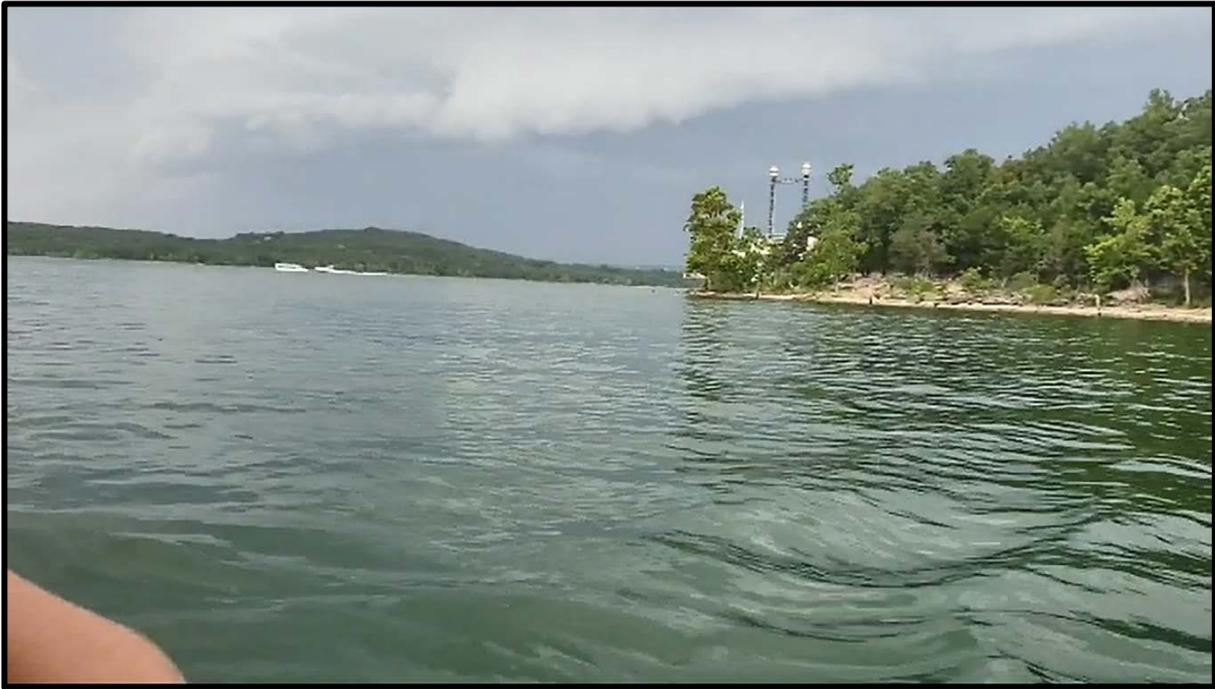
Figure 3. About 1856, screenshot from video taken by a passenger aboard the *Stretch Duck 7* shows calm water shortly after the vessel entered the lake.

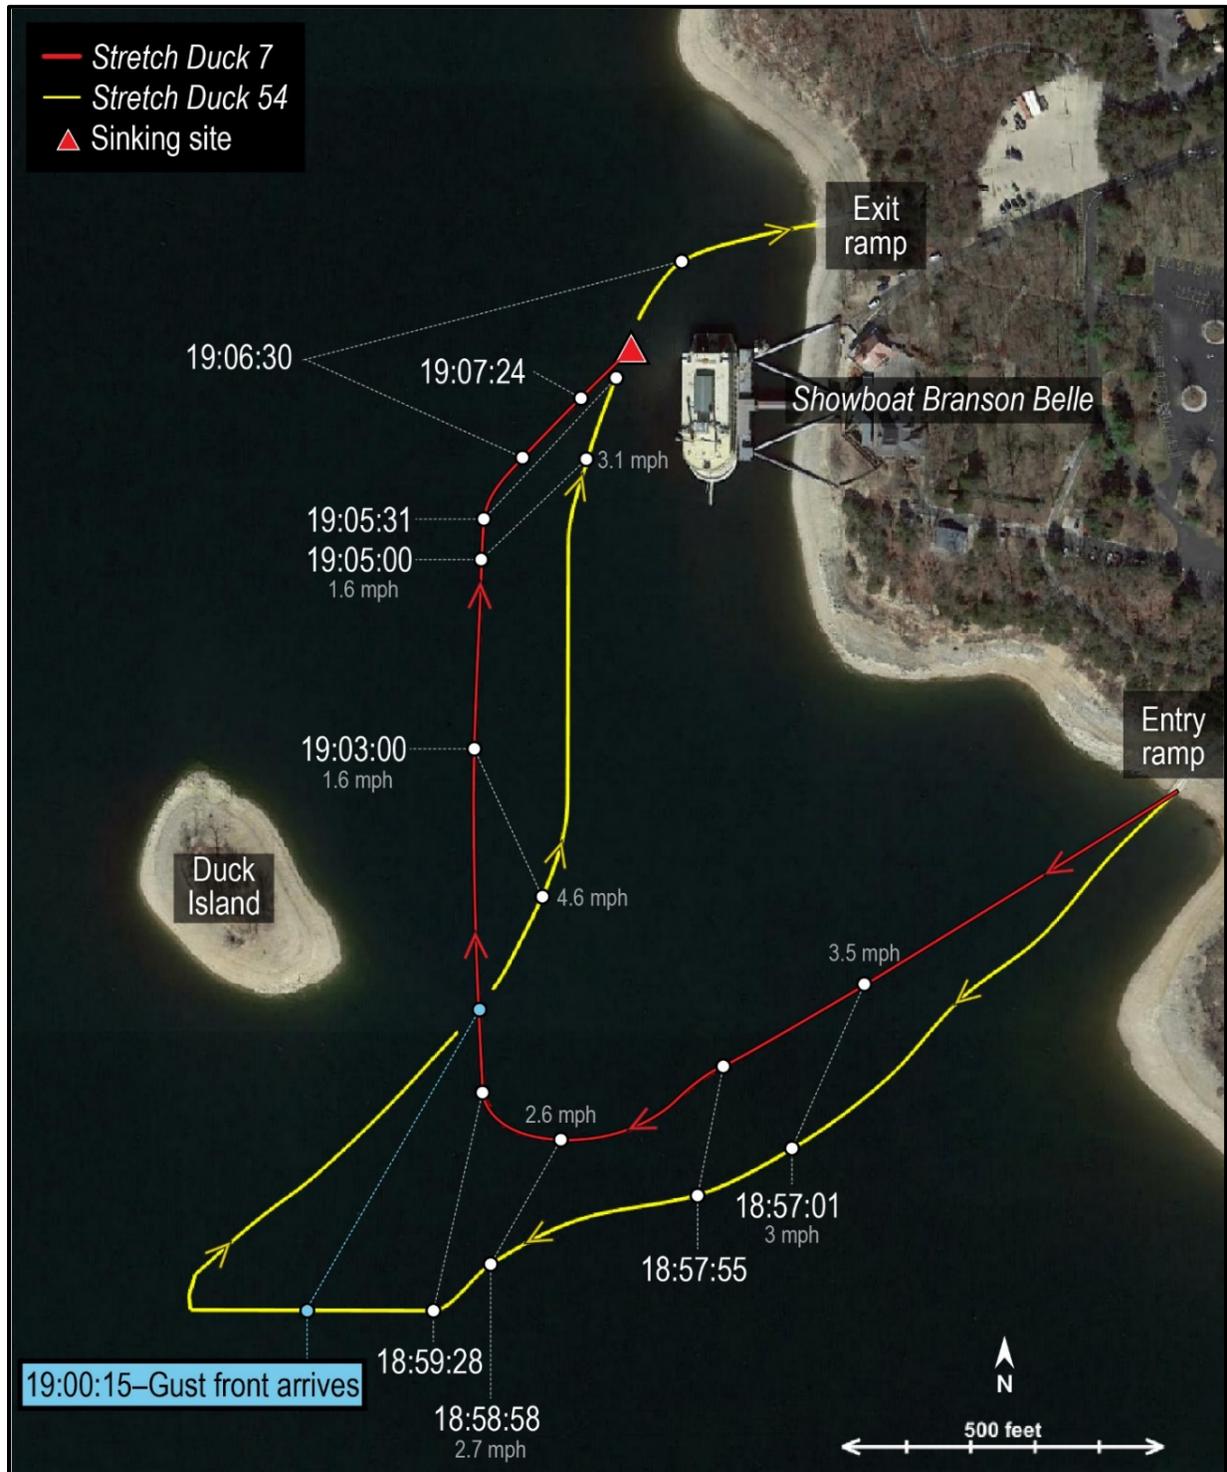
At 1859, when the *Stretch Duck 7* was about 600 feet away from a small island known locally as “Duck Island” (about 1,000 feet due west of the entry ramp), the captain turned north, altering from the usual course around the island. As [figure 4](#) shows, he took a more direct route toward the exit ramp, leaving on its port side the *Stretch Duck 54*, which was farther from shore. The captain of the *Stretch Duck 7* later stated that he felt he was “far enough around” to be closer to the exit than the entry ramp. Video from the camera mounted on the *Stretch Duck 7*'s bow showed that low-level darkened clouds were visible ahead. “Yeah, we’re gonna try and beat this weather off the water as fast as we can here,” the captain told the passengers. He then spoke about lightning as he assured them that it would not adversely affect the vessel’s steel frame. No other observations of lightning were made from persons aboard the *Stretch Duck 7*.

Figure 4. Vessel voyages on Table Rock Lake the evening of the accident. Red line represents the calculated trackline of the *Stretch Duck 7*, and yellow line represents the actual trackline of the *Stretch Duck 54* based on GPS data.¹³

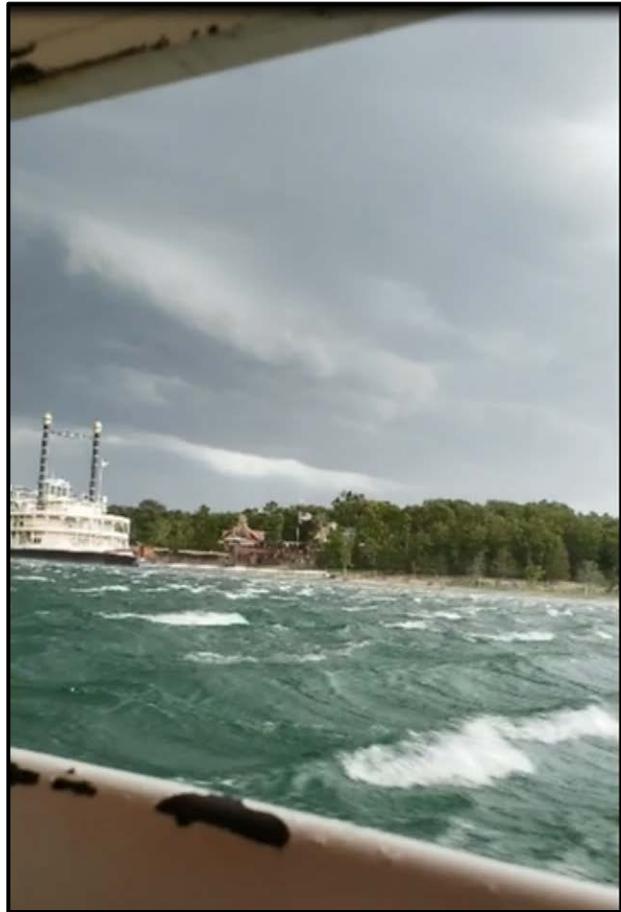
Increased winds began impacting the area at 1900. At 19:00:15, within a span of 15 seconds, the water surface changed rapidly, from a calm state to waves with whitecaps ([figure 5](#)).

Figure 5. About 1900, screenshot from passenger video shows whitecaps building on the lake seconds before the starboard-side curtain (top left) was closed on the *Stretch Duck 7*. In the background is the moored passenger vessel *Showboat Branson Belle*.

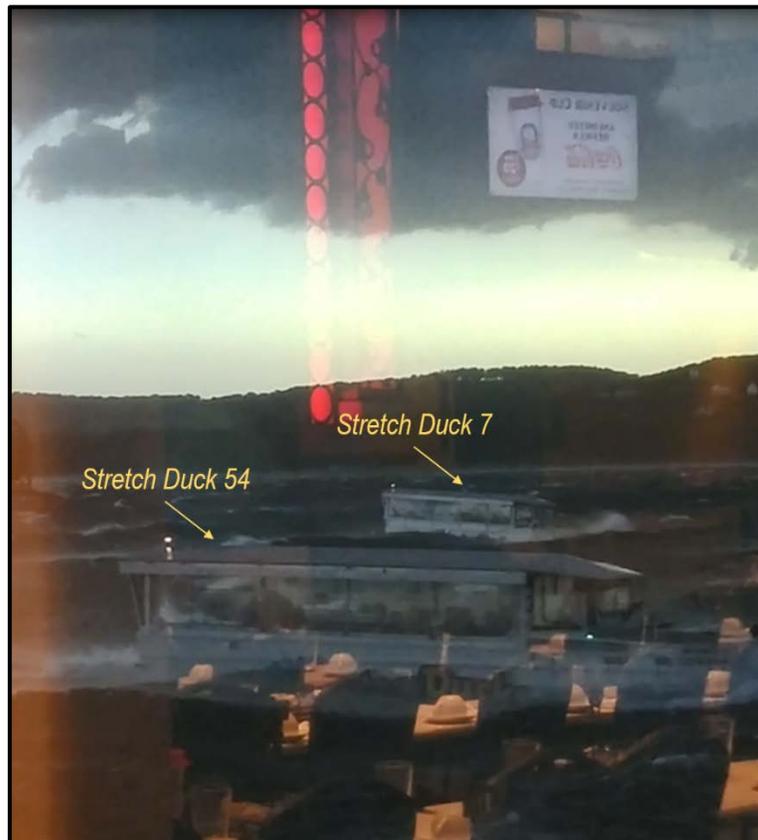
Figure 6. At 19:05:03, screenshot from video taken by a passenger inside the *Showboat Branson Belle* captures the *Stretch Duck 54* passing the *Stretch Duck 7* as they attempt to reach the exit ramp. Furnishing from the showboat's dining area is reflected in the glass. (Source: Jenny Carr)

Witness video (captured as a screenshot in [figure 6](#)) reveals that as the *Stretch Duck 7* was attempting to reach the exit ramp, the vessel's bow was intermittently submerged in the water. A few minutes earlier, at 1902, a sound consistent with the engine compartment cover closing was heard on the DVR.

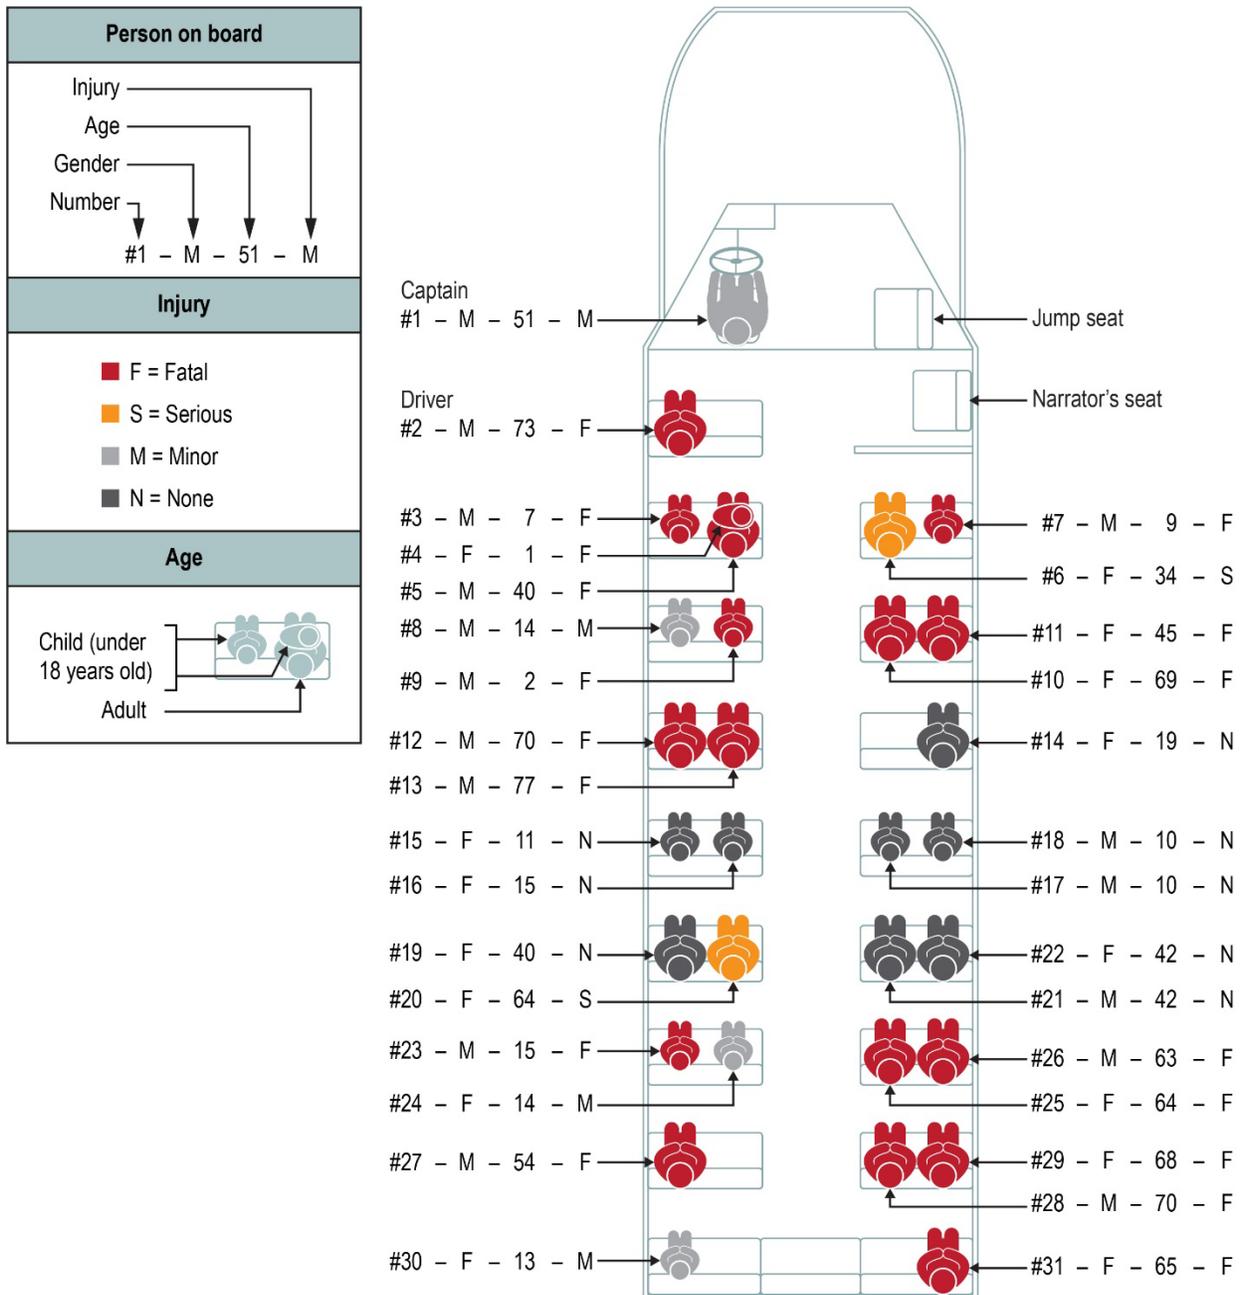
Figure 7. Stretch Duck 7 seating diagram on the evening of the accident.

Twenty-three of the 31 persons on board the *Stretch Duck 7* sustained some level of injury in the sinking. (The types of injury are enumerated in the table below and identified according to each passenger in [figure 7](#).) The eight passengers who reported no physical injuries were all under the age of 42. Individuals who either had no injury or had minor injuries swam to the area behind the *Showboat Branson Belle* from where they exited the water. Of the seven persons who were transported to a nearby hospital, two were deemed serious; four were minor, which included the captain; and one had no injury.²⁰ As a result of the accident, there were 17 fatal injuries: 16 passengers and the driver. The coroner determined that drowning was the cause of death for all the deceased.

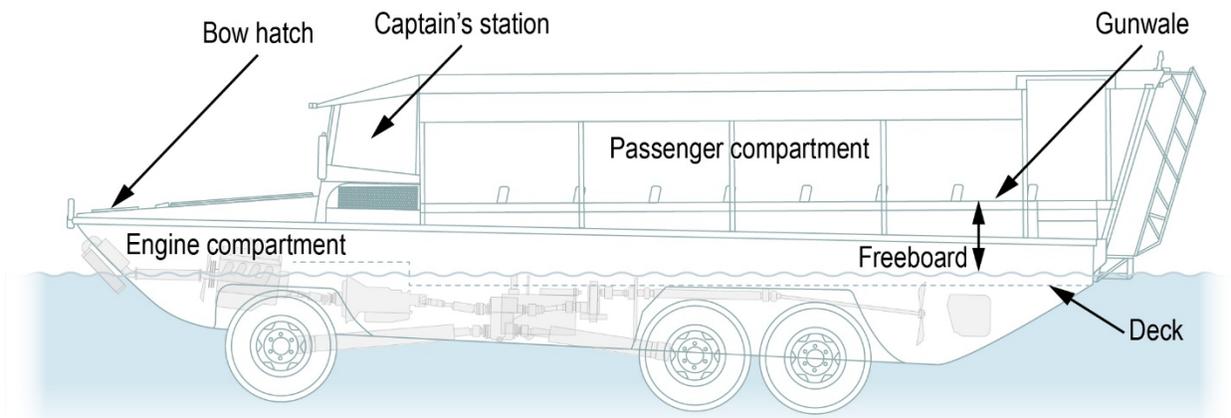
Figure 8. Profile drawing of *Stretch Duck 7* also showing engine, drive train, and propeller.

The *Stretch Duck 7* was propelled on both land and water by a Chevrolet 8-cylinder, 235-hp gasoline engine that was fitted in an engine compartment located forward of the captain’s station (see [figure 8](#)). The engine output shaft was connected to an automatic transmission that, through a single-speed transfer case, drove the forward and middle wheel sets for land operation; a separate output from the transfer case was connected to a three-bladed propeller for waterborne operations.

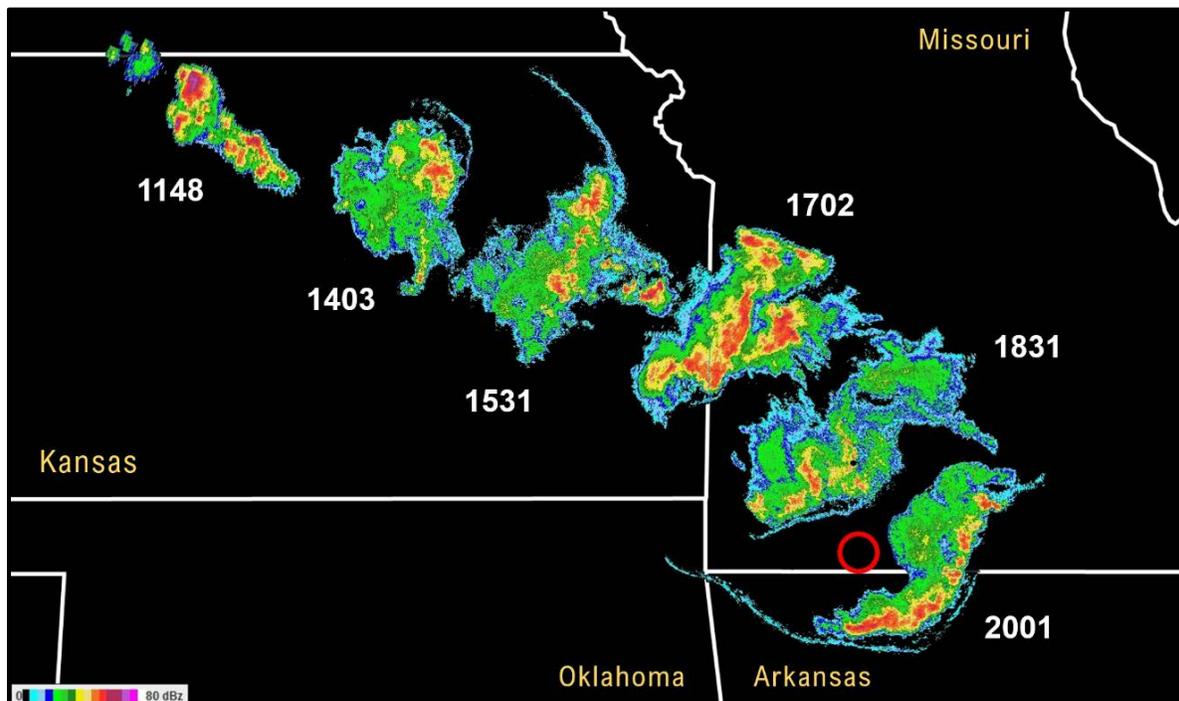
The National Weather Service Storm Prediction Center, which monitors non-severe and severe thunderstorm threats across the contiguous United States, concluded that the derecho impacting the accident site covered 473 miles (from north-central Kansas to northern Arkansas) and lasted for 9 hours 24 minutes. [Figure 14](#) depicts the progression of the storm system in a mosaic of edited radar images.

Figure 14. Mosaic of edited radar images depicting the progression of the derecho on July 19. Accident site is denoted by a red circle.

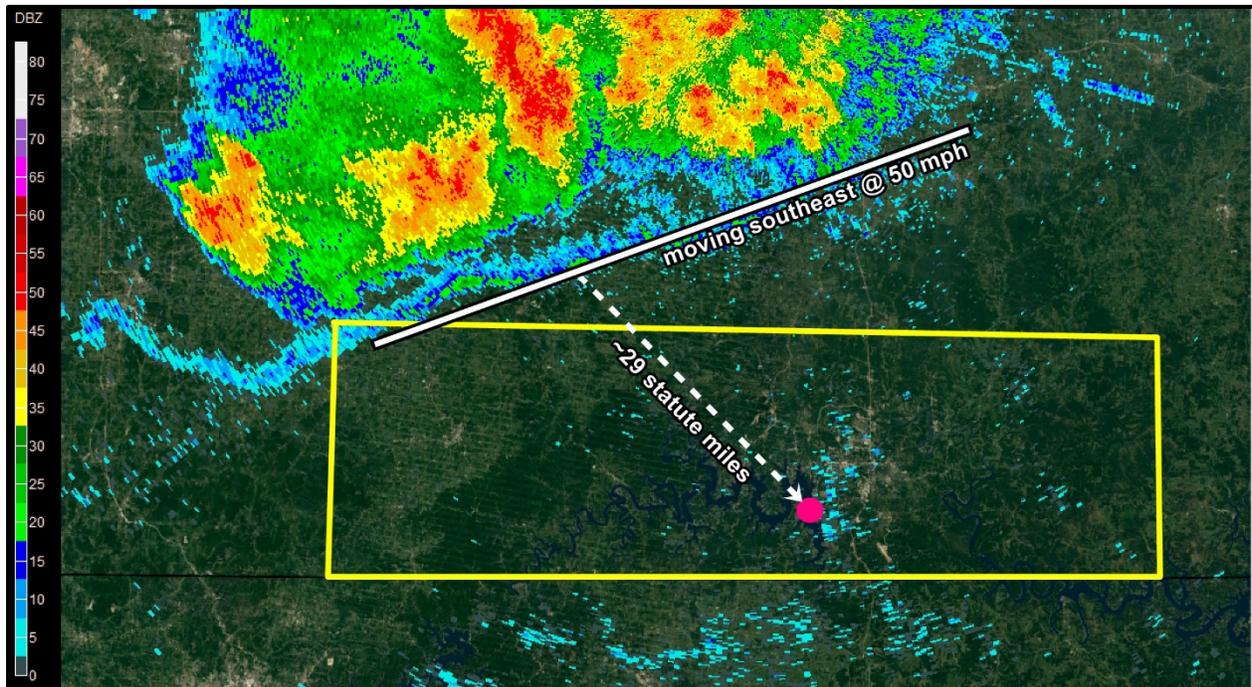
According to the meteorologist-in-charge, text of the severe thunderstorm warning included a description of the hazard(s), risk(s), impact(s), and timing of anticipated weather within the threat area, or polygon. [Figure 15](#) shows radar imagery of the storm system captured about 1829 when it was 29 miles away from the accident site. Overlaid onto the image is (1) a solid white line identifying the storm’s front, as defined by the senior forecaster; (2) a dashed white line identifying the shortest path the storm would have taken to the accident site if it was moving southeast; and (3) a yellow rectangle representing the polygon identified in the warning issued at 1832.

Figure 15. Radar image created postaccident from National Weather Service data captures the storm about 1829 as the gust front (solid white line) led the advancement of the system southeast toward Table Rock Lake (red dot). Yellow rectangle represents the threat area identified in the 1832 severe thunderstorm warning, which advised of 60-mph gusts.

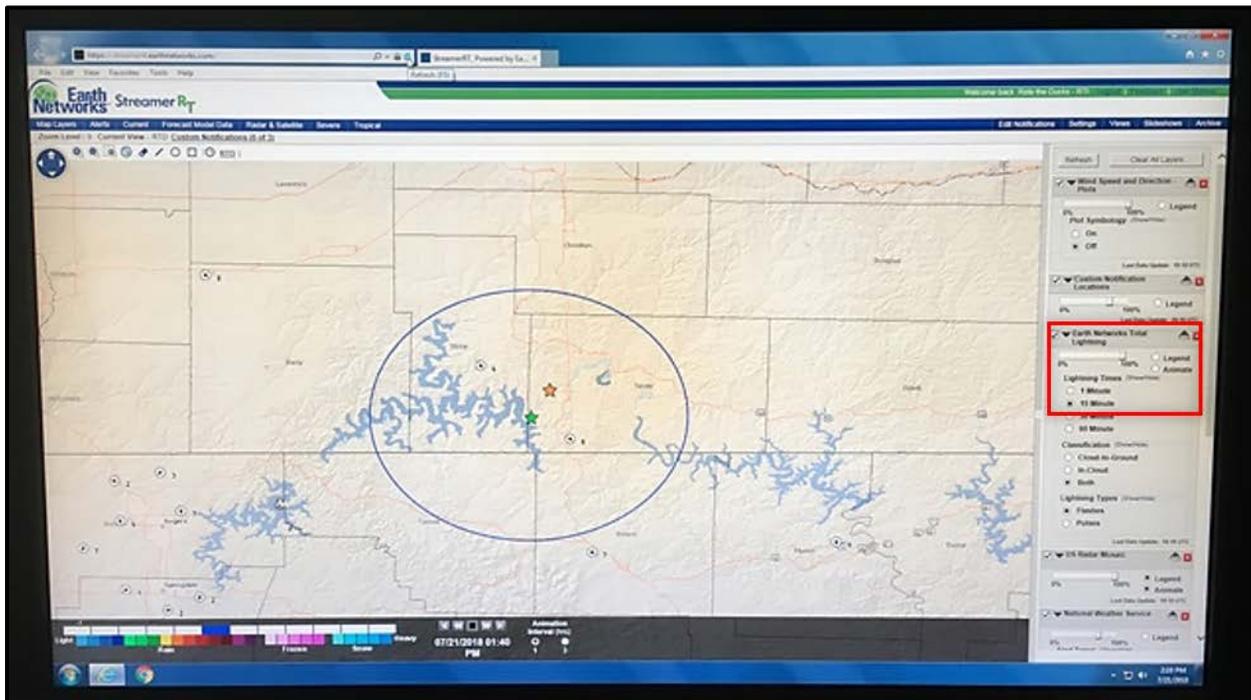
However, it is not known what overlays were active on the StreamerRT display in the office lounge on the day of the accident (see [figure 16](#)). According to Earth Networks, there were no system or data anomalies that day, and StreamerRT was operating as designed.

Figure 16. Screenshot of the StreamerRT display on the monitor in Ride The Ducks' lounge taken 2 days after the accident. Fifteen-minute lightning option was selected, as indicated by the red square.

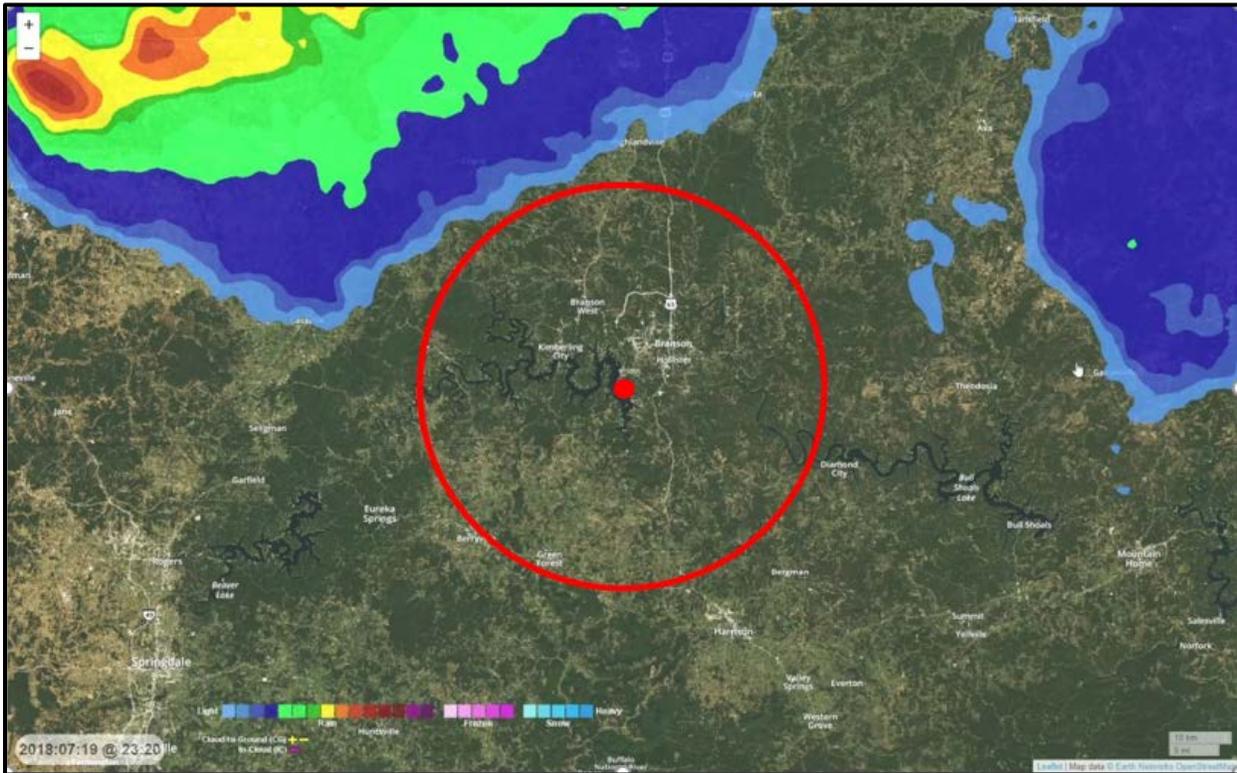
US Radar Mosaic. For the "Radar & Satellite" option in StreamerRT, Ride The Ducks personnel primarily used the "US Radar Mosaic" as standard. For other parameter options, most simply relied on the raw data presented on the screen, according to the operations manager. [Figure 17](#) shows one of the radar mosaic products displayed in StreamerRT that were available to users during

Figure 17. US Radar Mosaic product displayed on the StreamerRT monitor at 1825. Small red dot denotes a point very close to the accident location within a red circle that represents a radius of 20 miles. (The product has been mapped to a different background than what would have been seen in StreamerRT.)

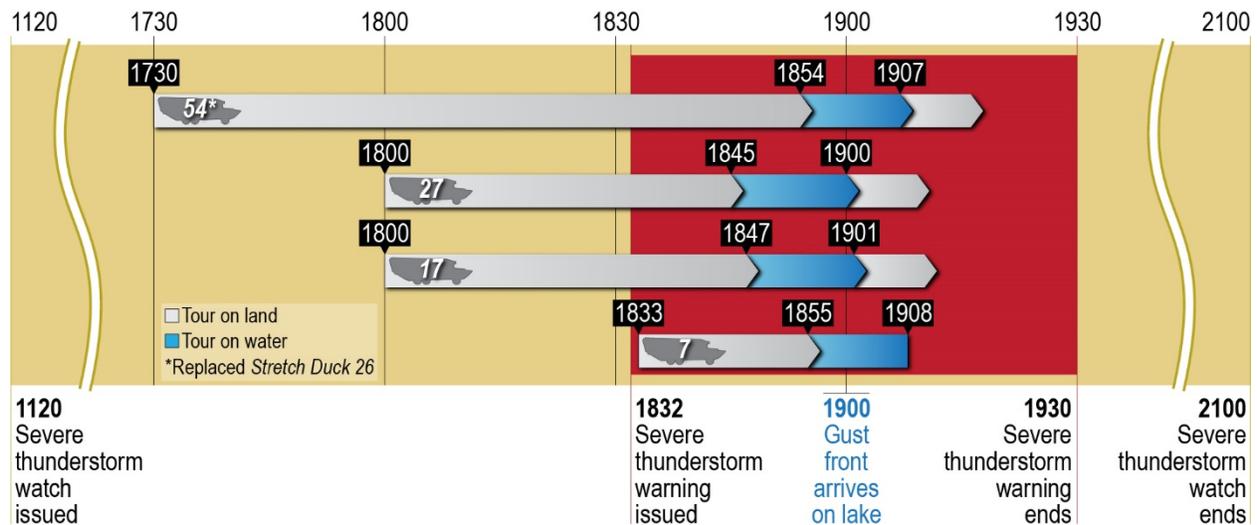
effect until 1930, the *Stretch Duck 27* entered the lake at 1845, the *Stretch Duck 17* at 1847, the *Stretch Duck 54* at 1854, and the *Stretch Duck 7* at 1855. (Figure 18 provides a graphic timeline of their water entry and exit during the period of the warning as well as the watch that was previously issued.) This span of 13 to 23 minutes after issuance of the severe thunderstorm warning provided sufficient time to suspend operations for the last tours of the evening. Furthermore, considering that the waterborne tours typically took about 20–25 minutes to complete, the last tour, which was the *Stretch Duck 7*'s, would not have been expected to finish until about 1915 to 1920, about 45–50 minutes after the warning was issued. Continuing with the tour would have placed the *Stretch Duck 7* on the water throughout the latter half of the warning.

Figure 18. Timeline tracking the tours of the four duck boats while on land (gray bar) and on water (blue bar) in relation to the severe thunderstorm watch and warning issued at 1120 and 1832, respectively. Tours begin with departure from Ride the Ducks' passenger boarding facility, follow to entry in Table Rock Lake, and complete with return to the duck dock, except for the *Stretch Duck 7*.
