Collision between US Navy Destroyer *Fitzgerald* and  
Philippine-Flag Container Ship *ACX Crystal*  
Sagami Nada Bay off Izu Peninsula, Honshu Island,  
Japan  
July 17, 2017

NTSB/MAR-20/02  
PB2020-101007

# Marine Accident Report

Collision between US Navy Destroyer *Fitzgerald* and  
Philippine-Flag Container Ship *ACX Crystal*  
Sagami Nada Bay off Izu Peninsula, Honshu Island, Japan  
June 17, 2017

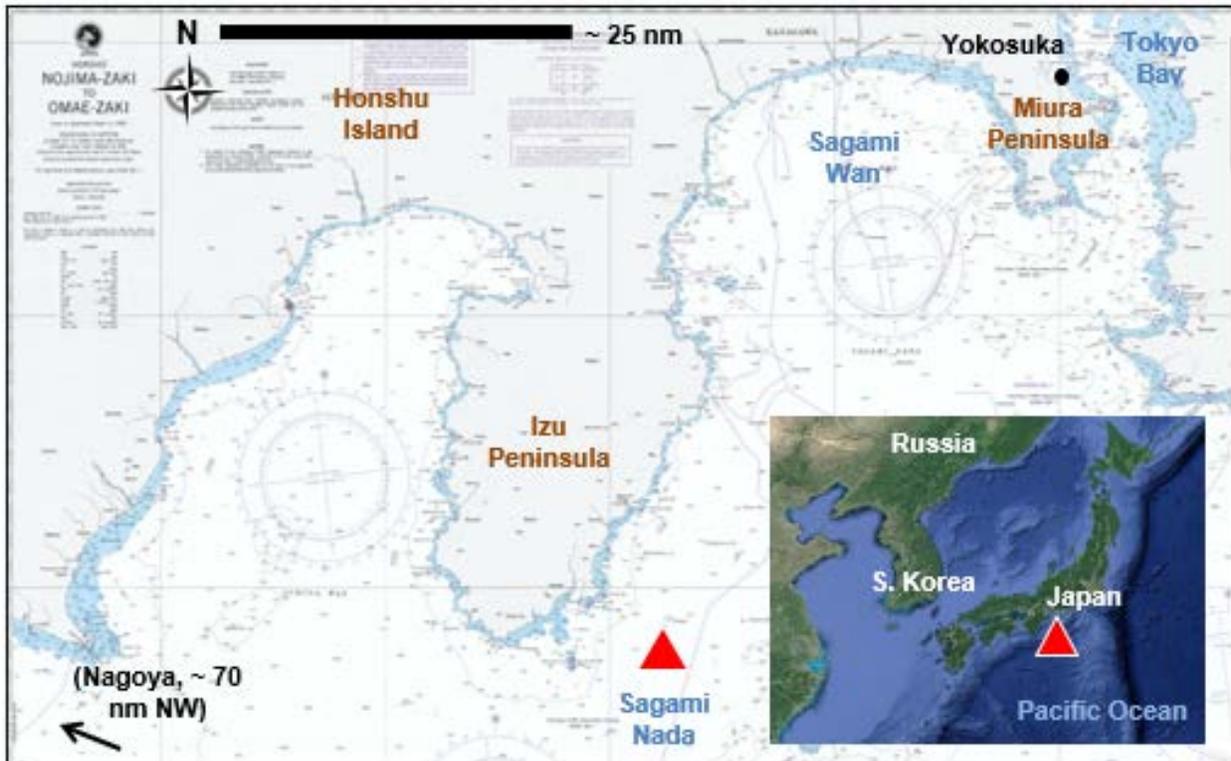
**Figure 2.** Chart of the accident area off the south coast of Honshu Island, Japan. The accident site is marked with a red triangle. (For more detail, see section 1.8 Waterway Information.) (Source for chart: National Geospatial Intelligence Agency, with annotations by NTSB. Background source for inset map: Google Earth.)

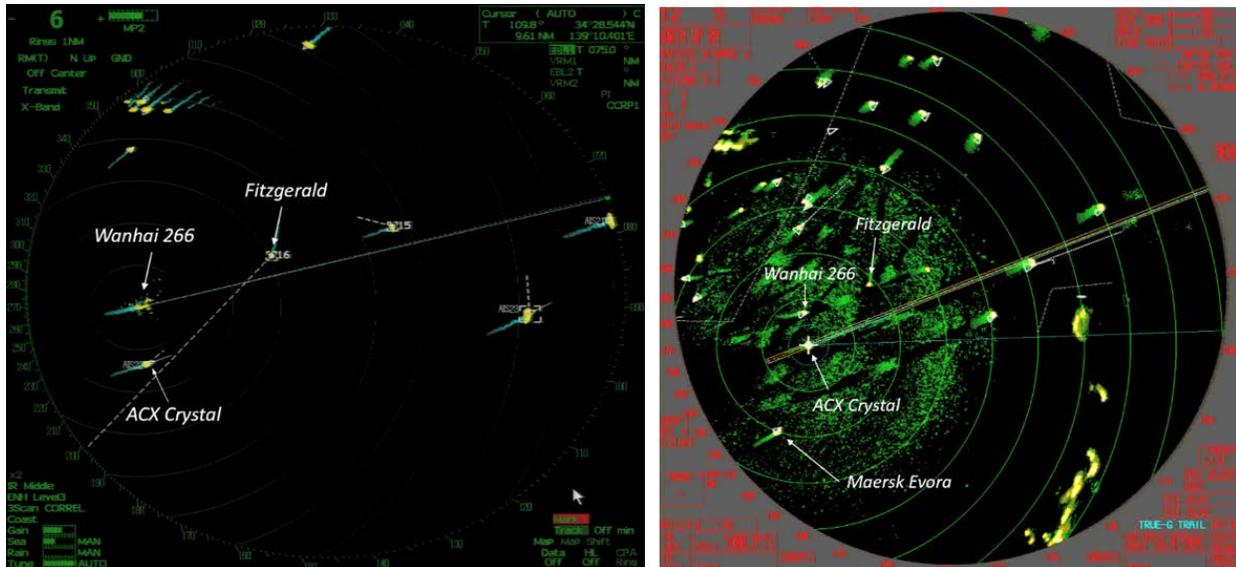
**Figure 6.** A comparison of radar screens from different vessels before the collision. Left, screen capture from the *Wan Hai 266* electronic navigation software, about 6 minutes before the collision. Right, screen capture from the *ACX Crystal* electronic navigation software (radar and ARPA), at the same time. (Vessel names have been added to screen images.)
