Capsizing and Sinking of
Commercial Fishing Vessel *Scandies Rose*
Sutwik Island, Alaska
December 31, 2019

Marine Accident Report

NTSB/MAR-21/02
PB2021-100924

NTSB/MAR-21/02
PB2021-100924
Notation 67259
Adopted June 29, 2021

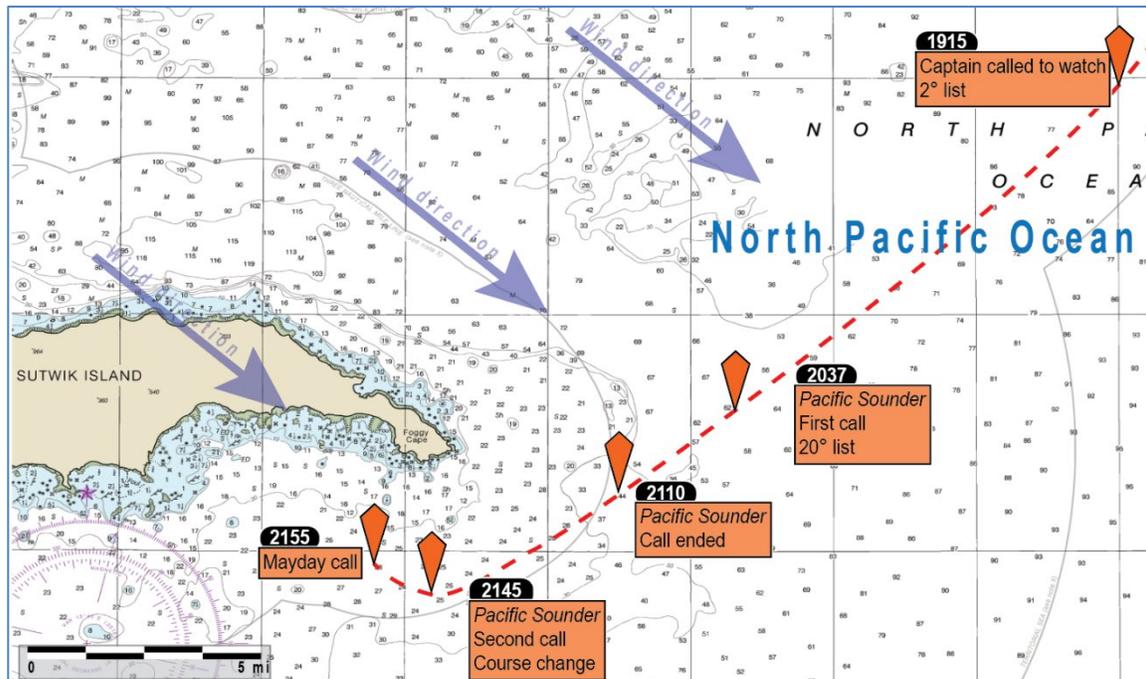
Figure 5. *Scandies Rose*'s positions over last 3 hours before mayday call.

About 2145, automatic identification system (AIS) data show that the *Scandies Rose* was about 2.5 miles south of Sutwik Island (see figure 5). The vessel had turned about 50° to starboard and held a northwesterly course in the direction of Sutwik Island's southern bay. After completing his work in the engine room, the captain of the *Pacific Sounder* called the captain of the *Scandies Rose* back. He said that the captain's “tone had changed” from their previous conversation. He said that the captain of the *Scandies Rose* said, I don't know how this is going to go,” and that his vessel's “list had gotten a lot worse.” The captain of the *Pacific Sounder* said that he had never heard that level of stress in the voice of the *Scandies Rose* captain before.

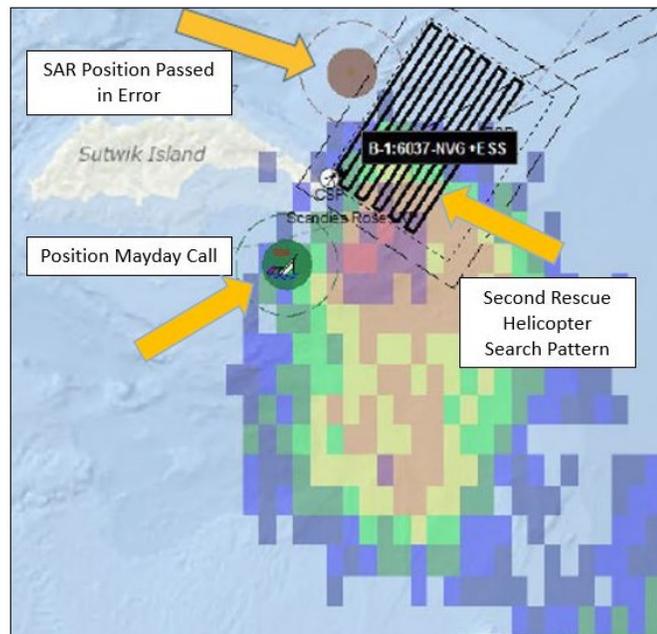
The coordinates where the two survivors were found had been reported back to the Coast Guard command center from the MH-60 via the on-scene C-130. These coordinates were used to generate a search pattern that was provided to the second helicopter. However, the location information relayed to the command center was incorrect and was north of Sutwik Island (7.8 miles north of the location of the captain's mayday transmission). The second helicopter arrived on scene at 0534 and followed the search pattern created from the northern coordinates, until it departed the scene at 0640 (see figure 7). It wasn't until after the second helicopter departed the scene to return to base that SAR command determined that the survivor recovery location coordinates were passed through the C-130 to the command center with an error, and that the second helicopter's search pattern was too far north. All subsequent searches were based off the coordinates from the captain's mayday call and the updated coordinates of the liferaft.

Figure 7. Second rescue helicopter search area, based off position passed in error. Purple and red indicates the highest-probability areas for locating survivors.

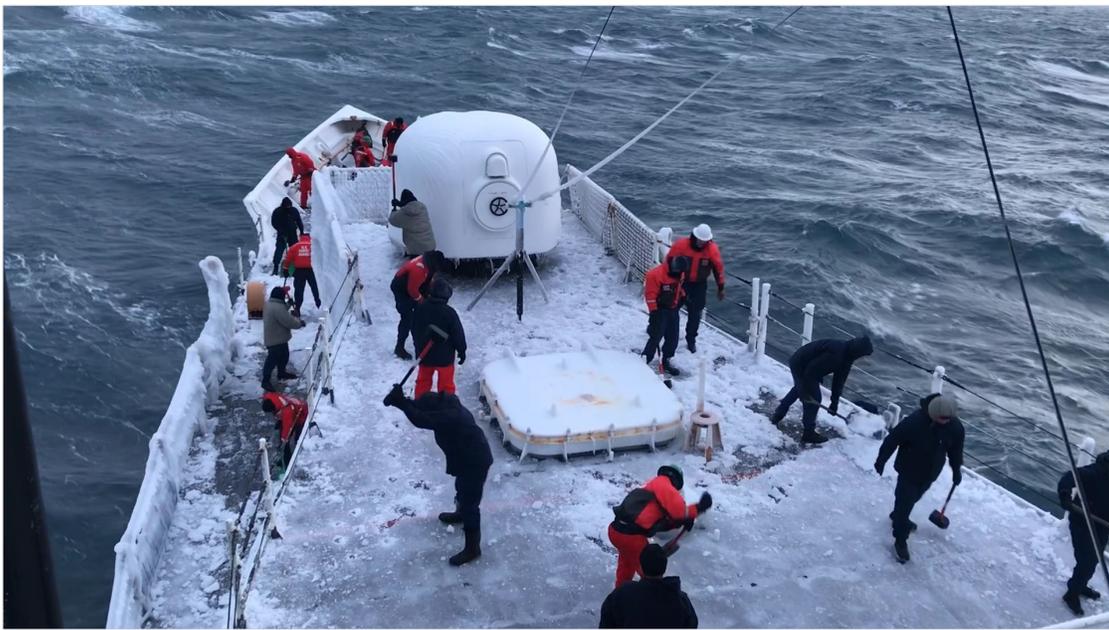
The captain of the *Mellon* reported that they arrived on scene around 1615 on January 1, but they had to stop the search pattern to break ice before sunset (1701) because 2 to 3 inches of solid ice had accumulated on the deck during the voyage, as shown in figure 8. The icing had built on the ship asymmetrically, and they had to steer 40° off their intended course due to the wind and waves to maintain search lines.

Figure 8. USCGC *Mellon* crew breaking ice during search efforts late afternoon on January 1.

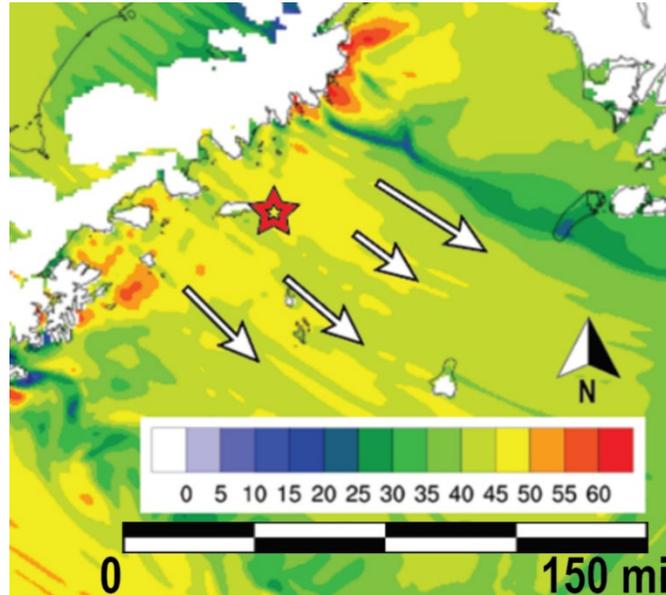
Weather Simulation. To validate the weather forecasts and further investigate the potential for williwaws, the NTSB ran a Weather Research and Forecasting (WRF) model.³⁰ The model used observational and model weather information to simulate the weather conditions along the Alaska Peninsula surrounding the time of the accident. The simulation indicated wind increasing with time, with sustained winds between 40 and 55 knots near the accident site at the accident time. (Wind gusts were not calculated.) Higher windspeeds were coming from the bays and passes in the lee of the Alaska Peninsula (red and orange on figure 18).

Figure 18. NTSB weather model showing near-surface wind in knots at 2100. The *Scandies Rose's* approximate location is marked by a star. White arrows show estimated wind direction.

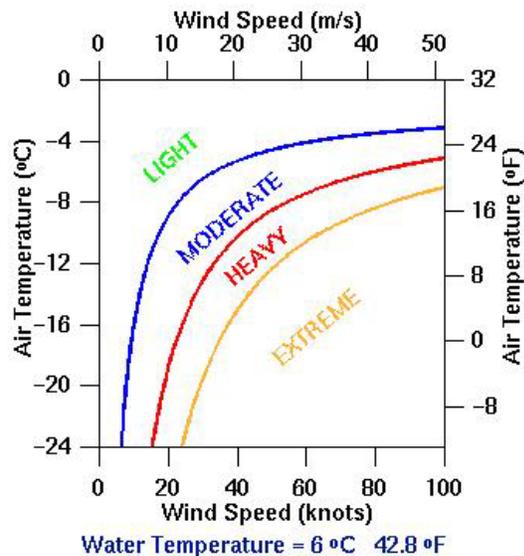
Figure 19. Overland (1990) sea spray ice accretion potential for water temperature of 6.0°C.

In general, more sea spray reaches the deck and superstructure when the vessel travels faster into the wind and waves, particularly for smaller vessels and vessels with less freeboard. The NWS Alaska currently uses an algorithm to estimate the amount of sea spray ice accretion and forecast situations of freezing spray and heavy freezing spray (Overland 1990). The rate of icing increases as the temperature drops and the wind speed and sea height increases. At the time of the accident, the sea spray ice accretion potential for vessels between 20 and 70 meters in length (which included the accident vessel, at 39.6 meters) is shown in figure 19.³¹

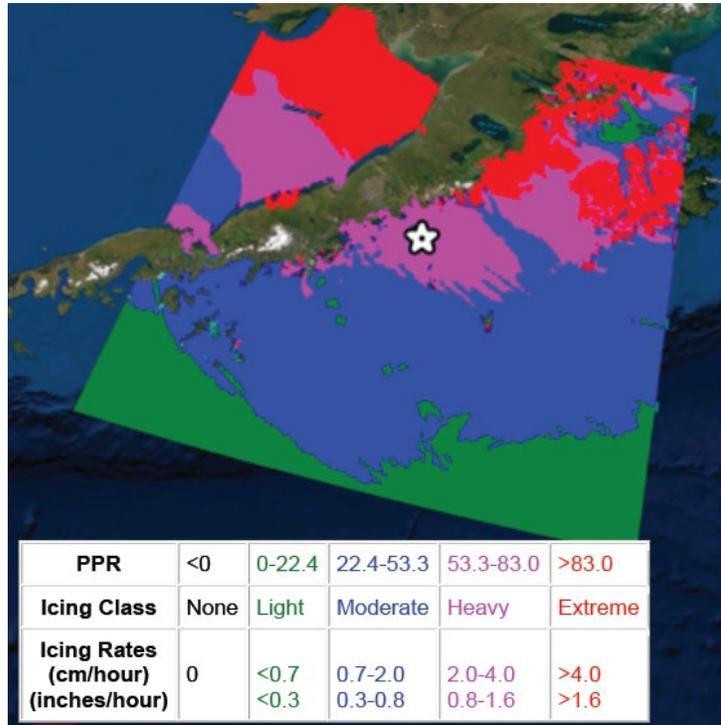
Figure 20. Modeled sea spray ice accretion values for the accident area on December 31, 2020, at 2200. The approximate accident location is marked by a star.

Using data from the NTSB weather model, the NTSB estimated the amount of sea spray ice accretion (measured in inches per hour) at times and locations along the *Scandies Rose*'s trackline. At the time of the sinking, about 2200 on December 31, the vessel was in an area that the NTSB weather model calculated as experiencing heavy sea spray ice accretion of up to 1.6 inches per hour (see figure 20).

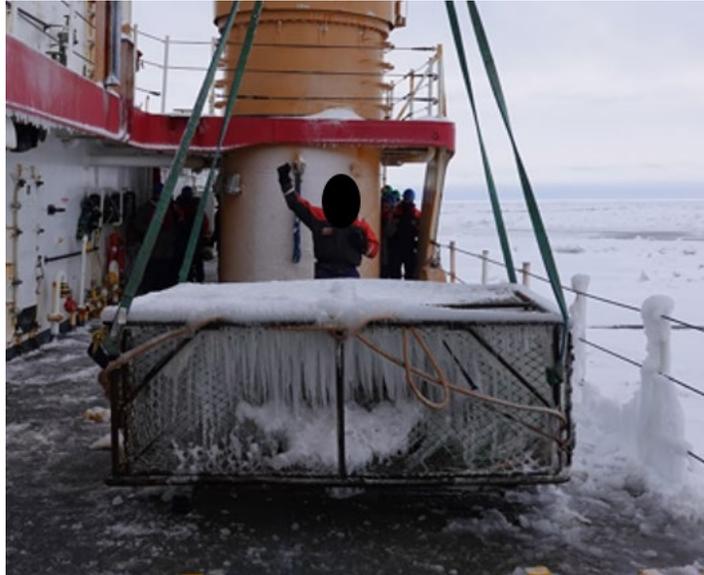
Following the sinking of the *Scandies Rose*, USCGC *Polar Star* simulated sea spray ice accumulation to observe how ice can potentially accumulate inside a crab pot. The crew used a garden hose with a mist applicator to spray fresh water over a 1,040-pound crab pot on the vessel’s deck while on patrol in the Bering Sea (see figure 23). After 72 hours, with temperatures ranging from 5°F to 15°F and variable winds, the pot weight more than tripled due to the accumulated ice, and the exact weight of the pot could not be determined because it maxed out the load cell used, which was rated for 3,000 pounds. The crew observed significant ice accumulation inside the pot, but the thickness of the ice, outside and inside the pot, was not determined.

Figure 23. Crewmembers aboard USCGC *Polar Star* weigh a crab pot following a 3-day freezing spray experiment.

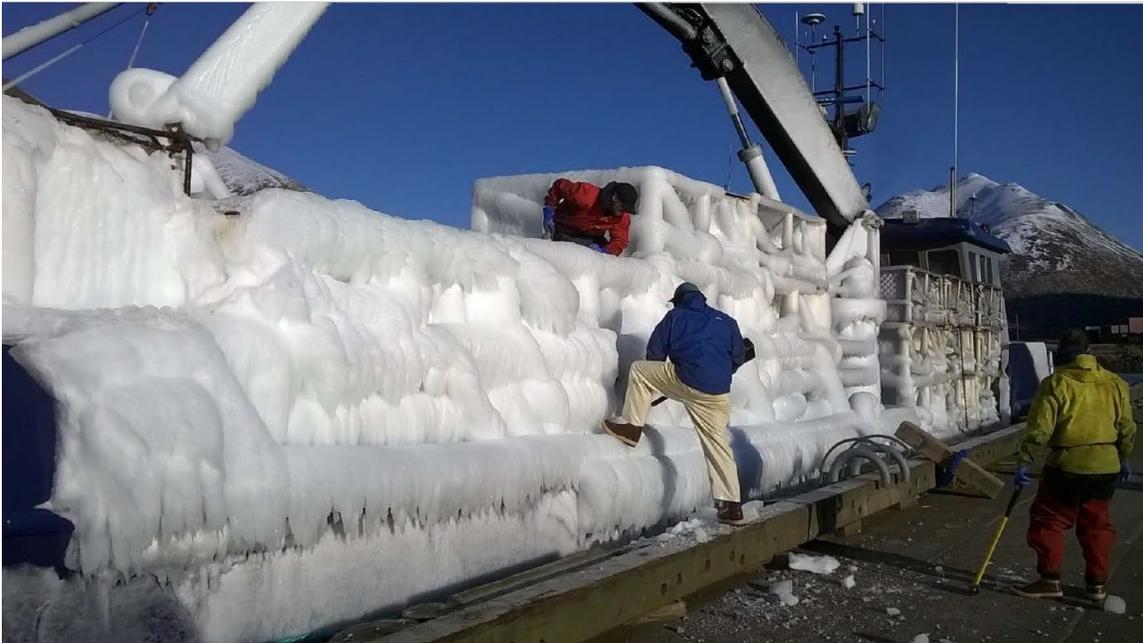
Figure 24. Ice accumulation on the fishing vessel *Sandra Five* in King Cove, Alaska, February 12, 2017. The vessel was operating the previous day in the Bering Sea in the vicinity of the *Destination* (NTSB 2018).

The NTSB also issued a safety alert in 2018 following the sinking of the *Destination* (NTSB 2018). The alert showed icing on vessels exposed to freezing spray operating near the capsized vessel (see figure 24) and provided operators with different precautions to take if icing conditions were encountered. The alert stressed that operators should understand their vessels' stability information and ensure that their vessels are operating within the limits set in the stability instructions.

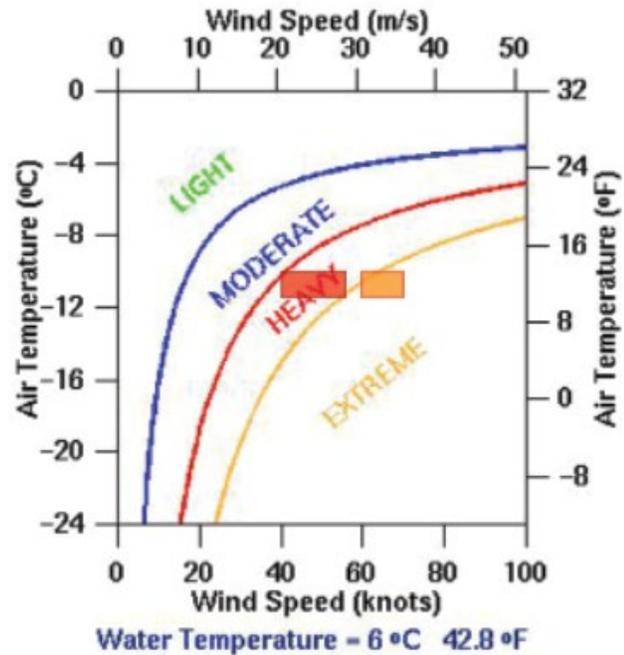
Based on the ice accretion rate obtained from the NTSB's weather model (which relied on weather conditions reported from the larger area's four weather stations) the *Scandies Rose* experienced progressively worse icing during the voyage.⁴³ Plotting the vessel's track, it is likely that the vessel first started accumulating ice around 0500 on December 31 (crew first observed icing at 0600). The vessel was then likely in light icing between 0500 and 1000, in moderate icing between 1000 and 1700, and in heavy icing between 1700 and 2200 (see figures 25 and 26). However, based on the localized weather conditions reported by the captain and crew, the *Scandies Rose* was likely experiencing ice accumulation greater than 1.6 inches per hour, which is categorized as extreme icing, over the final 2 hours of the voyage. The NTSB concludes that, based on the voyage timeline and the estimated ice accumulation over that period, the *Scandies Rose* likely accumulated between 6 and 15 inches of ice on surfaces exposed to wind and icing during the accident voyage.

Figure 25. Overland (1990) sea spray ice accretion potential for water temperature of 6.0°C. The weather conditions from 1700 to 2200 obtained from the weather model are noted in red and are primarily in the “heavy” portion of the graph. The weather conditions observed by the captain during the last 2 hours, about 2000 to 2200, are noted in orange and are primarily in the “extreme” portion of the graph.

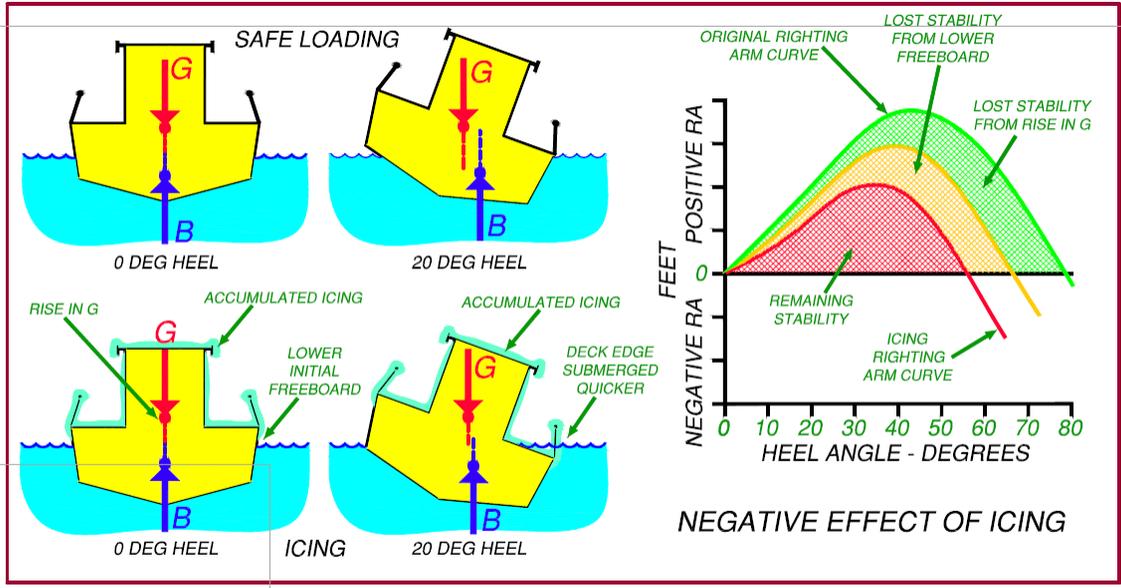
The loss of stability from ice may go unrecognized because, similar to overloading a vessel, initial stability levels at small angles of heel are only slightly reduced, which the crew may not notice as the vessel heels at smaller angles and returns. However, initial stability does not indicate the vessel's overall stability, as shown in a righting arm curve, which icing can significantly reduce. For example, a vessel that could return from a heel of 80° without the added weight of ice can capsize at lesser heel angles, such as 60°, as shown in figure 29.

Figure 29. Icing effect diagram from *A Best Practices Guide to Vessel Stability*, page 49.

The *Best Practices Guide to Vessel Stability* recommends corrective actions when icing conditions are encountered, including keeping freeing ports clear of ice to allow rapid draining of water off the decks.
