Fire aboard Roll-on/Roll-off Vehicle Carrier *Höegh Xiamen*

Pier 20, Blount Island

June 4, 2020

This report discusses the June 4, 2020, fire aboard the roll-on/roll-off cargo vessel *Höegh Xiamen*. None of the vessel's 21 crewmembers were injured, but nine shoreside firefighters responding to the accident were injured during firefighting efforts. The vessel and its cargo of 2,420 used vehicles were declared a total loss valued at \$40 million, and the vessel was later recycled. Safety issues identified in this report include training for and oversight of vehicle battery securement, regulatory exceptions for used and damaged flammable-liquid-powered vehicles, fire detection system deactivation during cargo loading, and effective emergency distress calls. One recommendation each was made to the Pipeline and Hazardous Materials Safety Administration, the US Coast Guard, and the National Maritime Safety Association; two recommendations were made to Grimaldi Deep Sea; and three recommendations were made to Höegh Technical Management.

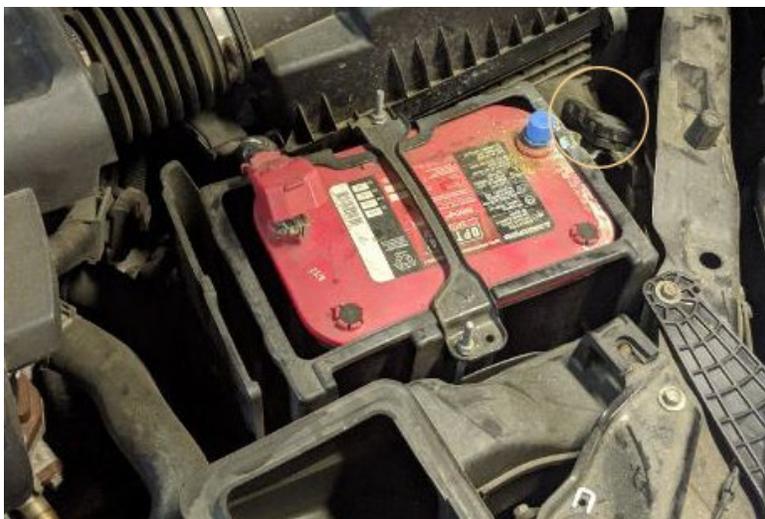
Grimaldi instructed SSA to create a "battery brigade" of ILA longshoremen who would be solely responsible for following behind vehicles as they were loaded and parked in order to disconnect the batteries. The brigade was required to disconnect the negative cable from the battery, tuck the cable away from the battery terminal, and cover the battery post with the battery cap (see figure 12). Once the cable was disconnected and the hood was shut, the brigade would mark the unit with grease marker to identify the vehicle as having a disconnected battery. Before loading, on May 22, 2020, the Grimaldi port captain emailed the company's written procedure to SSA and instructed, "Please note that I can't stress enough the importance of battery disconnect. Please ensure to have battery caps and adequate mechanics ordered to keep up with production."

Figure 12. Excerpt from Grimaldi battery disconnect procedure showing a vehicle battery secured with a blue plastic negative terminal cap and disconnected cable (*circled*) tucked inside. (Source: Grimaldi)
