MAR 21/05

Hazardous Liquid Pipeline Strike and Subsequent Explosion and Fire aboard Dredging Vessel *Waymon Boyd*

EPIC Marine Terminal, Corpus Christi Ship Channel, Corpus Christi, Texas

August 21, 2020

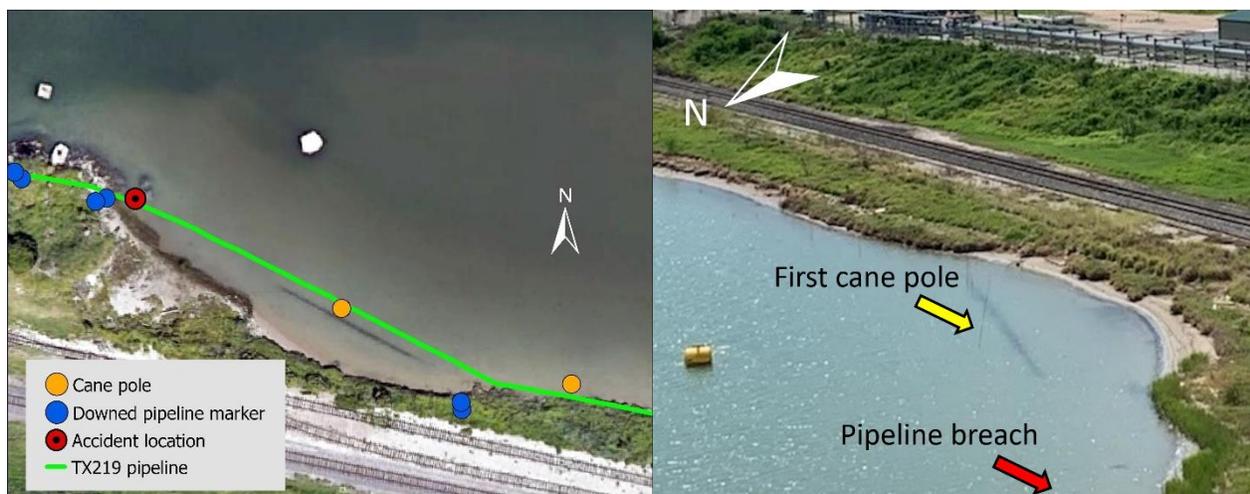
On July 25, category 1 Hurricane Hanna struck the Texas coast just south of Corpus Christi. The impact of the storm on the courtesy cane pole markings is unknown, but Texas law required the excavator to notify a utility owner if the status of markings changed (see section 1.10.1 for more information about federal and state statutes and regulations). There is no record of Orion contacting Enterprise regarding the cane poles after the hurricane passed. A photograph of the accident site taken some time after the storm, while phase 2 dredging operations were under way, shows the closest cane pole east of the accident pipeline breach was about halfway across the inlet in the channel that the pipeline crossed (see figure 6). A postaccident overhead image of the area shows the location of pipeline TX219 as well as the location of two cane poles and a downed pipeline marker, based on a postaccident survey conducted by SAM LLC.

Figure 6. Postaccident temporary and permanent pipeline marker survey locations, accident location, and pipeline TX219 (*left*); preaccident photo of marking cane pole (*right*). (Sources: Enterprise Products [*left*]; EPIC Crude Terminal Company [*right*]; images annotated by NTSB)

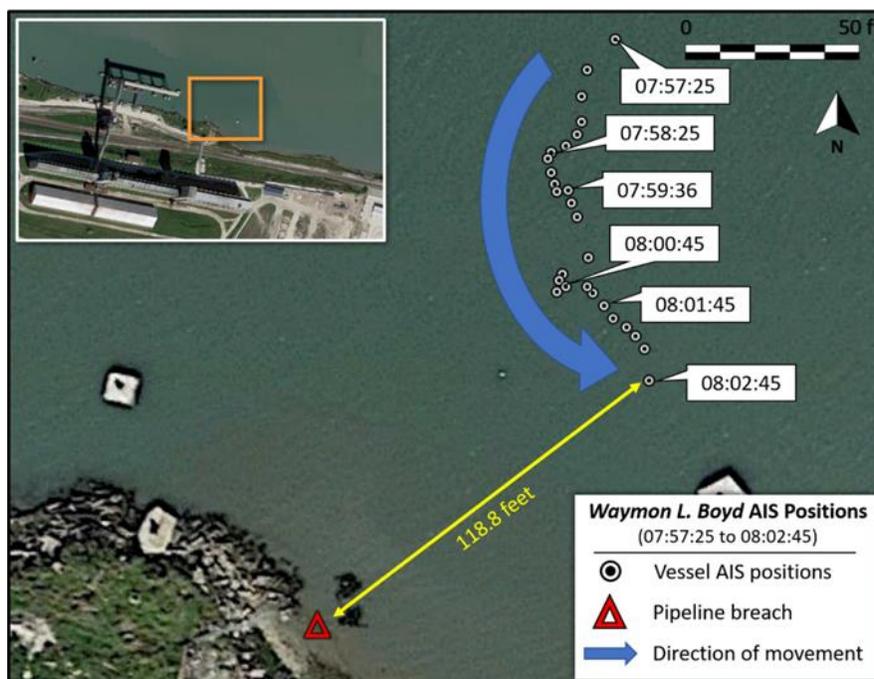
AIS data from the *Waymon Boyd* shows the vessel's movement in the minutes preceding the accident (see figure 9). Beginning at 0757:25, the dredge swung in a rough arc in a southeasterly direction, toward the shoreline, with a speed over ground between 0.1 and 0.3 knots. The dredge's direction of movement did not reflect its orientation (heading information was not reported by the vessel's AIS), but the dredge captain and leverman told investigators that the vessel's heading was changing from a westerly to southwesterly direction as it moved. At 0802:45 (5 minutes 20 seconds elapsed), the swing to port stopped. At this point, the AIS position of the vessel was about 118.8 feet from pipeline TX219. (The AIS antenna was mounted on the top of the lever room, with a horizontal distance of 119.1 feet from the forward end of the cutterhead.⁶)

Figure 9. *Waymon Boyd* AIS data from 0757:25 to 0802:45 on the accident date.
(Background source: Google Earth)

The leverman said that when the cutterhead was about 5 feet from the southern edge of the dredge template during his swing to port, water suddenly began shooting up off the surface of the waterway, about 2-3 feet landward of the cutterhead. He said the water spray reached as high as the top of the dredge. He did not see or smell any sign of gas. He told investigators that, not knowing what had occurred, he stopped the cutterhead, increased the speed of the motor driving the dredge's anchor winches, and operated the anchor winch control levers to swing the dredge to starboard, away from the spraying water, as quickly as possible. He then called the dredge captain.

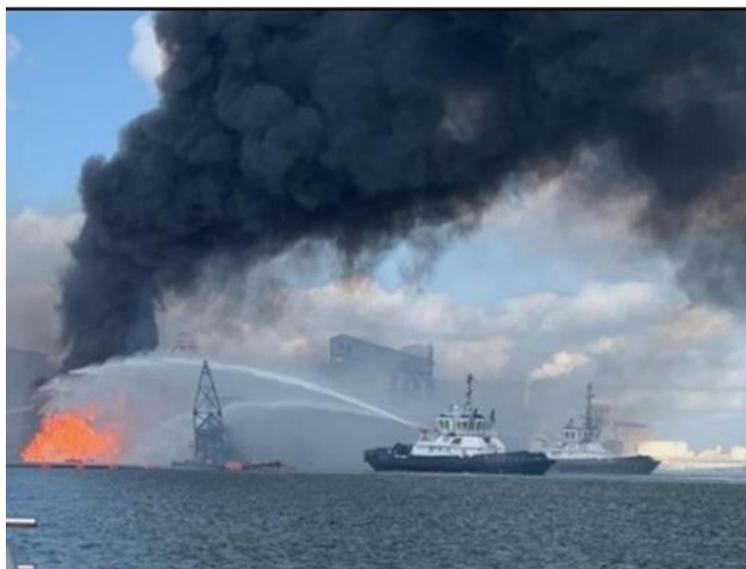
At 0934, the tugboats *Ted C Litton* and *Evelena* arrived on scene and began using their water monitors (cannons) to fight the fire on the dredge (see figure 11). About 20 minutes later, the tugboats *Signet Constellation*, *Signet Courageous*, and *Signet Stars & Stripes*, as well as the prevention and response tugboat *Signet Strength*, took over waterborne firefighting efforts.⁷

Figure 11. Tugboats *Ted C Litton* and *Evelena* fight the fire at the accident scene. (Source: Coast Guard)

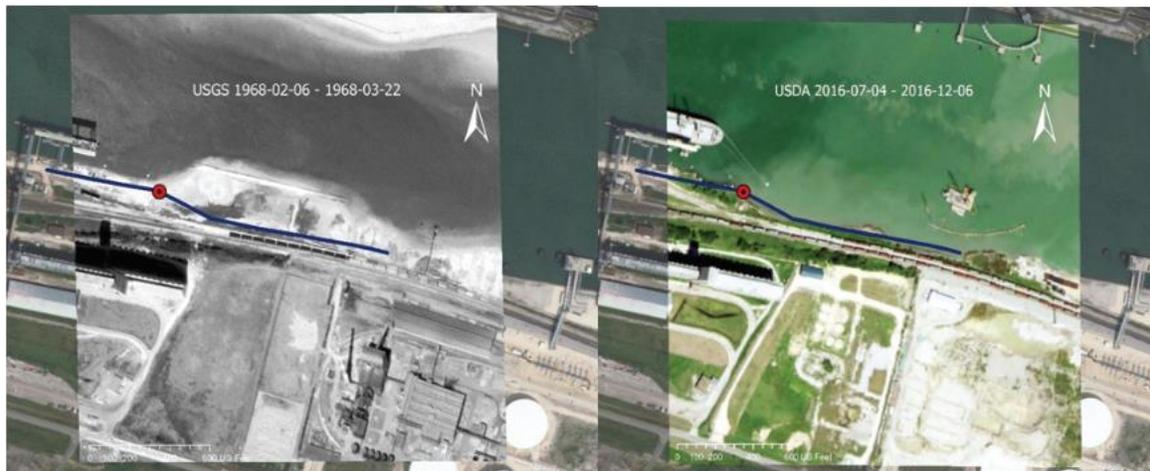
The breached segment of pipe was in the waterway from years of progressive land loss near the EPIC dock project area (see figure 15). The length of the pipeline TX219 segment traversing the waterway at the accident location was about 265 feet.¹⁴

Figure 15. EPIC dock project area, 1968 and 2016, showing the extent of land loss. The blue line indicates the TX219 location, and the red circle is the approximate accident location. (Sources: US Department of Agriculture [left]; US Geological Survey [right]; photos georeferenced and overlaid on a Maxar Technologies image)

In addition to the location of the pipelines, the December 28, 2018, TMI Solutions survey of existing utilities within the project area also included a depth of cover survey. The TMI survey found the pipeline had 0.4 feet of cover on the west end of the water exposure at the point where the pipeline transitioned back onto land nearest the accident location. The pipeline had 2.0 feet of cover at the east end of the underwater segment.
