# **NATIONAL TRANSPORTATION SAFETY BOARD**

## **MARINE ACCIDENT REPORT**

**UNITED STATES BULK CARRIER MARINE ELECTRIC  
CAPSIZING AND SINKING  
ABOUT 30 NAUTICAL MILES  
EAST OF CHINCOTEAGUE, VIRGINIA  
FEBRUARY 12, 1983**

NTSB/MAR-84/01

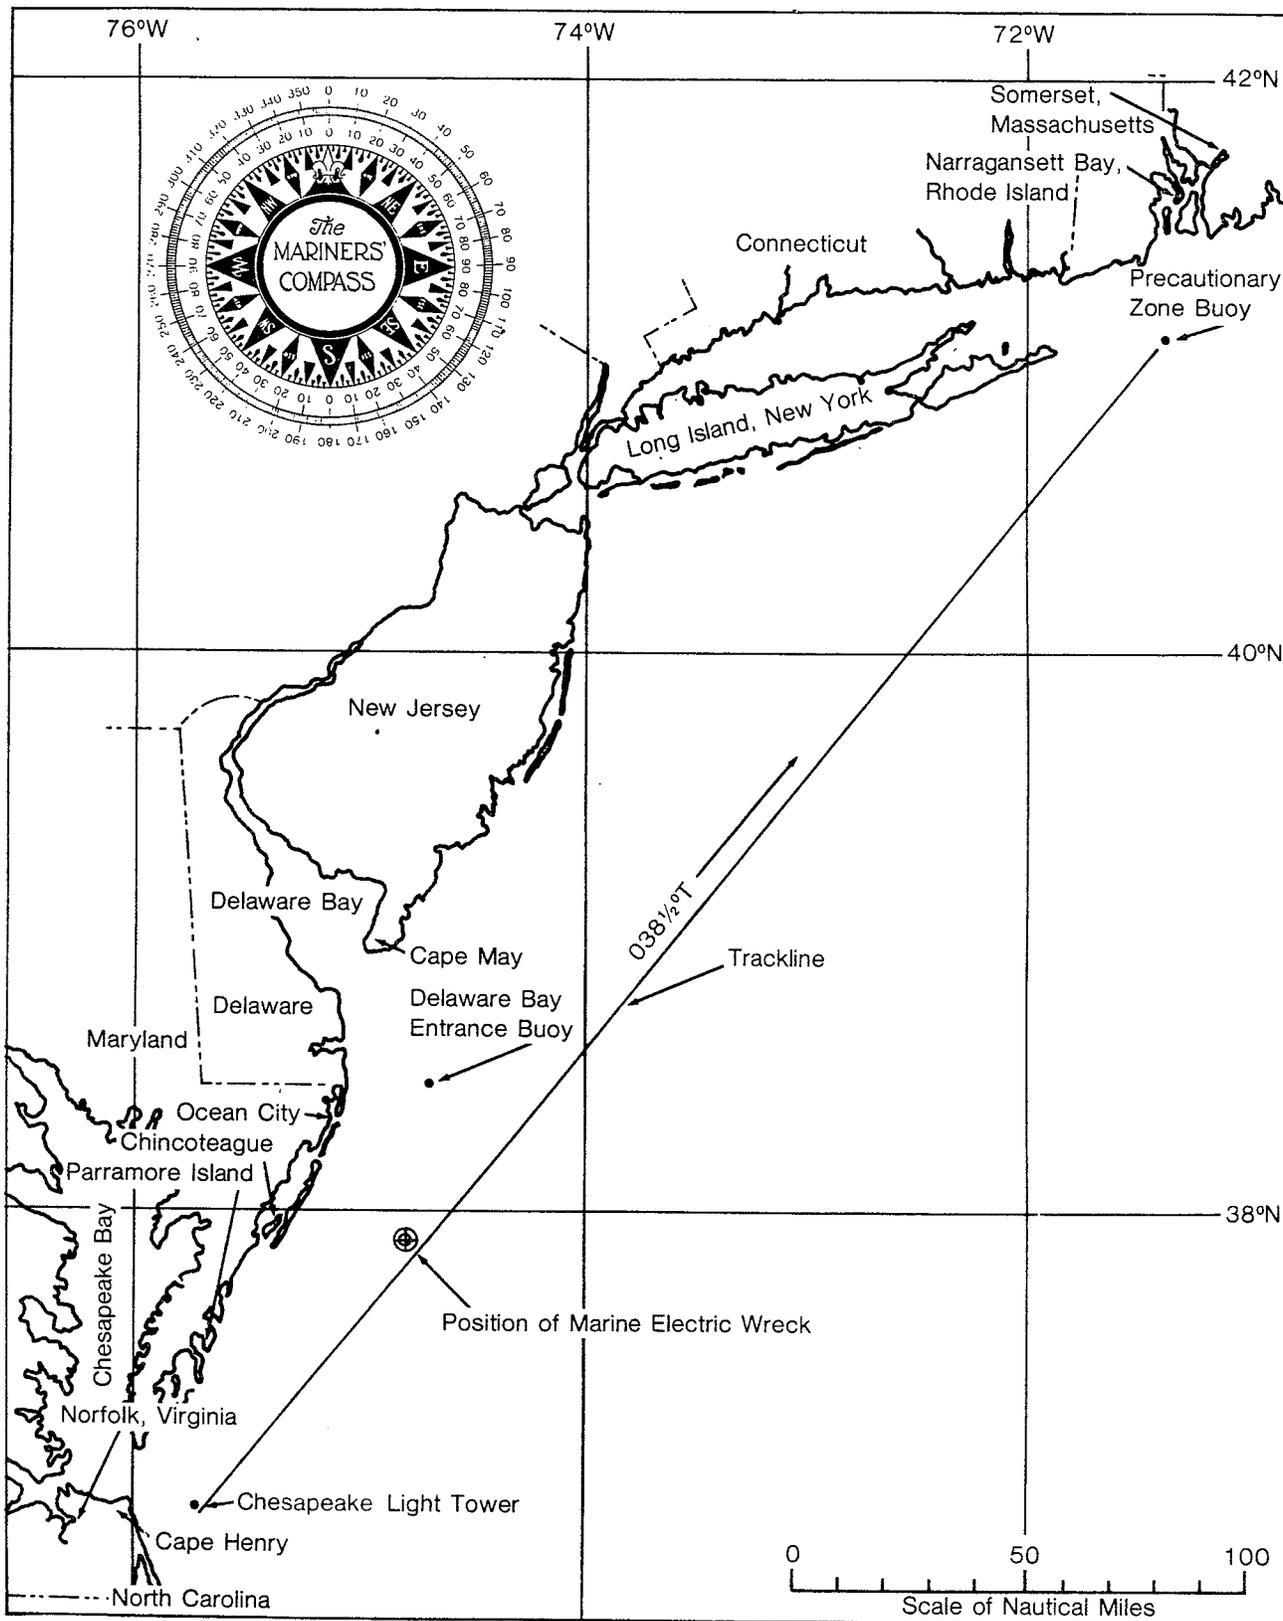
Figure 2.--MARINE ELECTRIC's normal northbound trackline and position of its wreck.

From a position 1 mile east of the Chesapeake light tower at the entrance to Chesapeake Bay, the MARINE ELECTRIC's normal northbound trackline to the whistle buoy at the center of the precautionary zone at the entrance to Narragansett Bay, Rhode Island, was a course of 038 1/2° T. (See figure 2.) This course took the vessel well outside the 10-fathom curve off the Virginia and Maryland coast. Along the trackline east of Chincoteague, the water depth is between 100 and 130 feet. About 15 nmi west of the trackline and 15 nmi east of Chincoteague, the water depth decreases to about 70 feet.

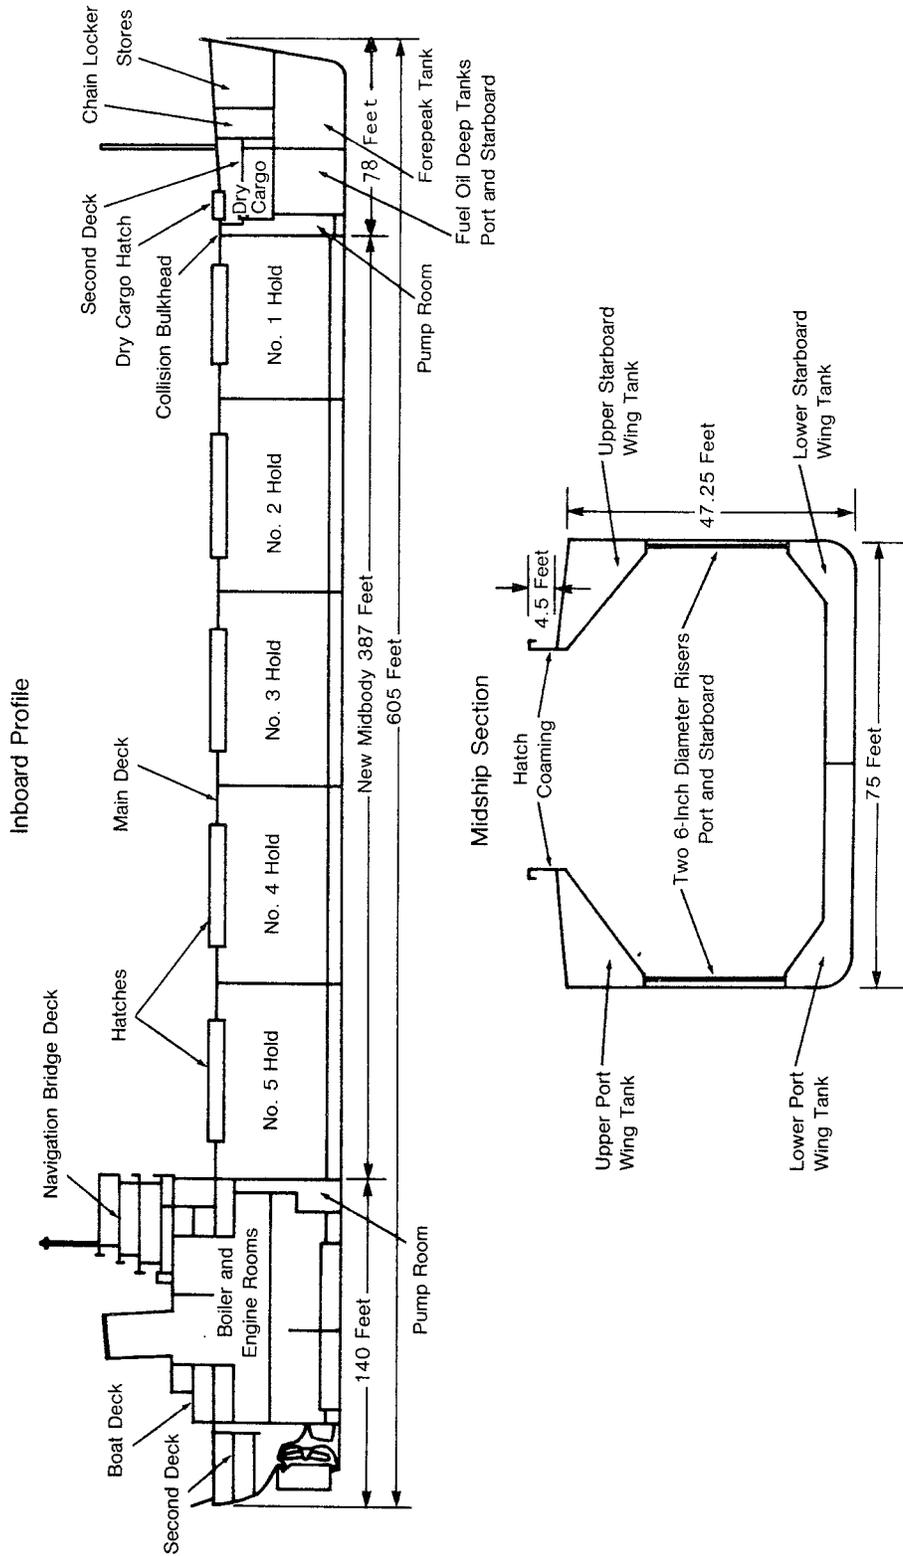
Figure 3.—Inboard profile and midship section of the MARINE ELECTRIC.

The stern section contained an after deckhouse and the machinery spaces. The midship house was moved aft and placed on top of the original after deckhouse. The new midship section contained five cargo holds and five upper and lower wing ballast tanks, port and starboard. Steel hatch covers on 4.5-foot coamings protected each cargo hold. (See figure 3.) The original bow section contained a small dry cargo space with a non-weather-tight hatch on the second deck, various storerooms, the forepeak tank, and the port and starboard fuel oil deep tanks. A hinged steel weather-tight hatch cover on a 2.5-foot coaming on the main deck protected the dry cargo area. This single panel hatchcover was about 11 feet 3 inches by 15 feet and was original T-2 tanker equipment.

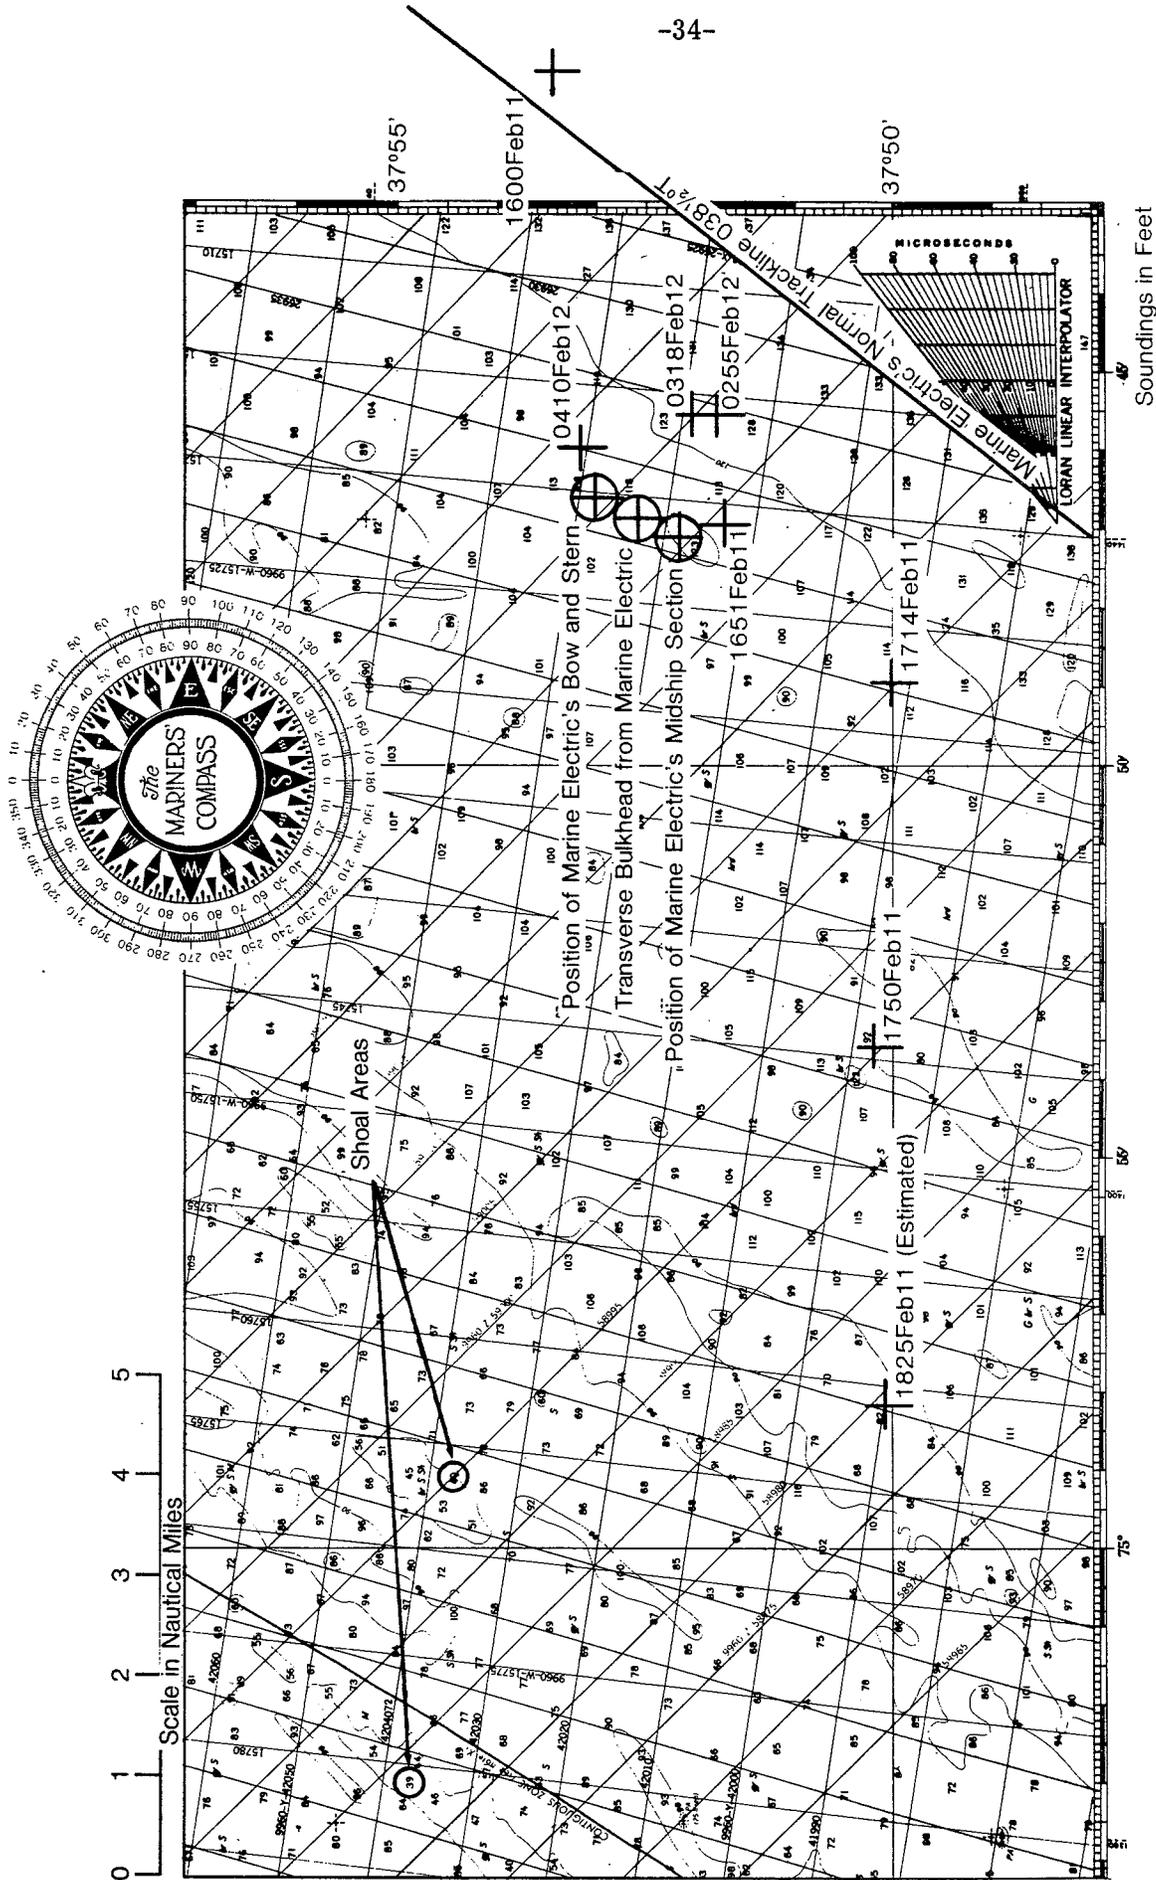
Figure 6.--Section of NOAA Chart 12211, dated July 17, 1982, indicating the MARINE ELECTRIC's position on February 11 and 12, 1983.

yards at a bearing of 205° T from the main wreck. (See figure 6.) The midship section was upright on a heading of 280° T with the portside intact and the starboard side missing. The starboard anchor was not found, but the starboard devil's claw was removed intact from the bow section, except for the tip of one claw which had broken off. The devil's claw turnbuckle was nearly unscrewed with only a couple of threads showing on the claw end; the threads on the other end were only partially screwed into the turnbuckle. The starboard chain could not be removed because of equipment problems, but four links of chain (later found not to belong to the MARINE ELECTRIC) were recovered from the sand near the stern section.
