**NATIONAL
TRANSPORTATION
SAFETY
BOARD**

MARINE ACCIDENT REPORT

**FIRE ABOARD
THE BAHAMIAN PASSENGER VESSEL
M/V SCANDINAVIAN SEA
CAPE CANAVERAL, FLORIDA
MARCH 9, 1984**

NTSB/MAR-85/03

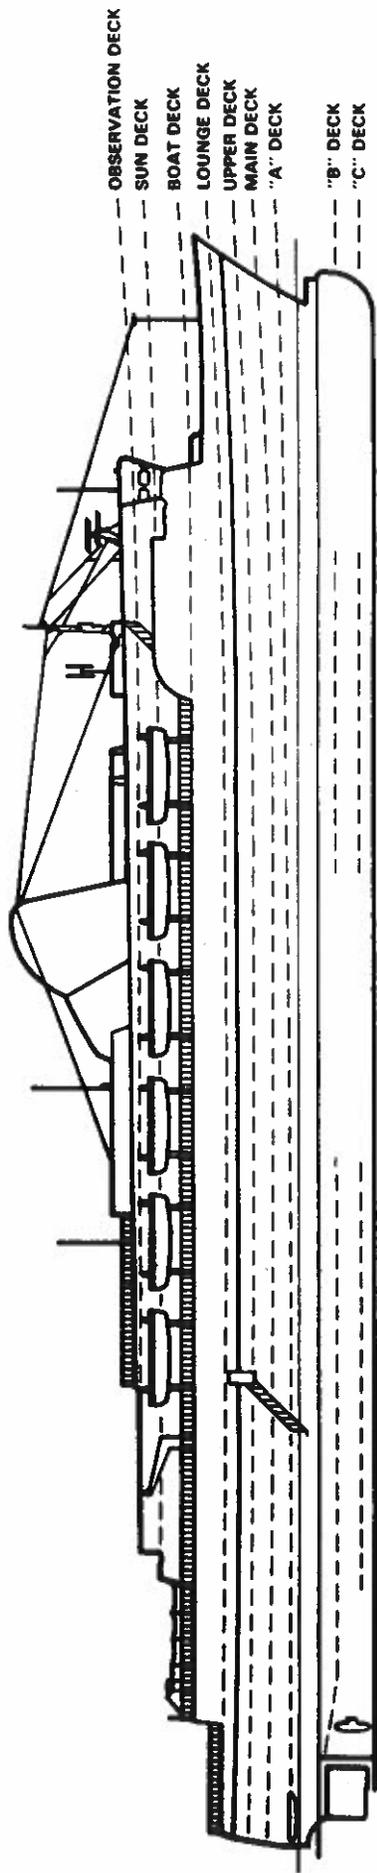
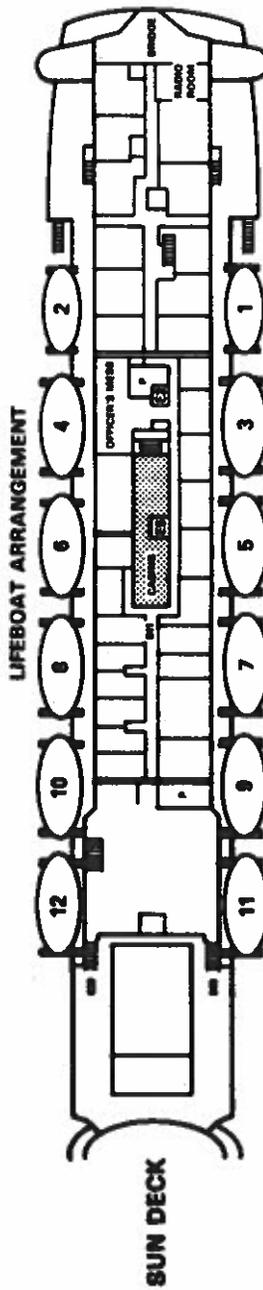
Figure 3.—General arrangement of SCANDINAVIAN SEA. (Sheet 1)

At 1920, the ship's plumber reached the chief officer via telephone and informed him that there was smoke below on the "A" deck forward. (See figure 3.) About the same time, the ship's fire detection alarm sounded, indicating a source of heat in zone 32, (the number indicating "A" deck forward), and the fire doors in the forward main vertical zone closed automatically. The chief officer took a "walkie-talkie" (portable radio) and immediately proceeded down to the "A" deck area to assess the situation. He then informed the master by radio that there was a considerable amount of smoke in the area and asked him to call out the ship's crew. The master ordered the radio operator to ring the fire alarm only in the crew areas to alert the crew and to order the vessel's firefighting groups to report to the area of the smoke. The ventilation systems were secured and the fire dampers 2/ were closed. The master then headed the vessel toward Cape Canaveral to return to the terminal.

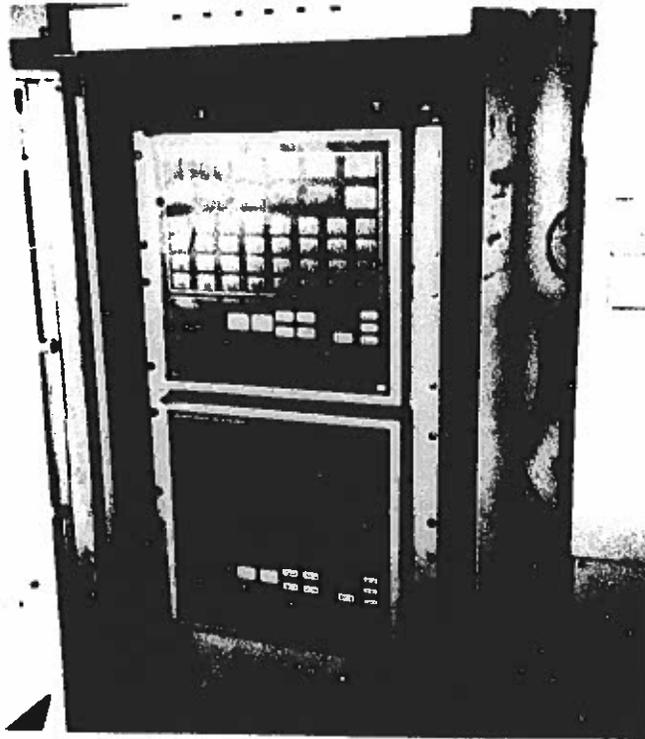
The vessel was equipped with heat sensing fire detection devices located in the accommodation and public spaces and a smoke detection system located in the cargo holds and engine spaces. The heat sensors were located on the overhead panels in the rooms and passageways. There were no heat sensors in the overhead spaces between the paneling and the underside of the steel deck above. The sensors were set for a temperature of 58° C (136° F), except for those located in the ship's galley which were set for 93° C (199° F). They were grouped into 64 alarm circuits which included the sprinkler alarms for the cargo spaces and were connected to the heat detection cabinet on the bridge (see figure 13). The accommodation spaces were not protected by a sprinkler system. Each group of sensors within each main vertical zone was augmented by a number of manual "break glass" type of alarms mounted on the passageway and public room bulkheads. The spring loaded alarm switches required no further manipulation after the glass was broken.

Figure 13.—Heat detection cabinet on the bridge.
