MARINE ACCIDENT REPORT

**FIRE ABOARD THE
BAHAMIAN PASSENGER SHIP
M/V SCANDINAVIAN SUN
PORT OF MIAMI
MIAMI, FLORIDA
AUGUST 20, 1984**

NTSB/MAR-85/08

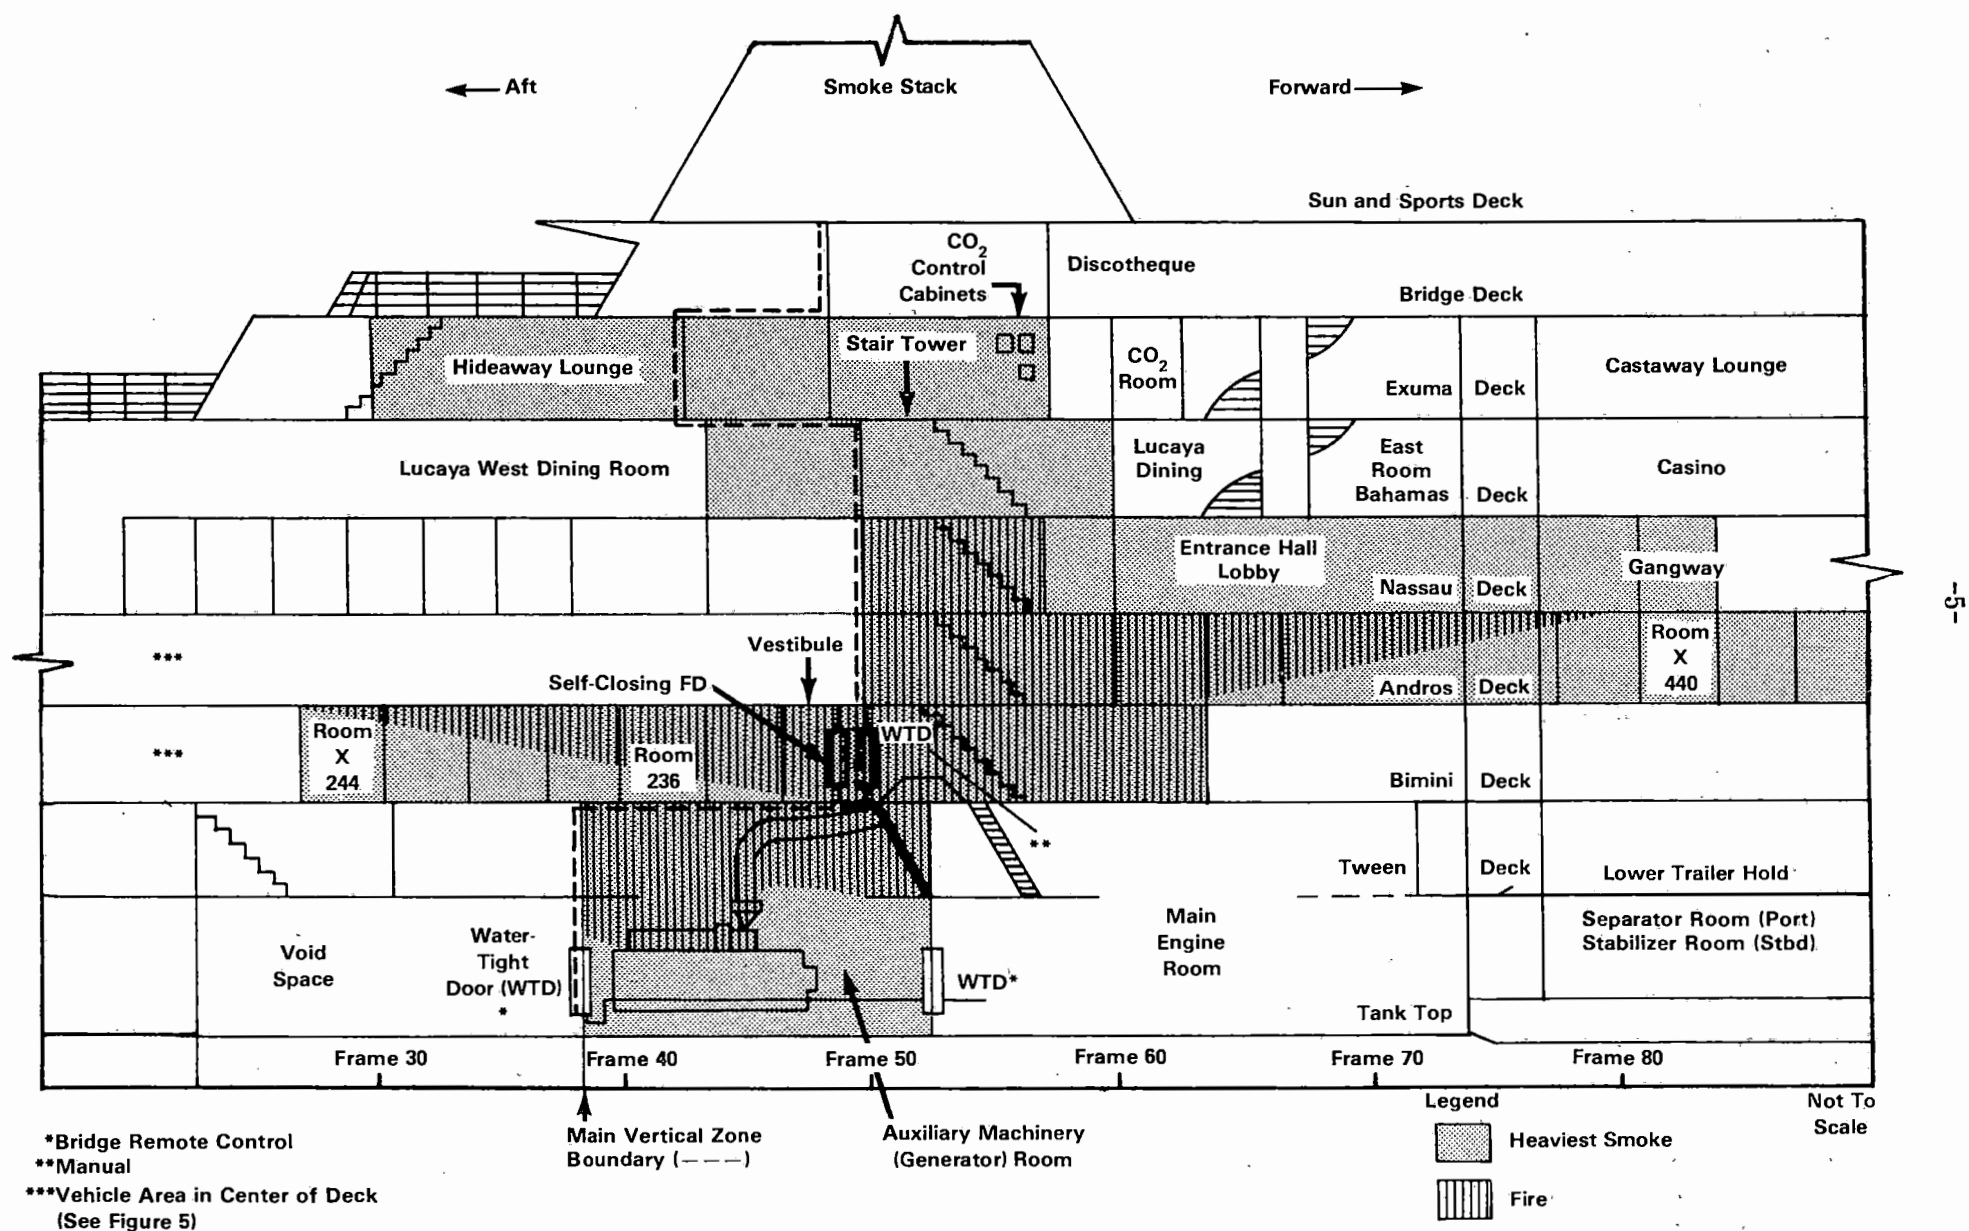
Figure 3.--Inboard profile, portside.

The master was in his room which is below the pilothouse and on the Exuma Deck when he heard the engineer's alarm. He immediately proceeded to the pilothouse where he saw that the fire detection panel indicator lights were flashing for the generator room; Bimini Deck-port side aft and vehicle area; Andros Deck-port side aft and amidships; Nassau Deck-aft, port and starboard and lobby; Bahamas Deck-Lucaya West dining room and casino; Exuma Deck-Hideaway Lounge, Castaway Lounge, smokestack, and starboard circular stairway; and Bridge Deck-circular stairway and Discotheque. (See figure 3.) The lights indicated that at least one fire detector in each zone had been activated.
