MARINE ACCIDENT REPORT

ENGINE ROOM FLOODING OF THE
U.S. TANKSHIP PRINCE WILLIAM SOUND
NEAR PUERTO VALLARTA, MEXICO
MAY 9, 1986

NTSB/MAR-87/07

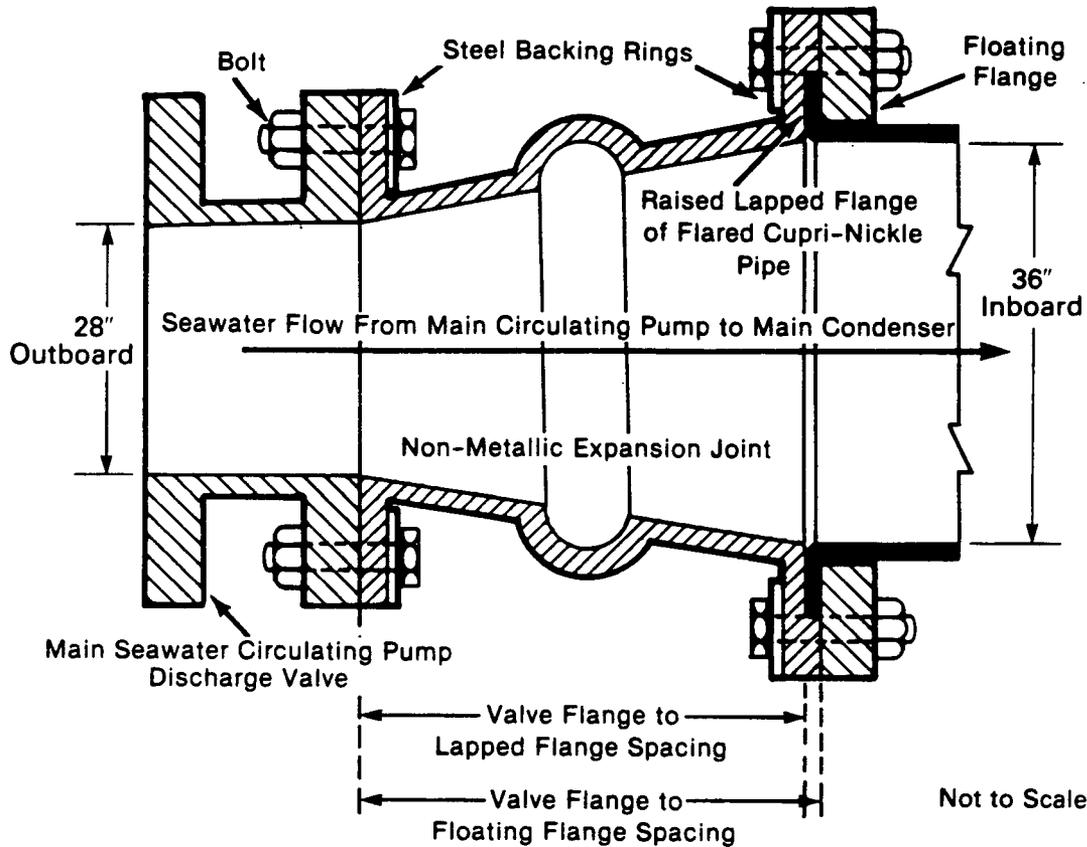
Cross-Sectional View of Concentric Tapered Expansion Joint as Installed in the PRINCE WILLIAM SOUND

Spacing Measured	Location Around Joint				Average
	Top	Bottom	Aft	Forward	
Flanges Face to Face (A)	19-3/16	19-1/16	19-7/16	18-13/16	19-2/16
Flanges Face to Face (B)	19	19-1/16	19-3/16	18-14/16	19-1/16
Valve Flange/Lapped Flange (B)	18-10/16	18-12/16	18-13/16	18-8/16	18-11/16
Valve Flange/Lapped Flange (C)	18-9/16	18-9/16	18-12/16	18-7/16	18-9/16

The service life of nonmetallic (rubber) expansion joints is also affected by stresses created by a nonuniform sealing surface (lapped flange face), eccentric and angular pipe misalignment, excessive axial separation (elongation), system pressure, and vibration magnitude and frequency. The pipe flange to which the 36-inch-diameter flange face of the forward main seawater circulator pump discharge expansion joint was attached consisted of a lapped flange. (See figure 7.) This lapped flange design created an uneven sealing surface which increased the stress in the corner between the expansion joint flange and the body of the expansion joint. Eccentric, angular, and axial piping misalignment was detected by the measurements of the face-to-face flange spacing

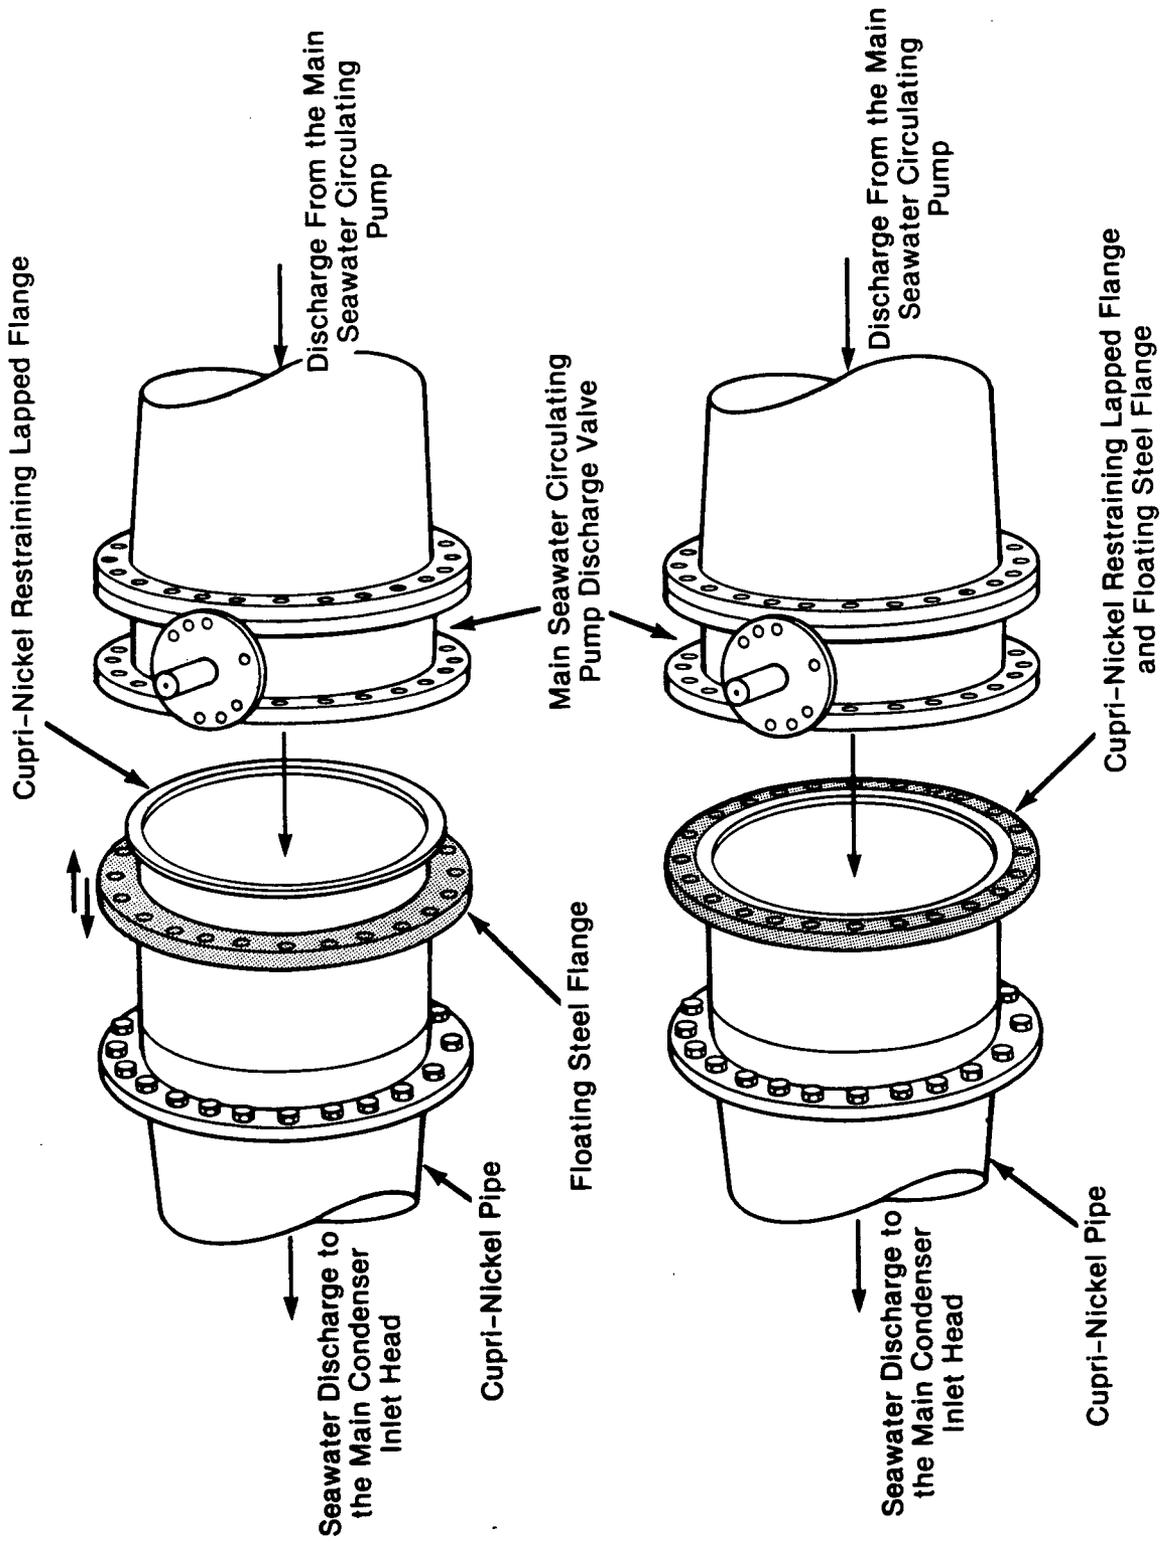
Figure 7.—Cupri nicked pipe with lapped flange.

During vessel construction, a floating steel flange was installed on the forward and aft 36-inch-diameter inlet head cupri-nickel piping to the main condenser. The main condenser cupri-nickel inlet head piping was fabricated so that the outboard end was turned or rolled 90° to the axis of the pipe to form a restraint flange which held the floating flange on the pipe. (See figure 7.)
