PB92-916401
NTSB/MAR-92/01

MARINE ACCIDENT REPORT

GROUNDING OF THE
U.S. TANK SHIP STAR CONNECTICUT
PACIFIC OCEAN, NEAR BARBERS POINT, HAWAII
NOVEMBER 6, 1990

ADOPTED: JANUARY 7, 1992

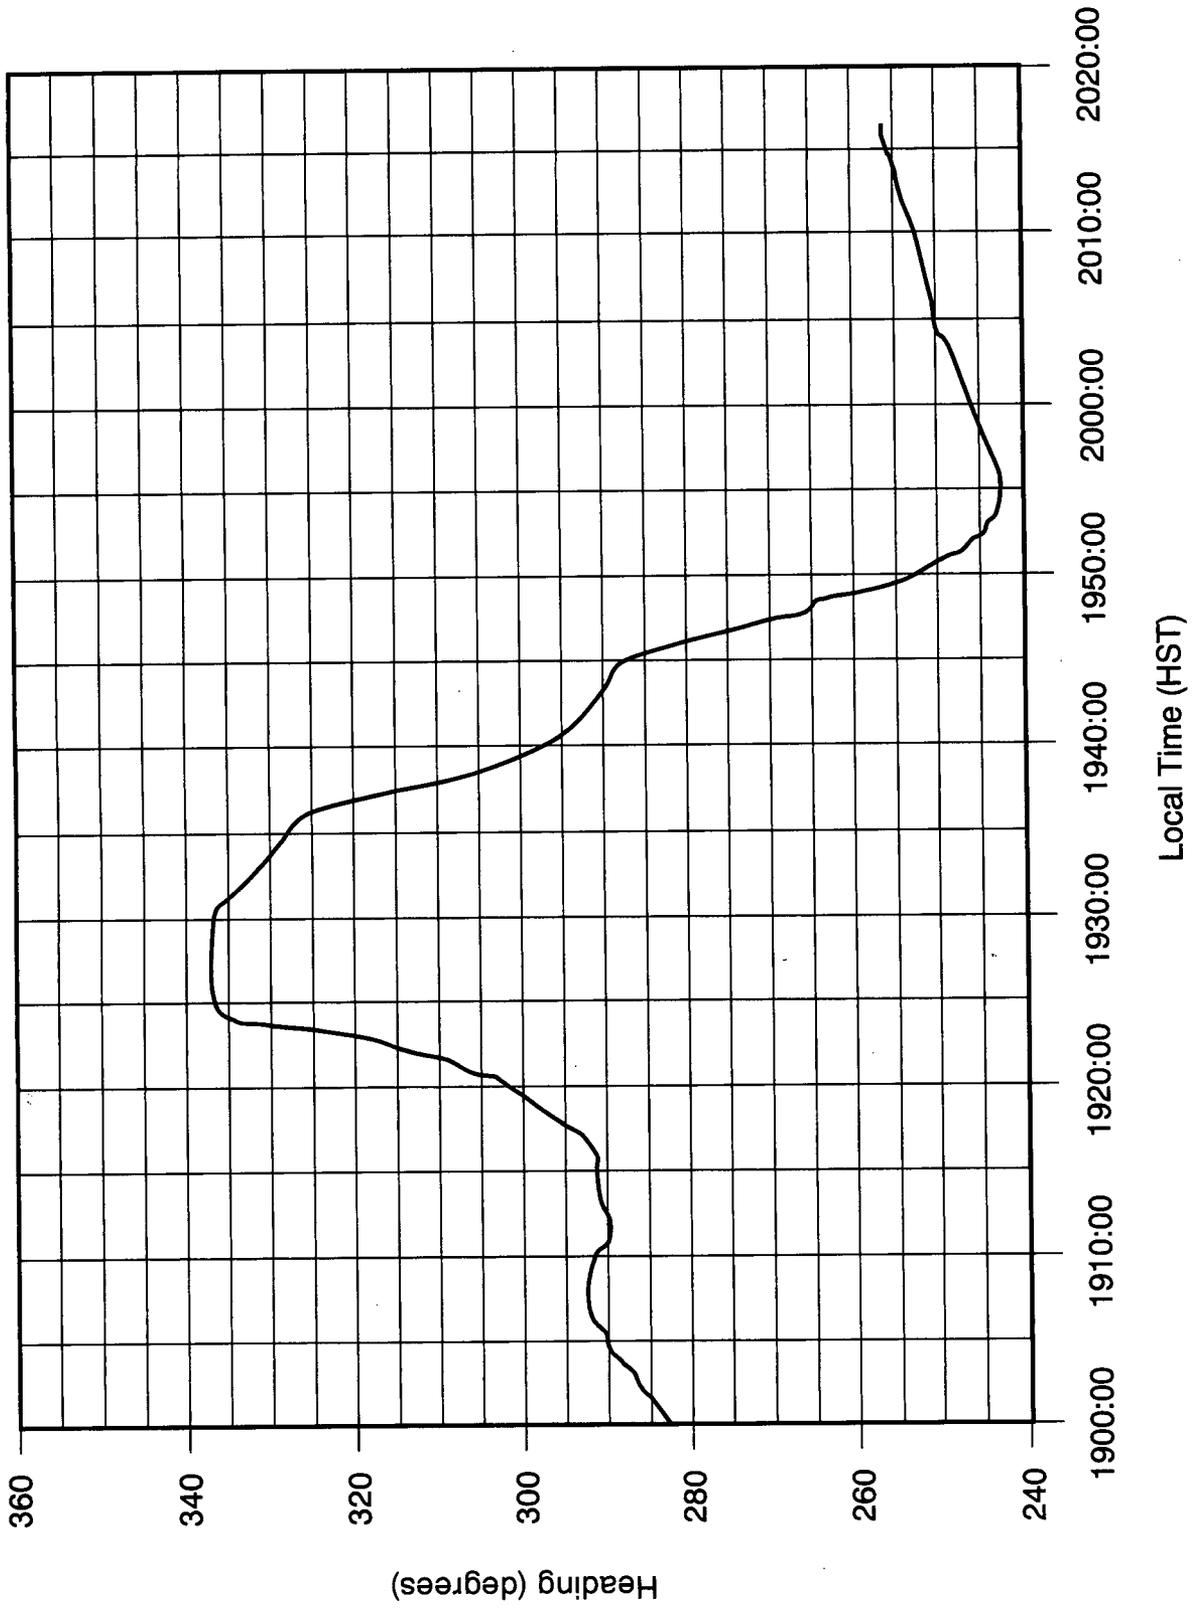
Figure 5.--Course recorder data.

Course Recorder.--At the time of the accident, the STAR CONNECTICUT's course recorder was operating, i.e., recording the ship's heading with respect to local time onto a moving roll of graph paper. After the accident, investigators removed the graph paper roll from the course recorder and sent it to the Safety Board's laboratory in Washington, D. C., where the staff photographed the pertinent section and returned the original document to the vessel operator. The Safety Board's laboratory used the photographic reproduction to graph the vessel's heading with respect to time as shown in figure 5.
