**MARINE ACCIDENT REPORT**

**FIRE ON BOARD THE U.S. FISH PROCESSING VESSEL  
ALASKA SPIRIT, SEWARD, ALASKA, MAY 27, 1995**

**Adopted: June 11, 1996  
Notation 6594A**

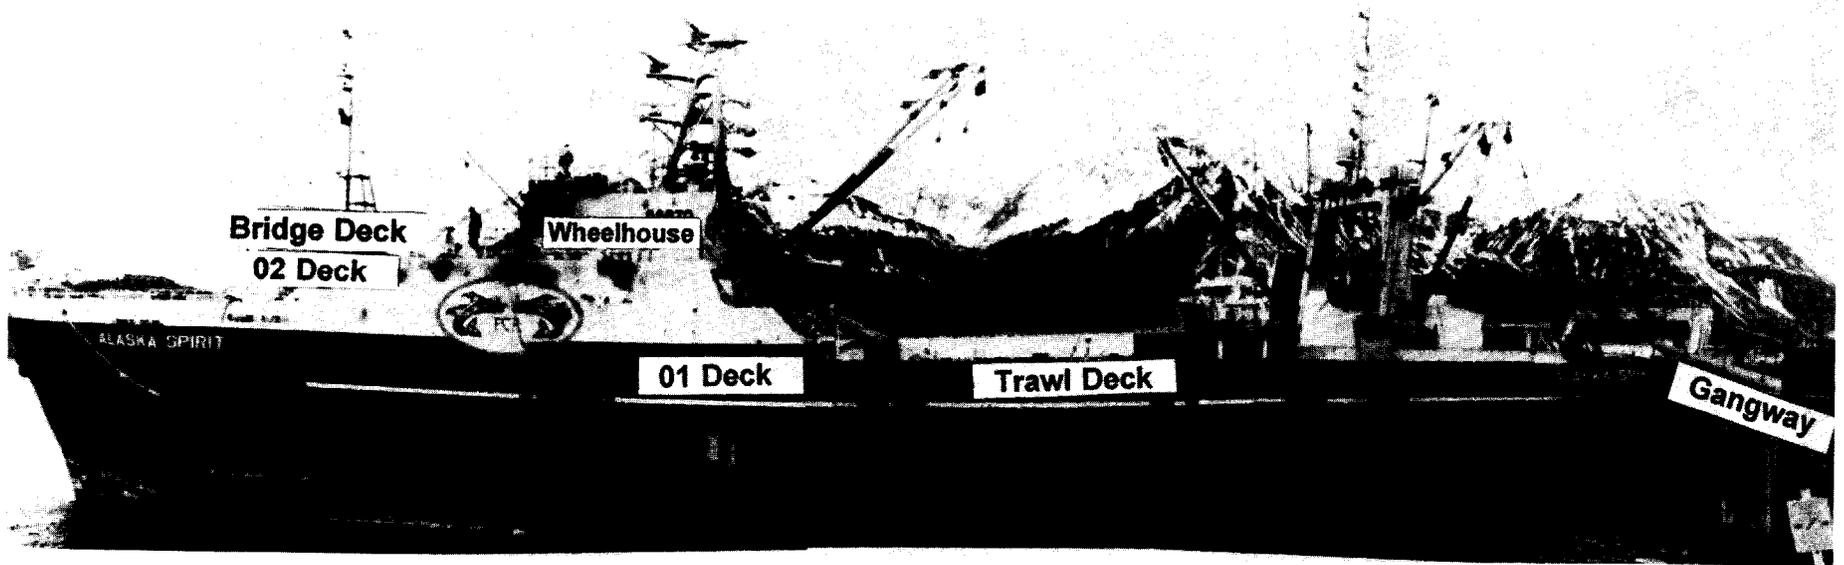
Figure 1 — Port side view of the ALASKA SPIRIT while moored at Seward, Alaska

The cook testified that he returned by car from Anchorage at 0204<sup>4</sup> on May 27 and parked near the ALASKA SPIRIT's gangway. He was walking towards the ALASKA SPIRIT's gangway when he noticed flames and smoke on the 02 deck aft port door and in the wheelhouse (see figure 1). As the cook headed toward the 01 deck, he met the watchman, who had just exited the engine room stairwell on the trawl deck. He climbed the outside stairwell from the 01 deck and looked into the 02 deck aft doors (see figure 6).

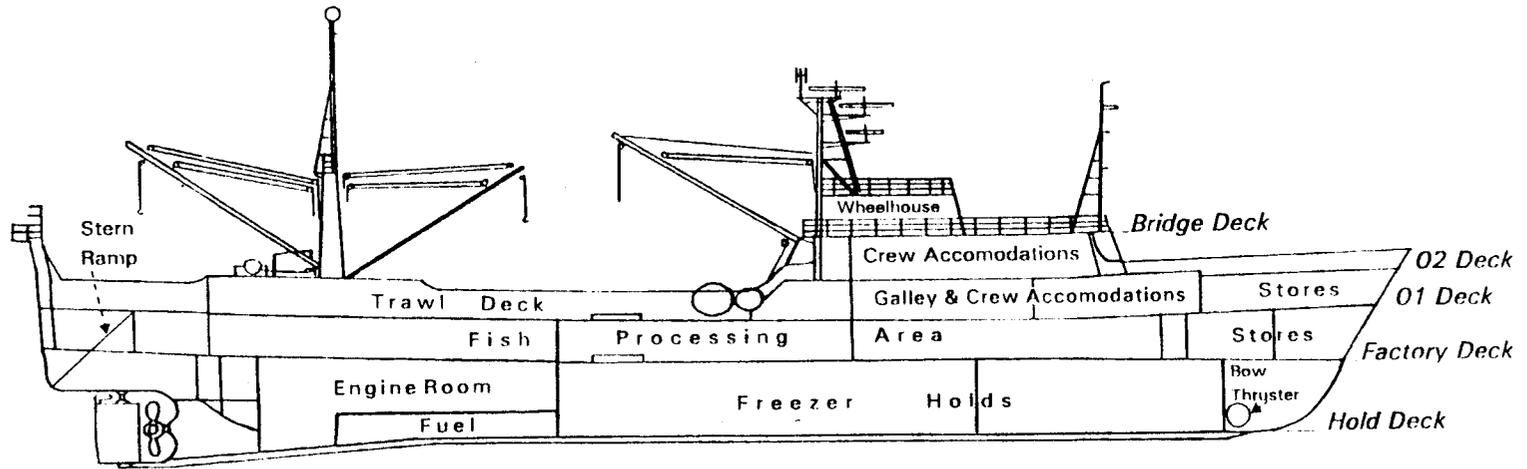
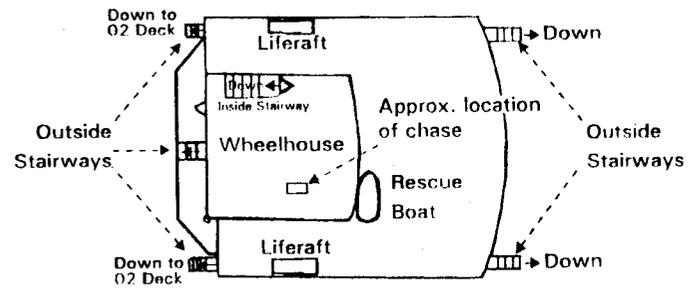
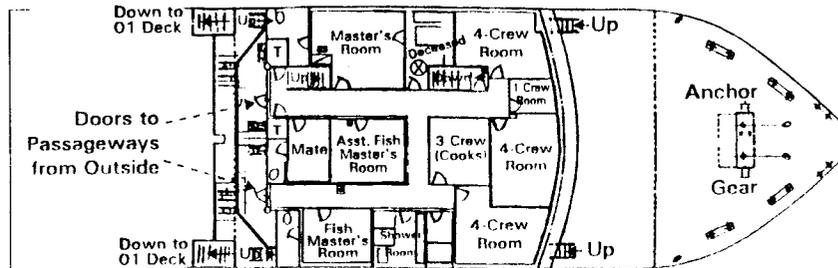
Figure 3 — Plan of the ALASKA SPIRIT

About 2130 on May 26, the four deckhands were in the port-forward crewroom on the 02 deck (see figures 3, 4, and 5) discussing their off-duty plans for the evening. Three of the four deckhands decided to go into town. They departed the vessel about 2200. The remaining deckhand left the crewroom, stopped briefly in the galley, and went to his room (a four-person room on the forward starboard side of the 01 deck) to sleep. About 0100 on May 27, one of the three deckhands who had gone into Seward returned to the vessel and signed in on a chalkboard in the galley. He retired to his room on the 01 deck port side aft (at the foot of the inside stairwell to the 02 deck) and apparently went to sleep.

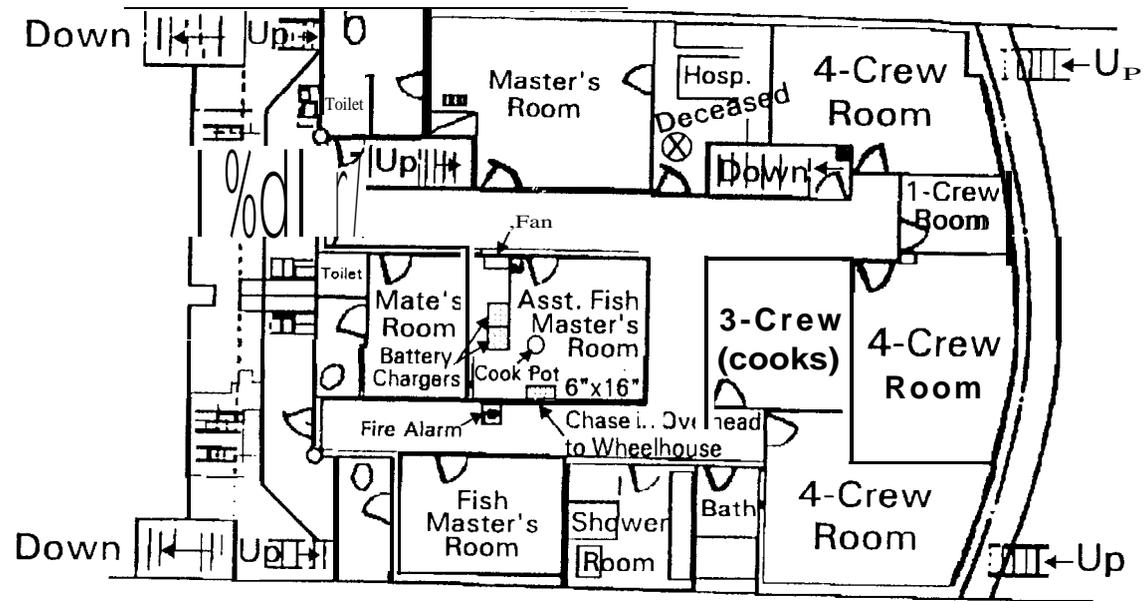
Figure 5 — Enlarged plan view of the 02 deck

The SVFD deputy fire chief said that, from the position of the body, it looked as if the master had been headed back into the hospital room when he collapsed. The hospital room adjoined the master's room through an interior door (see figure 5). Directly opposite the corridor door to the master's room was a ventilation fan opening in the assistant
