MARINE ACCIDENT/INCIDENT SUMMARY REPORT

**CAPSIZING OF QUESTAR MOTORBOAT AND
DROWNING OF OPERATOR SOUTH OF SHELTER
ISLAND NEAR JUNEAU, ALASKA
AUGUST 21,1994**

Accident Number: DCA-95-MM-032

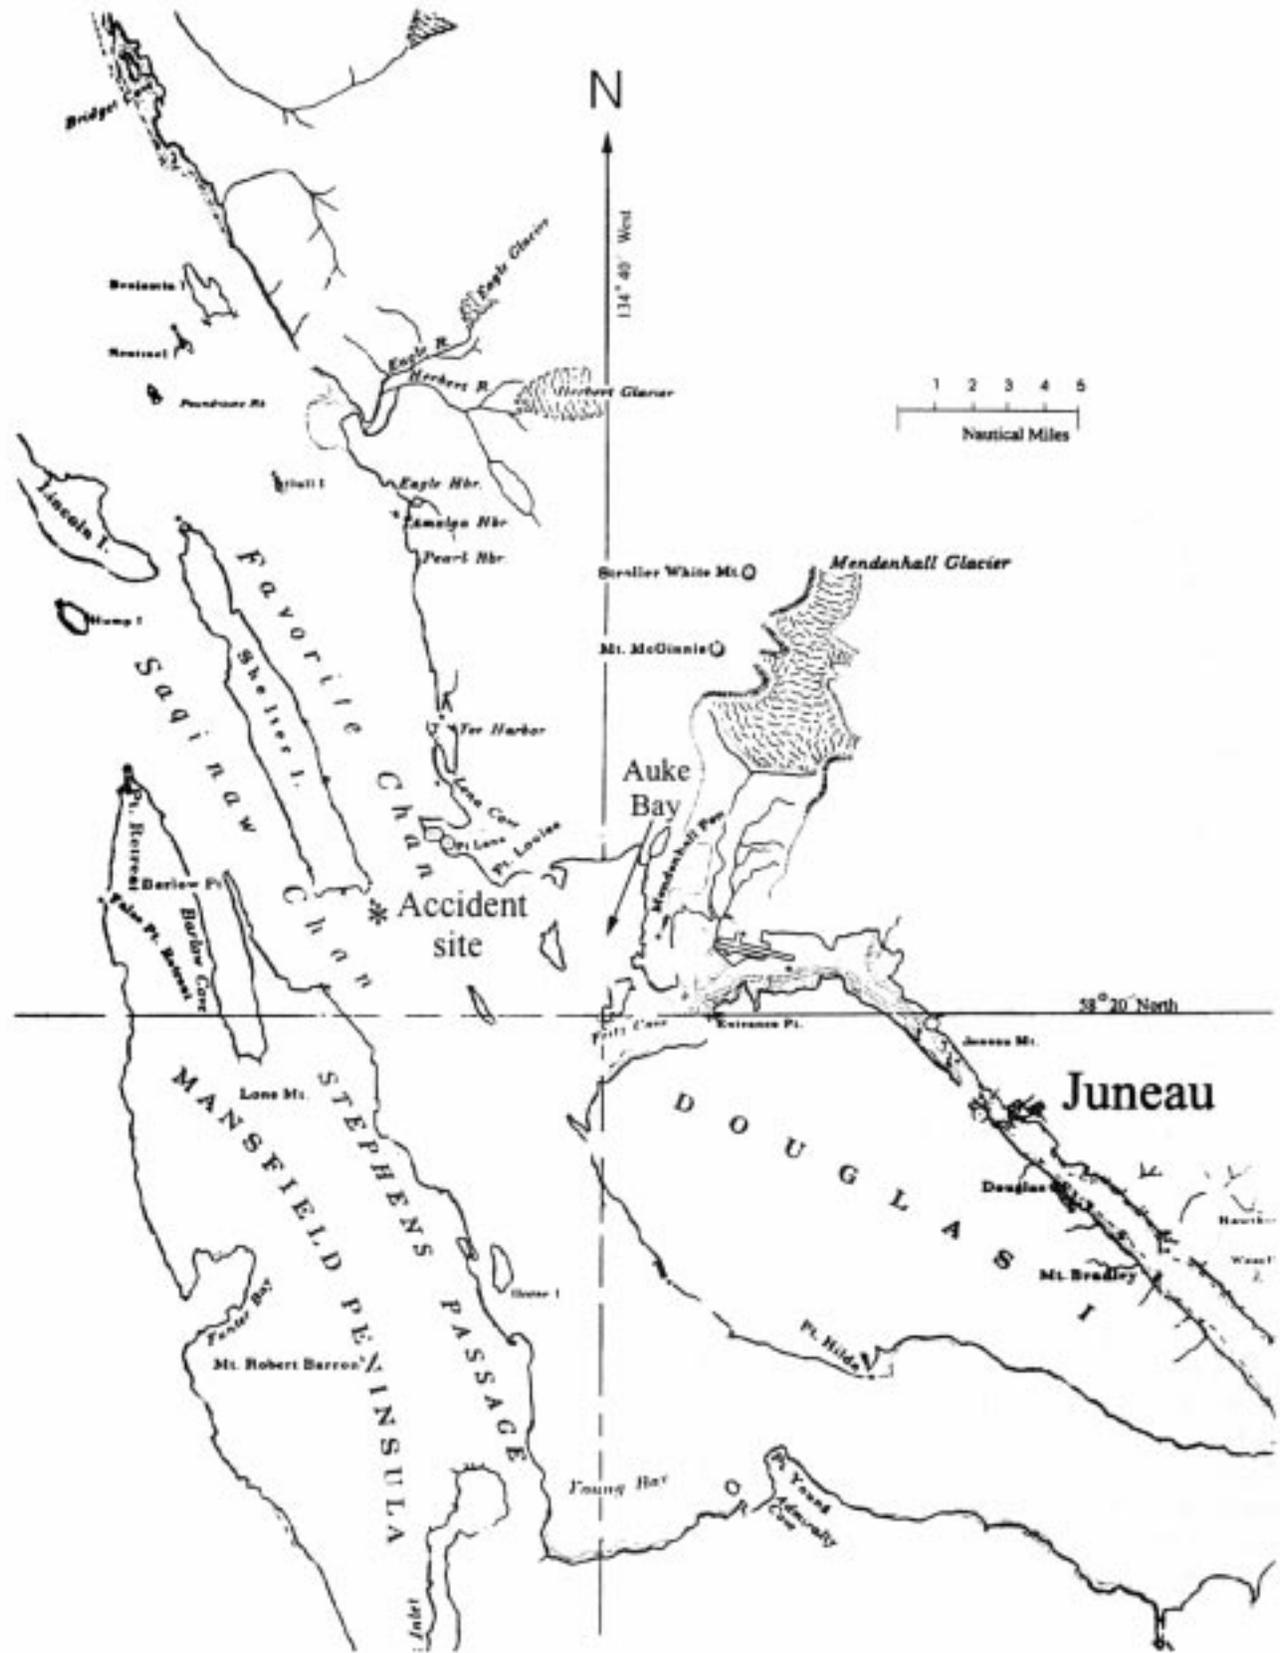
Figure 3 -- Location of the accident (not to scale)

During the morning and early afternoon of August 21, 1994, two men, the owner/operator, 45, and his passenger, 26, aboard an 18-foot Questar motorboat (see figures 1 and 2), were participating in the Golden North Salmon Derby south of Shelter Island, Lynn Canal, near Juneau, Alaska (see figure 3). The derby is an annual 3-day fishing tournament held in the Juneau area to raise scholarship funds. The Coast Guard estimated that up to 1,000 vessels would participate in the derby. The weather was overcast with showers, the wind was out of the south at 25-30 knots, and the seas were 3-5 feet. Sea water temperature was about 55 °F. The National Weather Service in Juneau had issued a small craft advisory¹ for the Eastern Gulf Coast of Alaska, including the Lynn Canal and area around Juneau.
