Issued April 28, 2022

MIR-22/14

Grounding and Sinking of Fishing Vessel *Sage Catherine Lane*

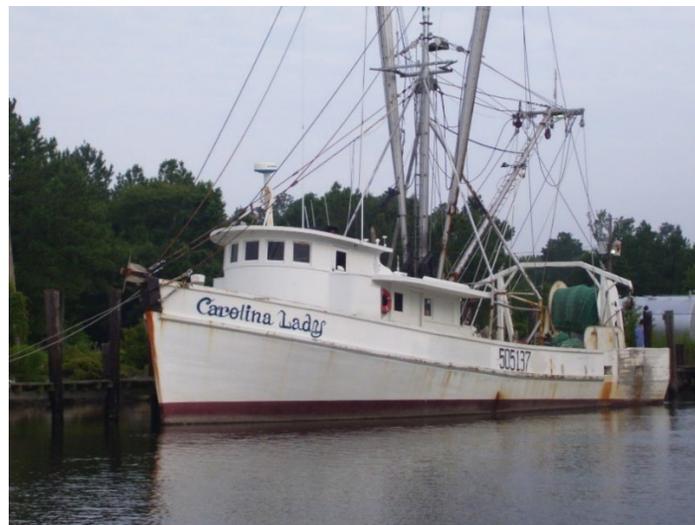
Figure 1. *Sage Catherine Lane*, under previous name and ownership, before the casualty. (Source: US Coast Guard)

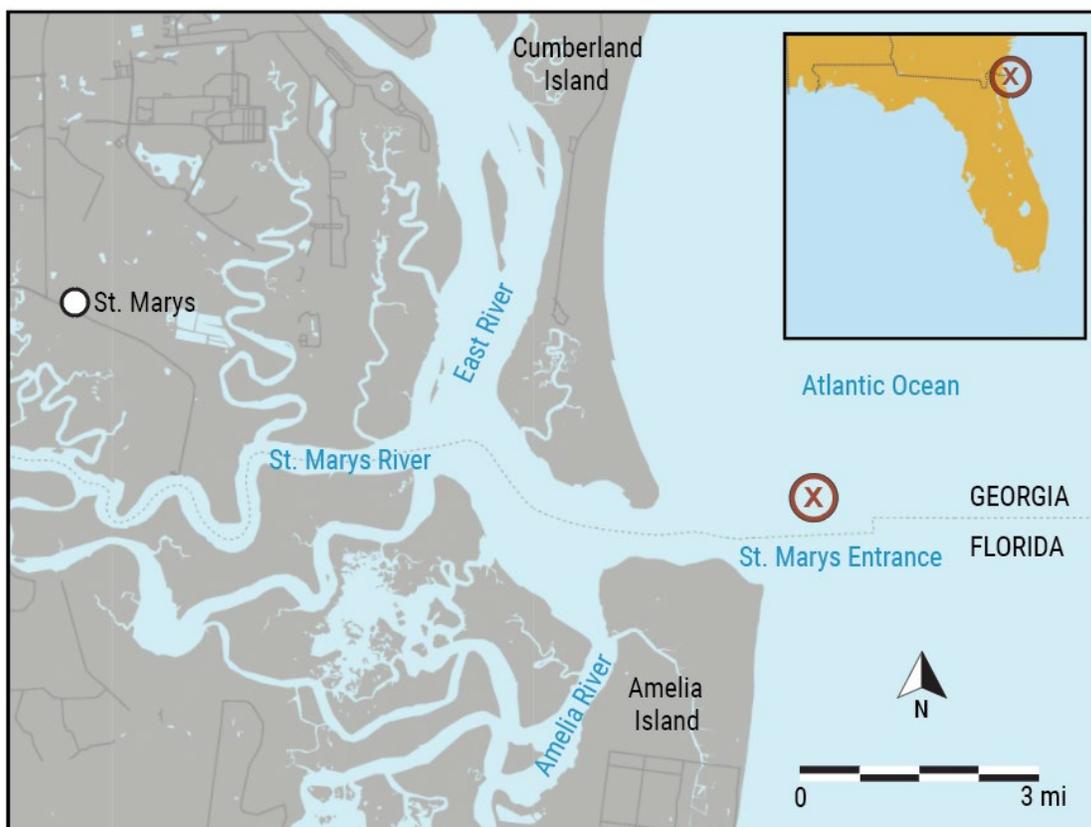
Figure 2. Area where the fishing vessel *Sage Catherine Lane* struck the St. Marys Entrance north jetty, as indicated by a red X. (Background source: Google Maps)
