Issued May 10, 2022

MIR-22/15

Engine Room Fire aboard Containership *President Eisenhower*

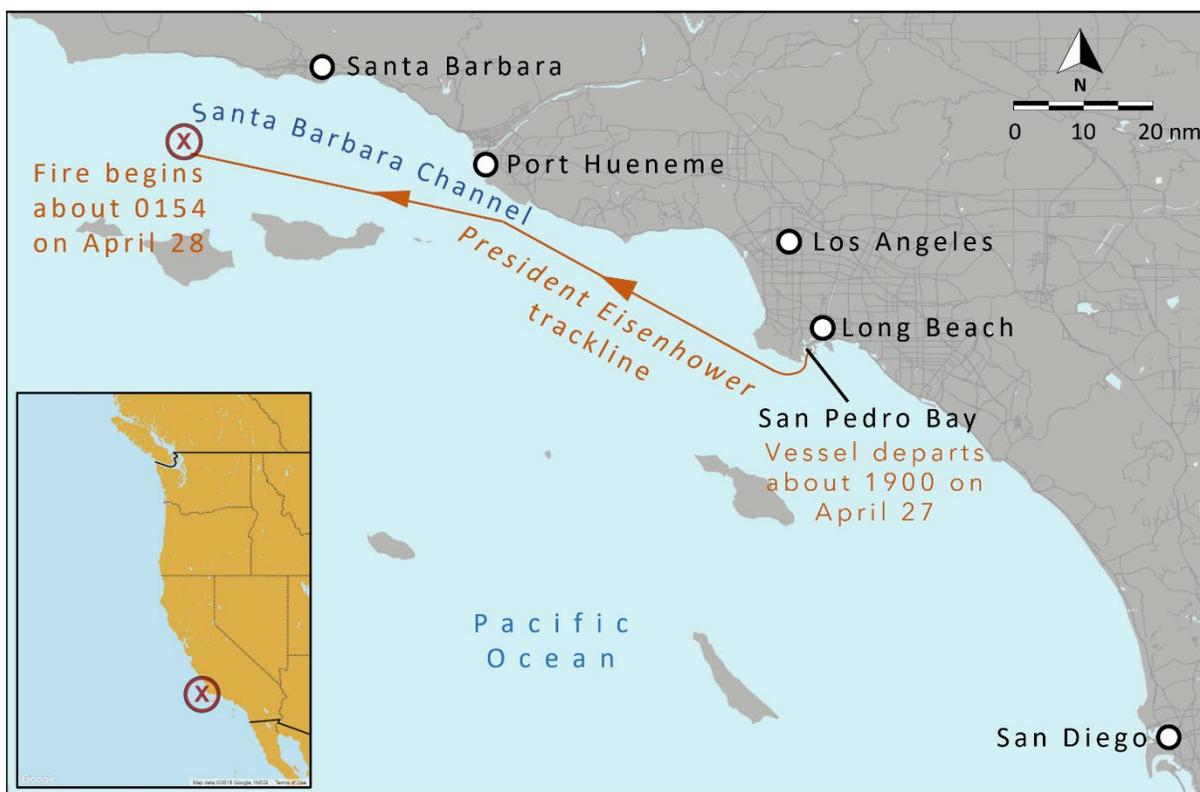
Figure 2. Area where fire erupted in the engine room of the *President Eisenhower*, as indicated by the red triangle. (Background source: Google Maps)
