MIR-22/21

Sinking of Commercial Fishing Vessel *Emmy Rose*

Atlantic Ocean

November 23, 2020

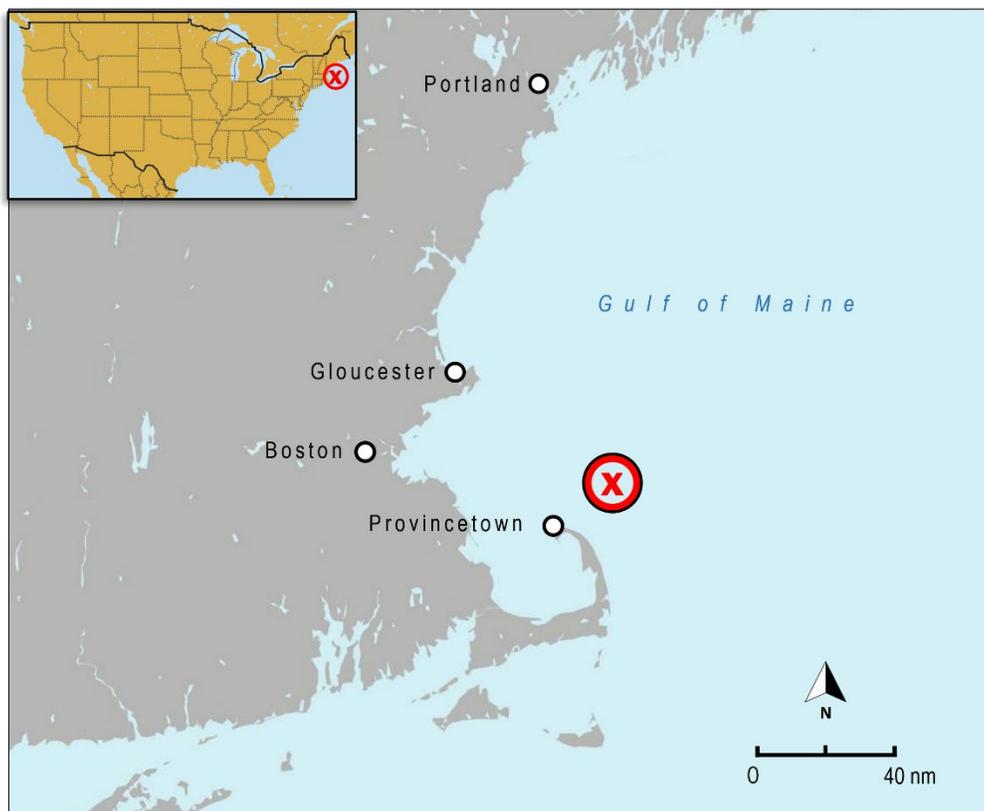
Figure 2. *Emmy Rose* sinking site (marked with a red X). (Background source: Google Maps)

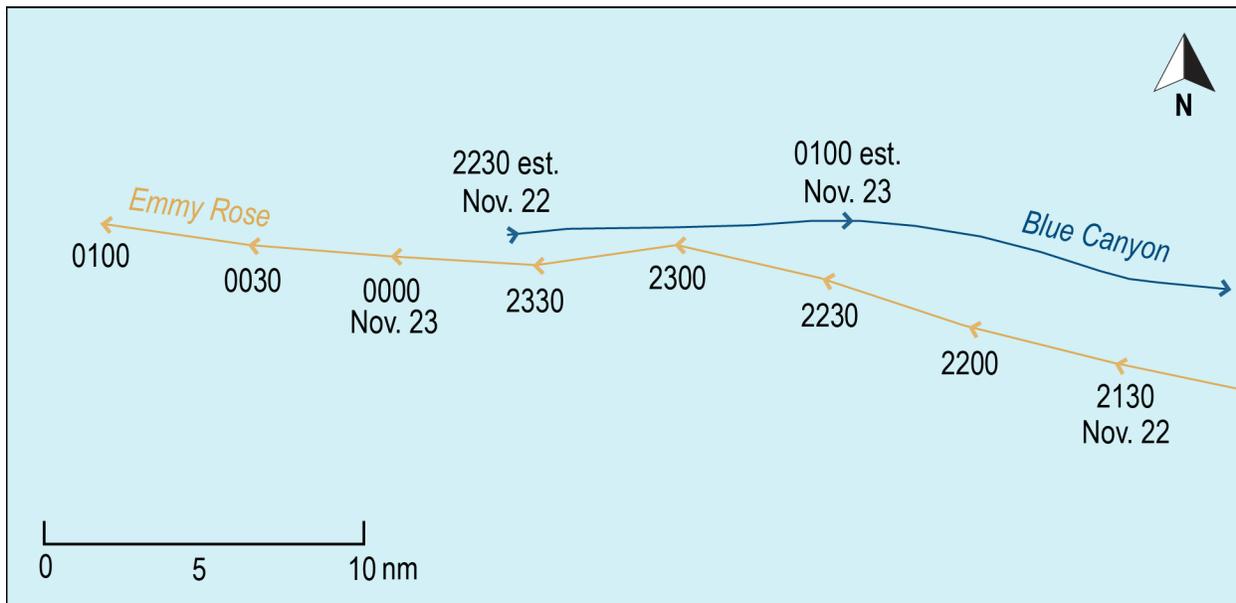
About 2300, the *Emmy Rose* passed within 1.3 miles of the fishing vessel *Blue Canyon* (see figure 3). The *Emmy Rose* maneuvered away from the *Blue Canyon* and continued on its course for Gloucester at 7 knots. The captain of the *Blue Canyon* stated

Figure 3. Location of *Emmy Rose* and *Blue Canyon* at their closest point of approach, about 2300 on November 22, based on VMS data.

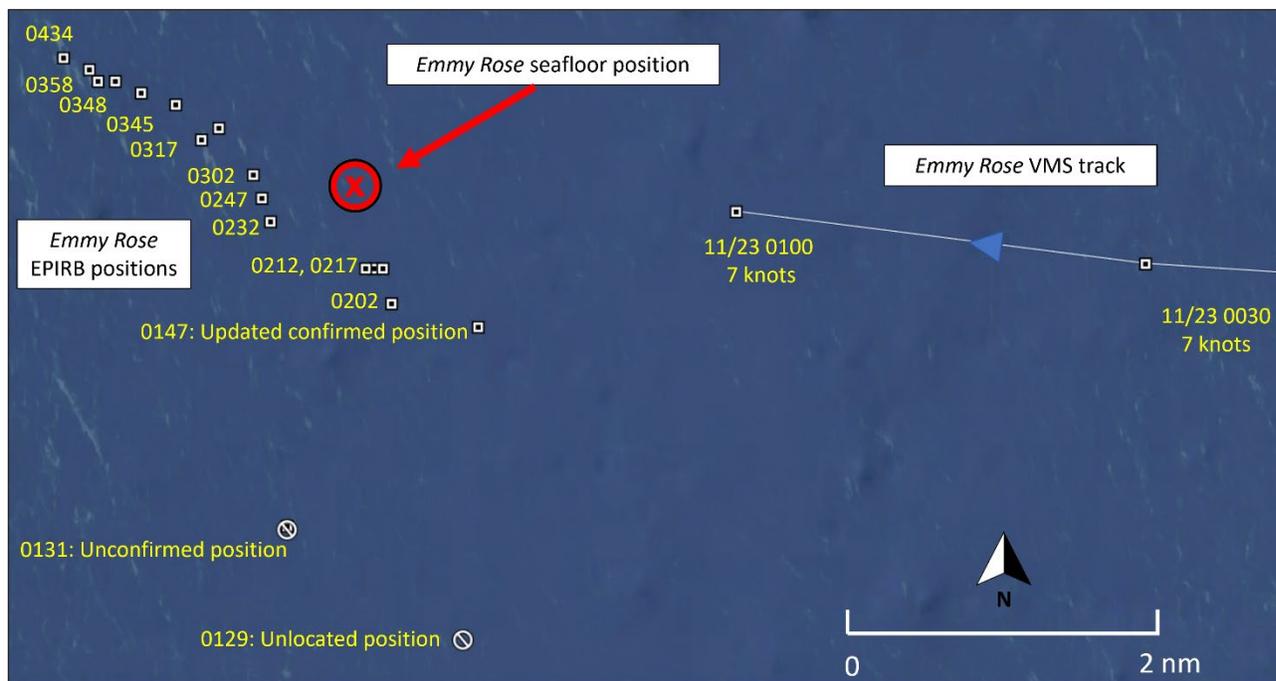
At 0129 on November 23, 2020, the Coast Guard Rescue Coordination Center in Boston received an alert from the 406-megahertz (MHz) non-GPS-enabled emergency position indicating radio beacon (EPIRB) registered to the *Emmy Rose*. This initial “unlocated first alert” position was about 2.4 miles southwest from the 0100 VMS position of the *Emmy Rose* (see figure 4).⁵

Figure 4. Emmy Rose final VMS track and EPIRB positions. The red X indicates the sinking site. (Background source: Google Earth)

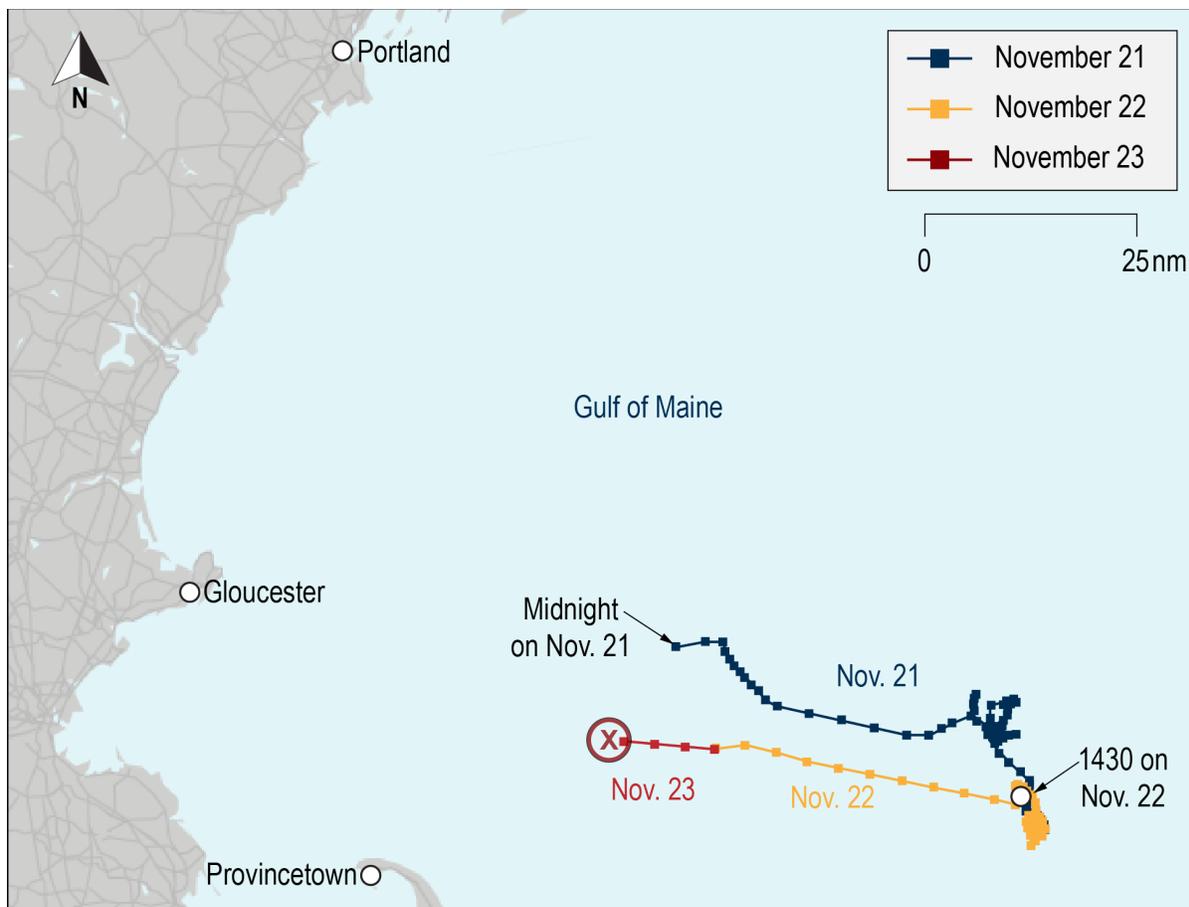
At 0130, Coast Guard watchstanders notified the vessel's shoreside manager, and he attempted several times to contact the crew of the *Emmy Rose* on the satellite phone and via email, but there was no response. At 0131, a second EPIRB alert was received with an unconfirmed position, and at 0147, a confirmed alert with an updated position was received (see figure 5). Over the next 3 hours, over a dozen subsequent signals were transmitted as the EPIRB drifted toward the northwest until it was recovered by the Coast Guard. There were no very high frequency (VHF) radio transmissions received from the *Emmy Rose*.

Figure 5. *Emmy Rose* trackline from November 21 to 23. A red X indicates the location of the confirmed EPIRB signal on November 23. (Background source: Google Maps)

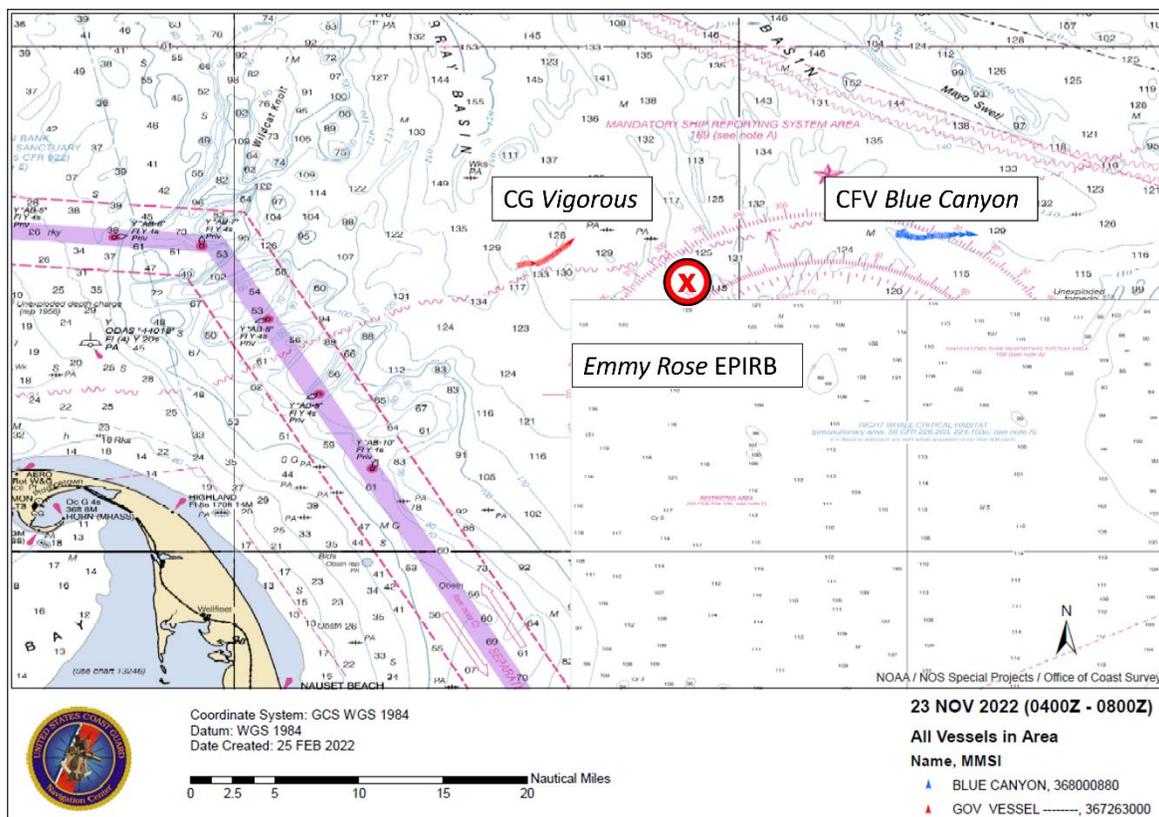
After the sinking of the *Emmy Rose*, the Coast Guard Navigation Center performed a search for vessels that were in the vicinity of the *Emmy Rose*'s EPIRB position from 2300 on November 22 to 0300 on November 23 to explore the possibility of an unreported collision. The fishing vessel *Blue Canyon* and the Coast Guard cutter *Vigorous* were detected but were not within several miles of the sinking site (see figure 14). No other vessels were located near the *Emmy Rose* in the 2.5 hours before the sinking.

Figure 14. Search for vessels near the *Emmy Rose* from November 22 at 2300 to November 23 at 0300. A red X marks the location of the *Emmy Rose* based on the EPIRB signal. (Source: Coast Guard Navigation Center)
