Issued September 29, 2022

MIR-22/24

# Engine Room Fire on board Towing Vessel *Capt. Kirby Dupuis*

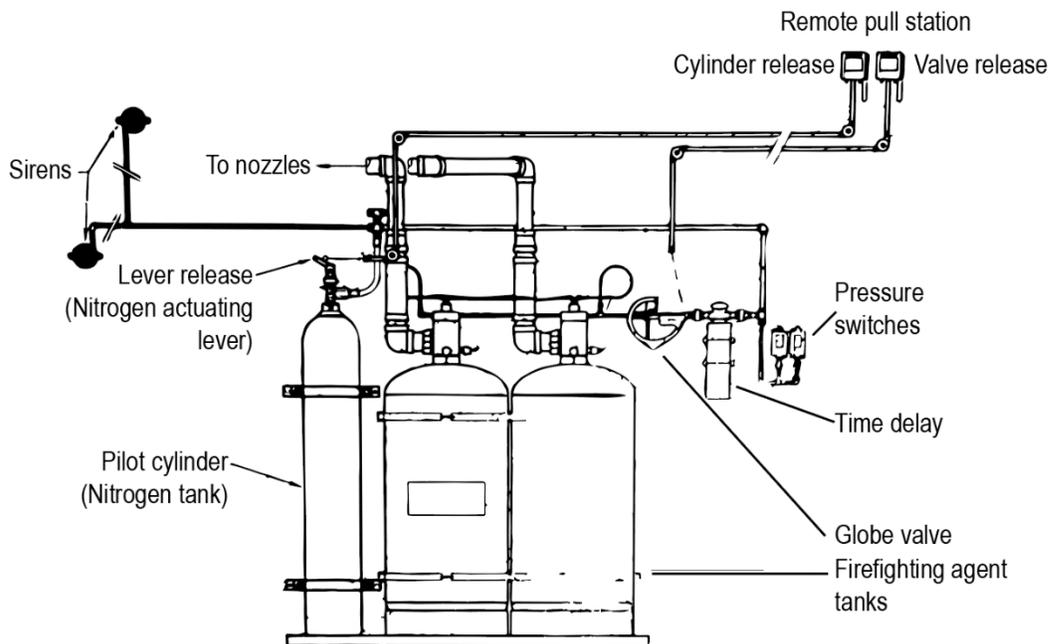
**Figure 7.** Schematic of *Capt. Kirby Dupuis* fixed fire-extinguishing system.

When investigators inspected the fire-extinguishing system, they observed that the “valve release” remote pull lever was pulled out as per the instructions, and its corresponding globe valve was open. However, the “cylinder release” remote pull lever was not fully extended, and its corresponding nitrogen cylinder’s actuating lever remained in the “set” position.
