MIR-22/26

Capsizing of Liftboat *SEACOR Power*

Port Fourchon, Louisiana

April 13, 2021

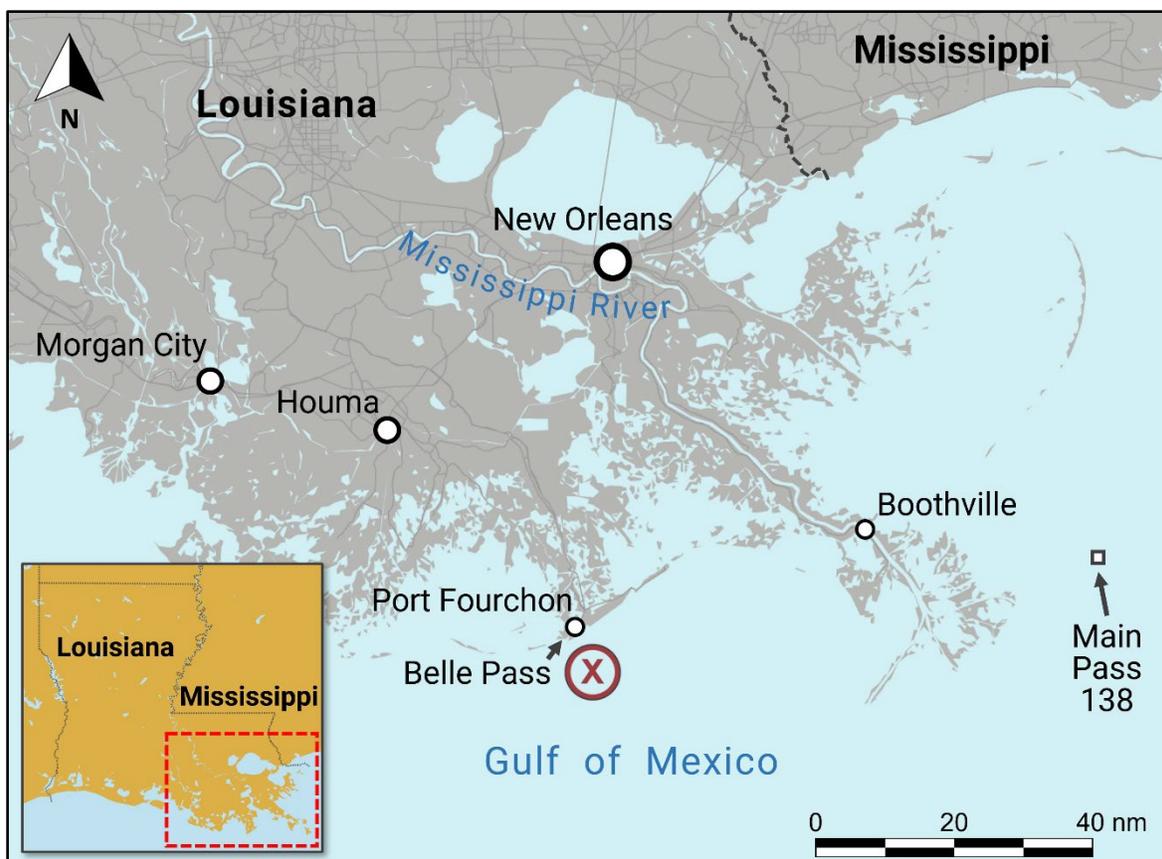
With the mate at the helm, the liftboat cleared the Belle Pass jetties at 1413 and proceeded into the open waters of the Gulf of Mexico (see Figure 3). The *SEACOR Power* was making a speed of 3.3 knots with all four propulsion engines online, each driving their respective propellers. As the vessel proceeded on a southerly heading, it encountered 2- to 4-foot seas on the bow. About 1440, the liftboat began taking a more southeasterly heading. Its speed over the next 40 minutes ranged from 2.3 to 3.1 knots.

Figure 3. The *SEACOR Power* departed Port Fourchon en route to Main Pass 138. The location of the capsizing is indicated by a red X. (Background source: Google Maps)

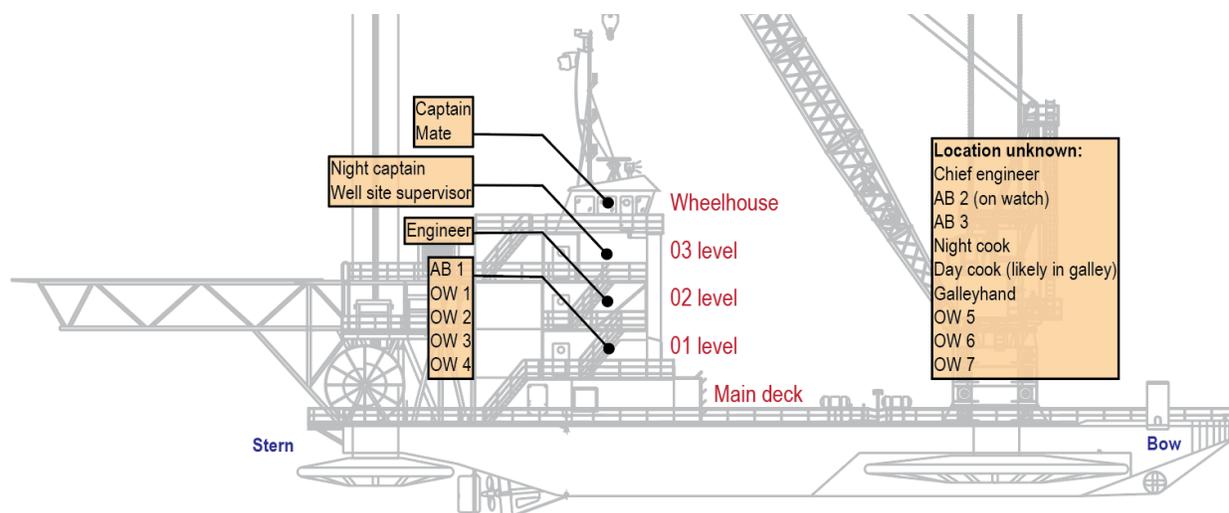
With the vessel on its starboard side, the starboard exterior doors were below the water. Portside doors had to be reached by moving upwards, and port bulkheads became the overhead. Of the 19 personnel aboard the *SEACOR Power*, 9 people (the mate, the night captain, ABs 1 and 2, the night cook, the well site supervisor, and OWs 1, 2, and 3) are known to have survived the initial capsizing (see Figure 4).

Figure 4. Known crewmember locations at the time of the capsizing.

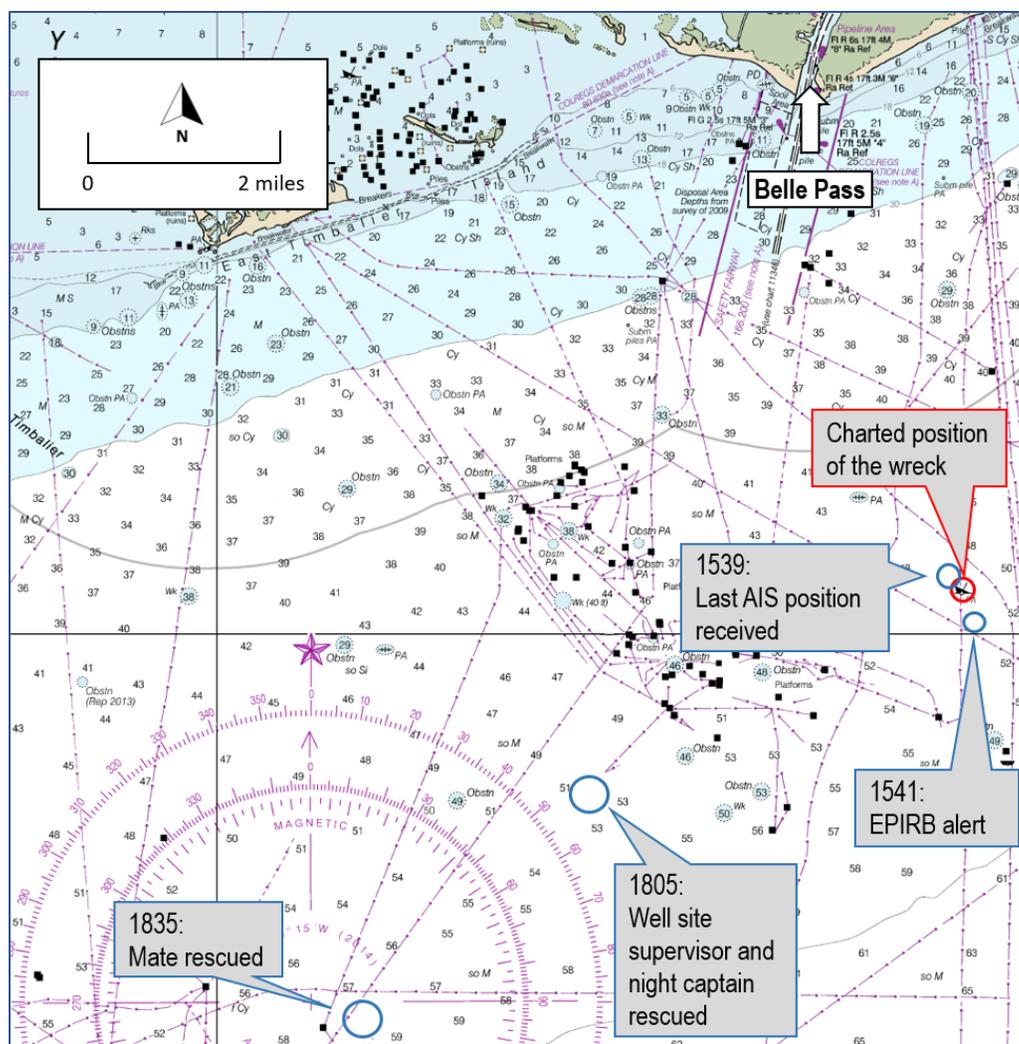
The *SEACOR Power* night captain drifted 4 miles west-southwest over almost 2.5 hours while wearing a lifejacket in the 75° water. He spotted the OSV *Christian Chouest* and waved to it on each wave crest while still clinging to a mattress, until they spotted him at 1748. The OSV crew hauled the night captain aboard at 1805. The well site supervisor also drifted 4 miles west-southwest of the wreck in a lifejacket. He recalled waving to the *Christian Chouest*, when it stopped 150 feet from him to rescue the night captain, but its crew did not see him. The crew boat *Mr. Lloyd* happened upon the well site supervisor and rescued him, also at 1805 (see Figure 7).

Figure 7. Extract of updated National Oceanic and Atmospheric Administration chart 11357 (annotated by NTSB), showing the locations of the Good Samaritan rescues and the actual location of the wreck. Black squares denote oil rig platforms. Depths are in feet.

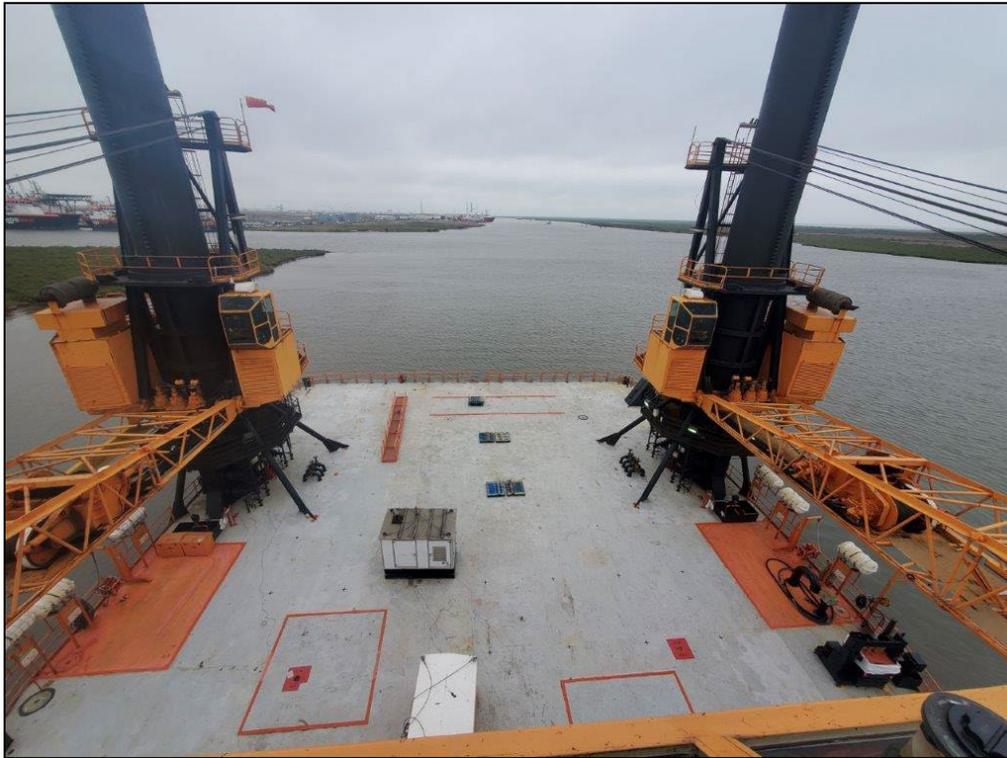
The forward main deck of the vessel provided a large, open area for working and cargo stowage (see Figure 11). The deck in this area was coated with non-skid

paint; investigators examined the deck on the vessel following salvage and noted no damage to the non-skid coating other than minor scrapes and gouges.

Figure 11. *SEACOR Power* main deck cargo/working area looking forward. (Source: SEACOR Marine)

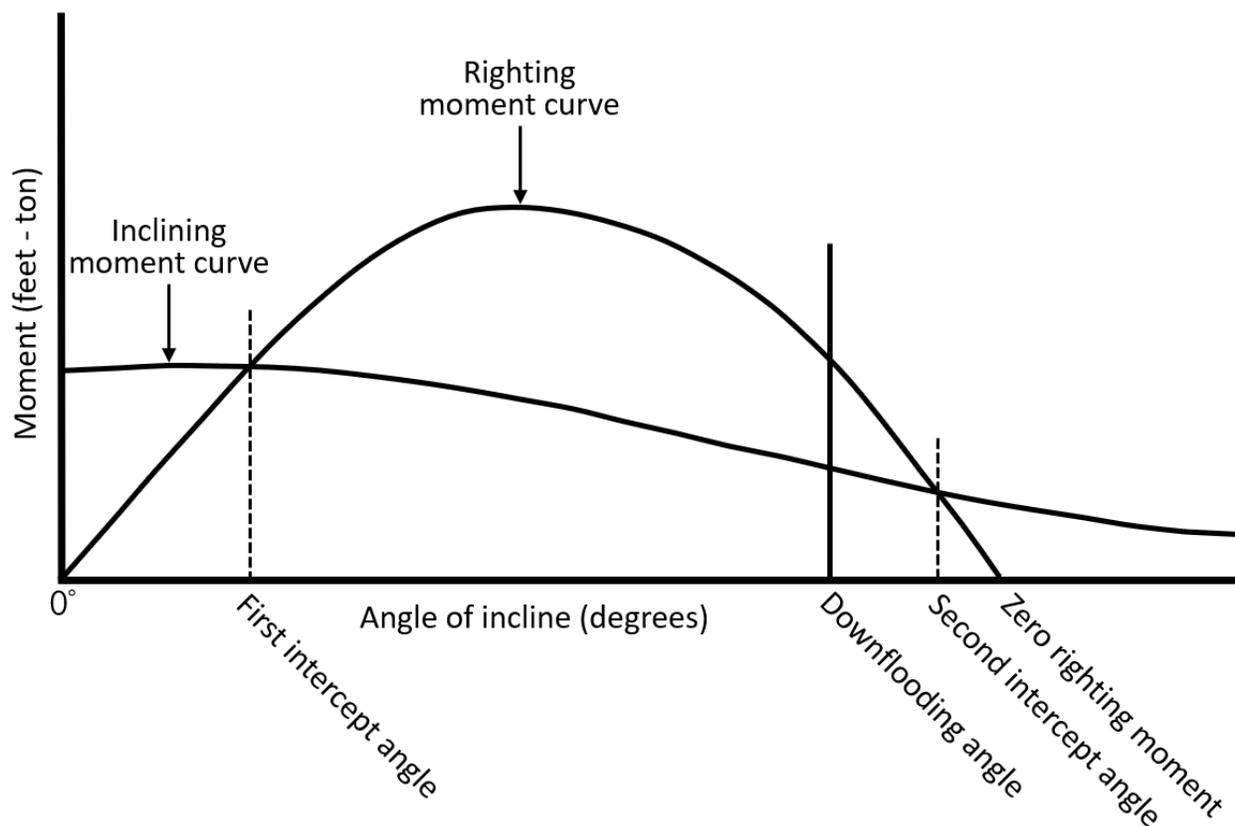
Liftboat intact stability requirements are expressed as the relationship between a vessel's righting moment (the vessel's tendency to return to equilibrium) and wind inclining moment (the sum of a given wind's forces acting on a vessel) when the vessel is inclined from upright (0°) to the angle of downflooding or the angle that the vessel capsizes. Righting moments and wind inclining moments can be plotted as curves on a graph of intact stability (see Figure 21). See [Appendix C: Load Lines and Principles of Stability](#) for additional information.

Figure 21. Righting and inclining moment curves for intact stability. The second intercept angle is the angle at which the vessel will capsize when subjected to a given wind. (Adapted from Graph 174.045, 46 CFR 174)

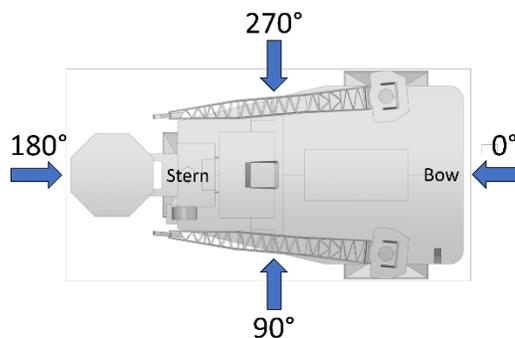
The Coast Guard conducted two sets of analyses for each condition that it evaluated. In its first set of analyses, the model was not permitted to twist (or yaw) about its vertical axis as it was inclined, which was in keeping with the methodology used at the time of the *SEACOR Power*'s construction in 2002. With this "fixed-axis" constraint, the model had a tendency to lose stability and the righting moment curve was truncated as it was inclined towards axes just off the bow or stern, a phenomenon known as "fading stability." The MSC noted that this phenomenon was unrealistic because an actual vessel will yaw as it is inclined, rotating to the position where righting energy is weakest.

Figure 22. Diagram of a liftboat showing relative wind directions. (Background source: MSC)
