Issued February 1, 2023

MIR-23-02

Engine Room Fire aboard Passenger Vessel *Natchez*

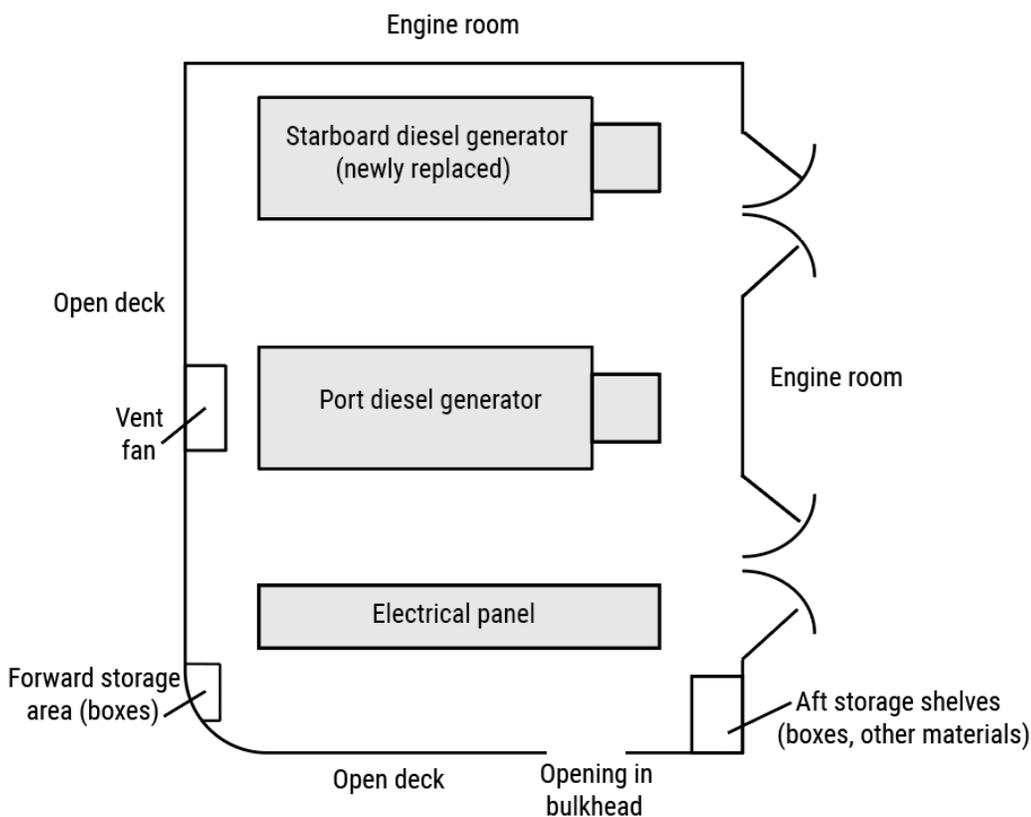
Figure 4. Layout of the *Natchez* generator space, located on the main deck in the forward port corner of the engine room (not to scale).
