February 6, 2024

MIR-24-03

Capsizing and Sinking of Fishing Vessel *Hotspur*

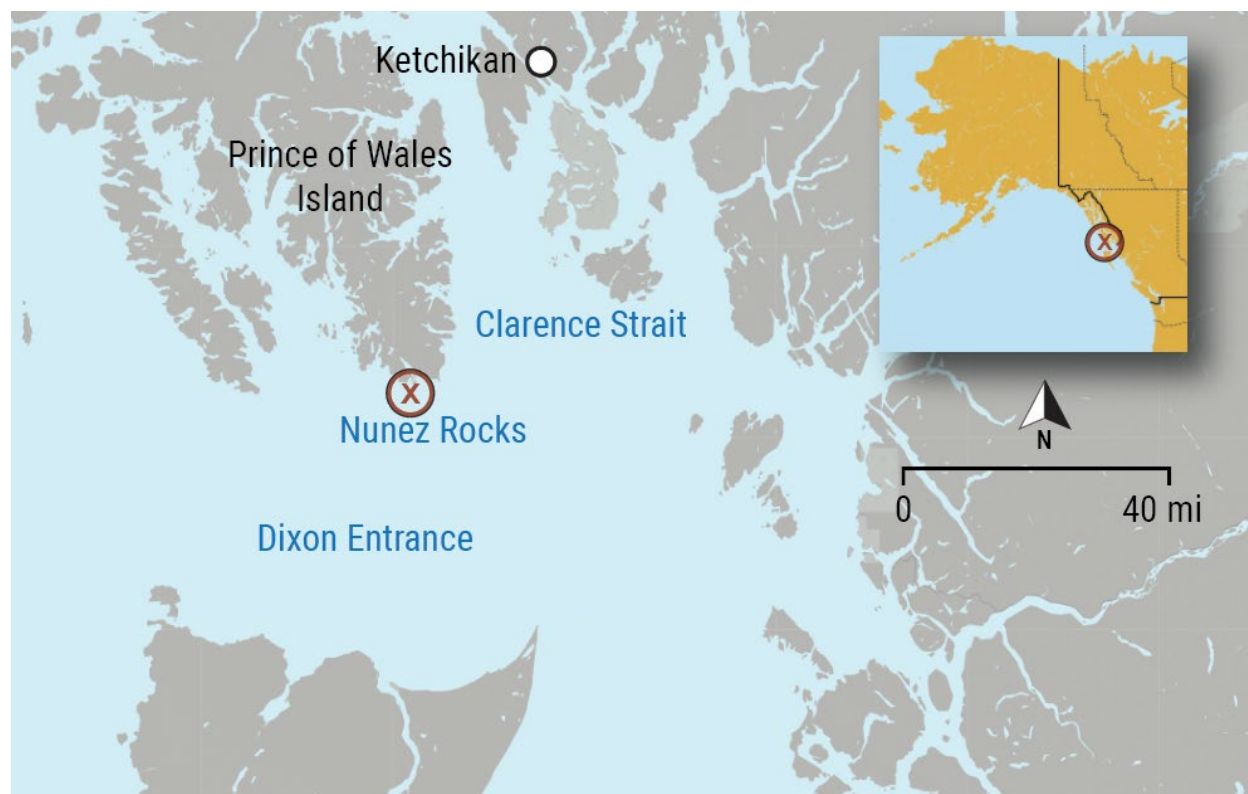
Figure 2. Area where the *Hotspur* sank, as indicated by a red X. (Background source: Google Maps)

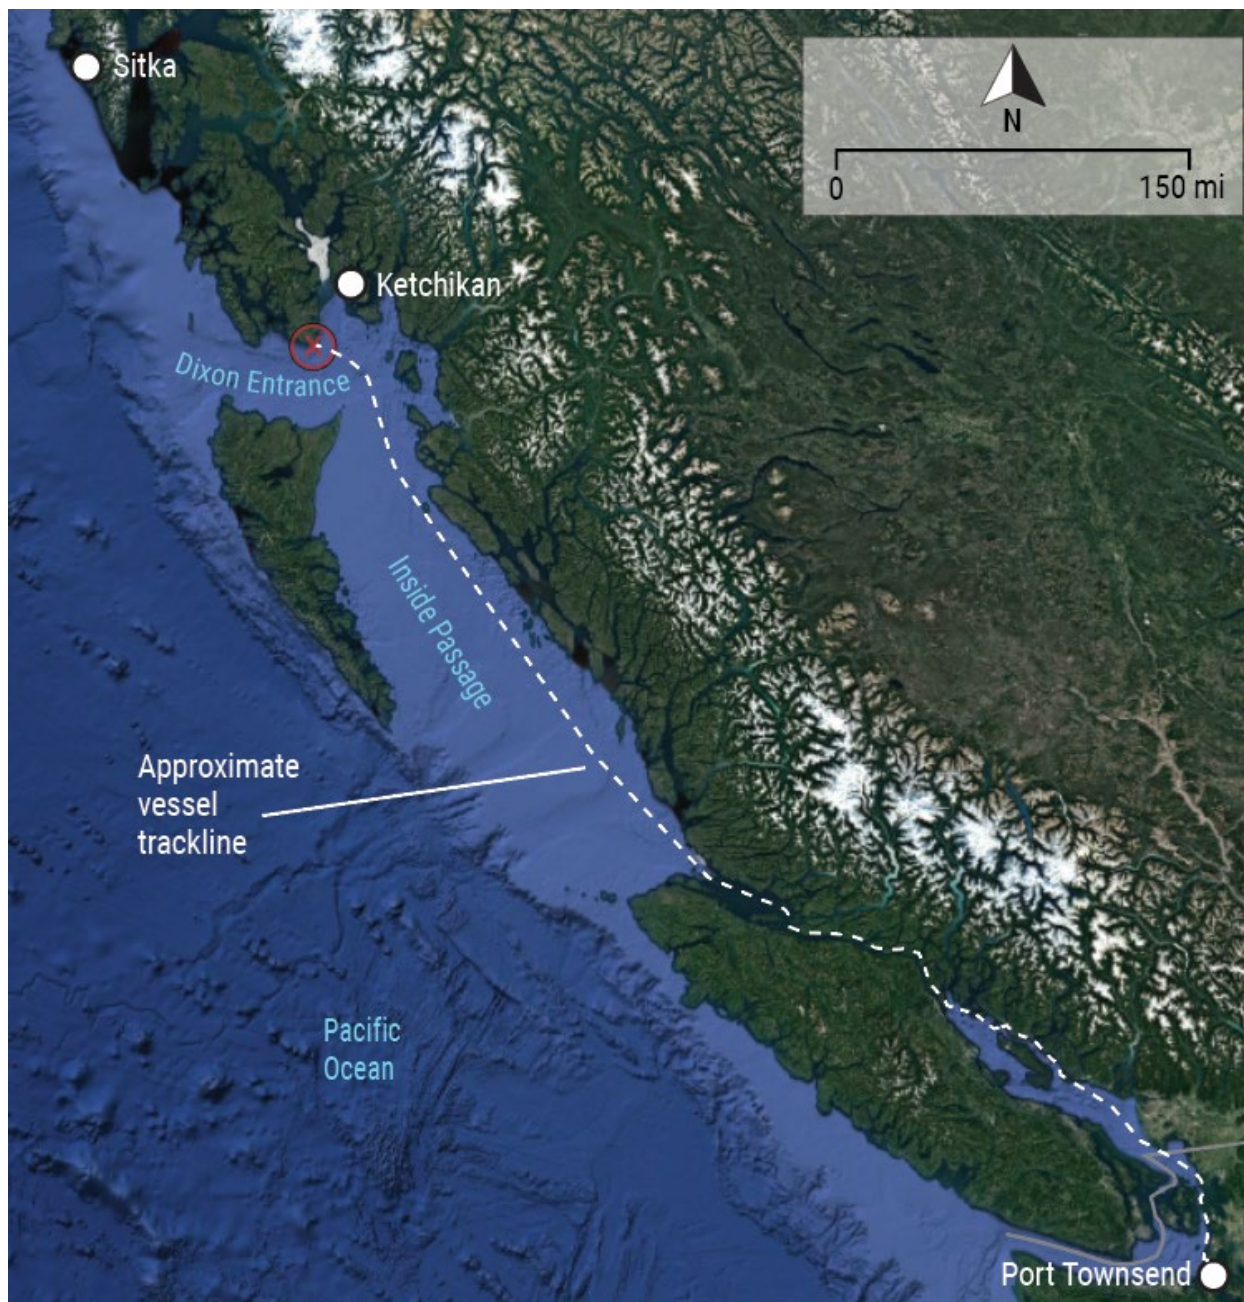
Figure 4. Approximate trackline of the *Hotspur's* casualty voyage from Port Townsend toward Ketchikan, with the location where the sinking occurred, as indicated by a red X. (Background source: Google Earth)
