January 29, 2025

MIR-25-05

## Engine Room Fire aboard Cargo Vessel *Stride*

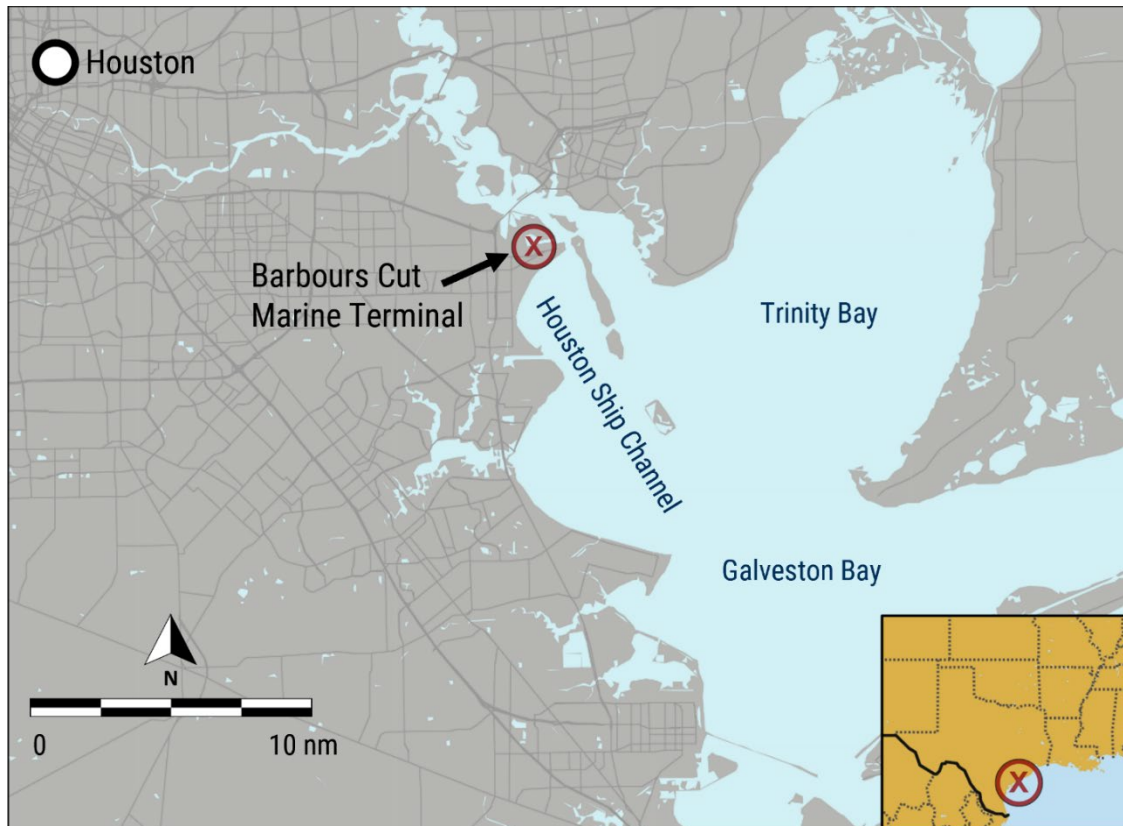
On January 8, 2024, about 0331 local time, a fire broke out in the engine room aboard the cargo vessel *Stride* during bunkering operations while it was docked at the Barbours Cut Marine Terminal in LaPorte, Texas (see figure 1 and figure 2).<sup>1</sup> Crewmembers shut down all ventilation to the engine room, and the fire self-extinguished. Shoreside firefighters and the ship's emergency teams removed three crewmembers from the engine control room who were unable to escape the fire; two died on scene, and one was seriously injured. No pollution was reported. The vessel was declared a constructive total loss, valued at \$12 million.<sup>2</sup>

**Figure 2.** Area where the fire broke out aboard the cargo vessel *Stride*, as indicated by a circled X. (Background source: Google Maps)

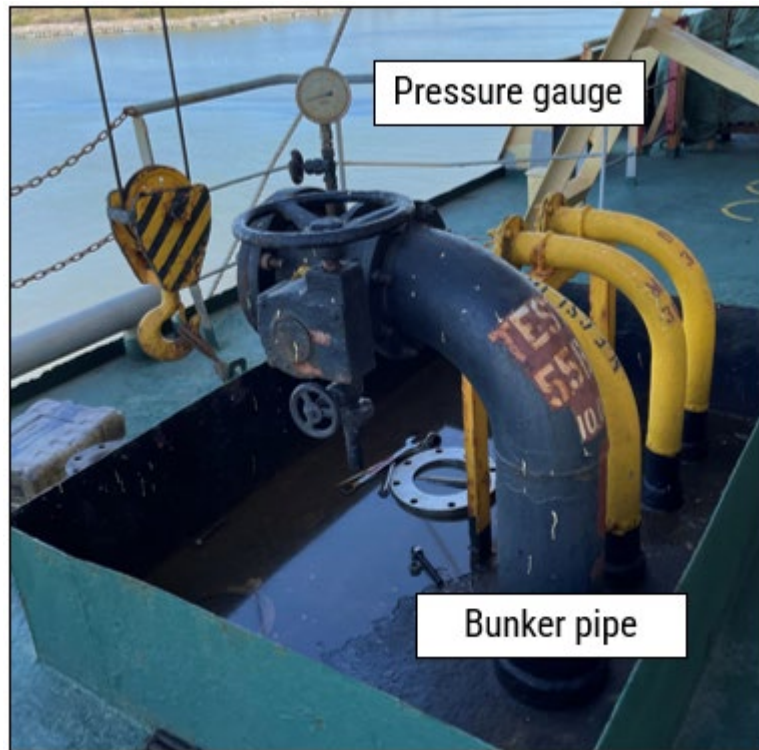
The following morning, about 0150, the towing vessel *Jacques-Imo* arrived alongside the *Stride* with the fuel barge *Shamrock 500* to deliver VLSFO and LSMGO to the *Stride*. About 0235, the 4-inch-diameter bunker hose from the *Shamrock 500* was connected to the 8-inch fill pipe at the bunker manifold of the *Stride* on the A deck, starboard side (see figure 4). The fitter from the *Stride* crew was stationed, as required by company policy, at the bunker manifold with two handheld radios: one to

**Figure 4.** Bunker manifold of the *Stride* on the A deck, starboard side.
