Contact of Crane on board *Royal Engineer* Tow with Terminal Cargo Crane

On January 4, 2024, about 1620 local time, the towing vessel *Royal Engineer* was transiting the Cooper River near North Charleston, South Carolina, while pushing the crane barge *Stevens 1471* when the barge crane contacted a ship-to-shore crane at the North Charleston Terminal (see figure 1 and figure 2).¹ There were no injuries, and no pollution was reported. Damage to the terminal's crane was estimated to be over \$4.5 million.²

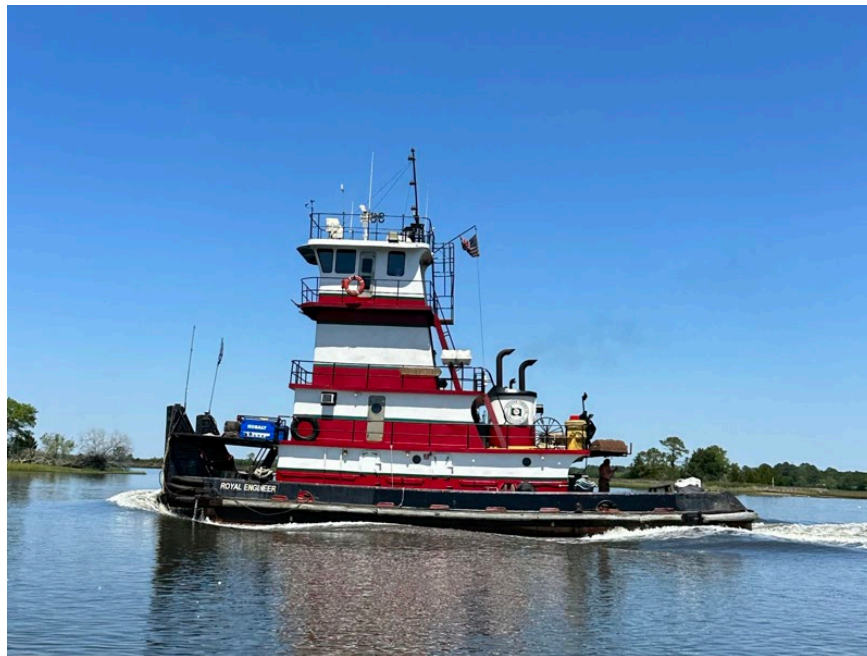
Figure 1. *Royal Engineer* underway on unknown date before the contact. (Source: Lisa Kolibabek)

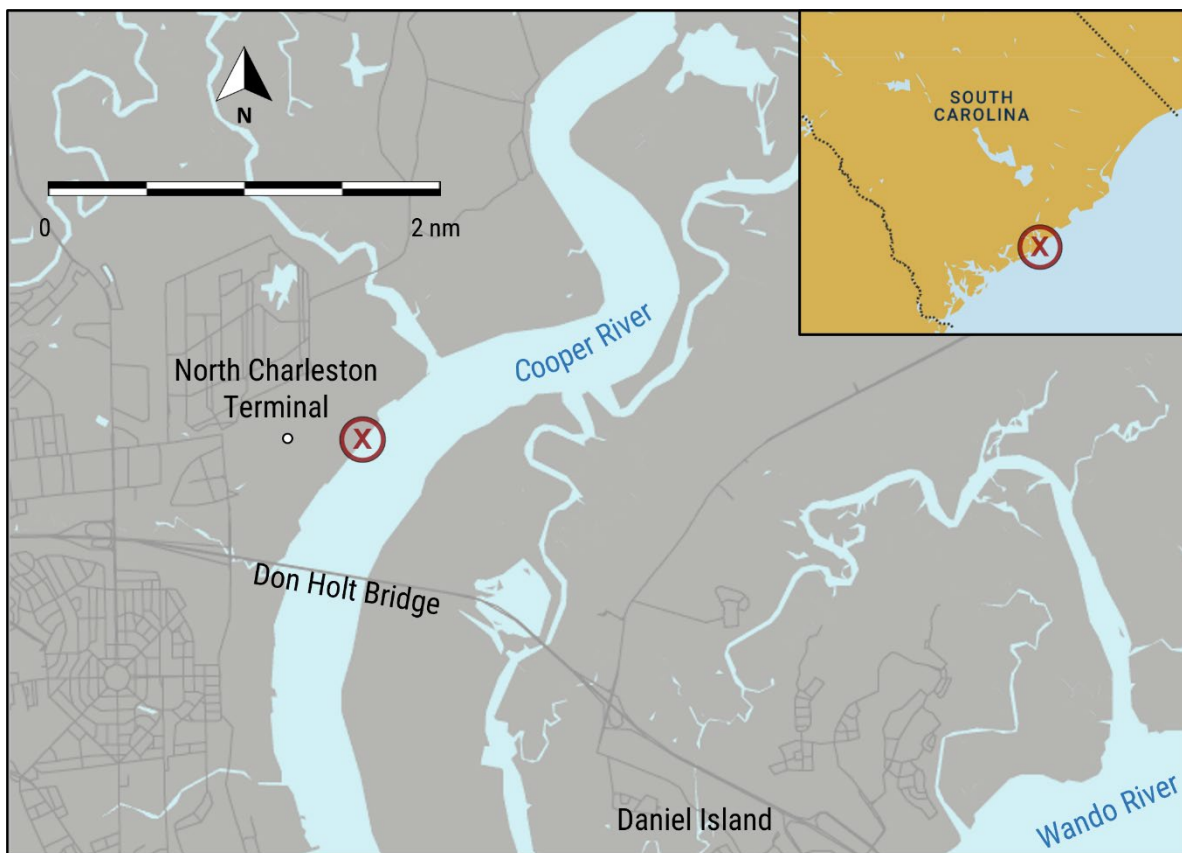
Figure 2. Area where the *Royal Engineer* pushing the *Stevens 1471* contacted a ship-to-shore crane at the North Charleston Terminal as indicated by a circled X. (Background source: Google Maps)
