MIR-25-29

Listing and Partial Sinking of Yacht *Lovebug*

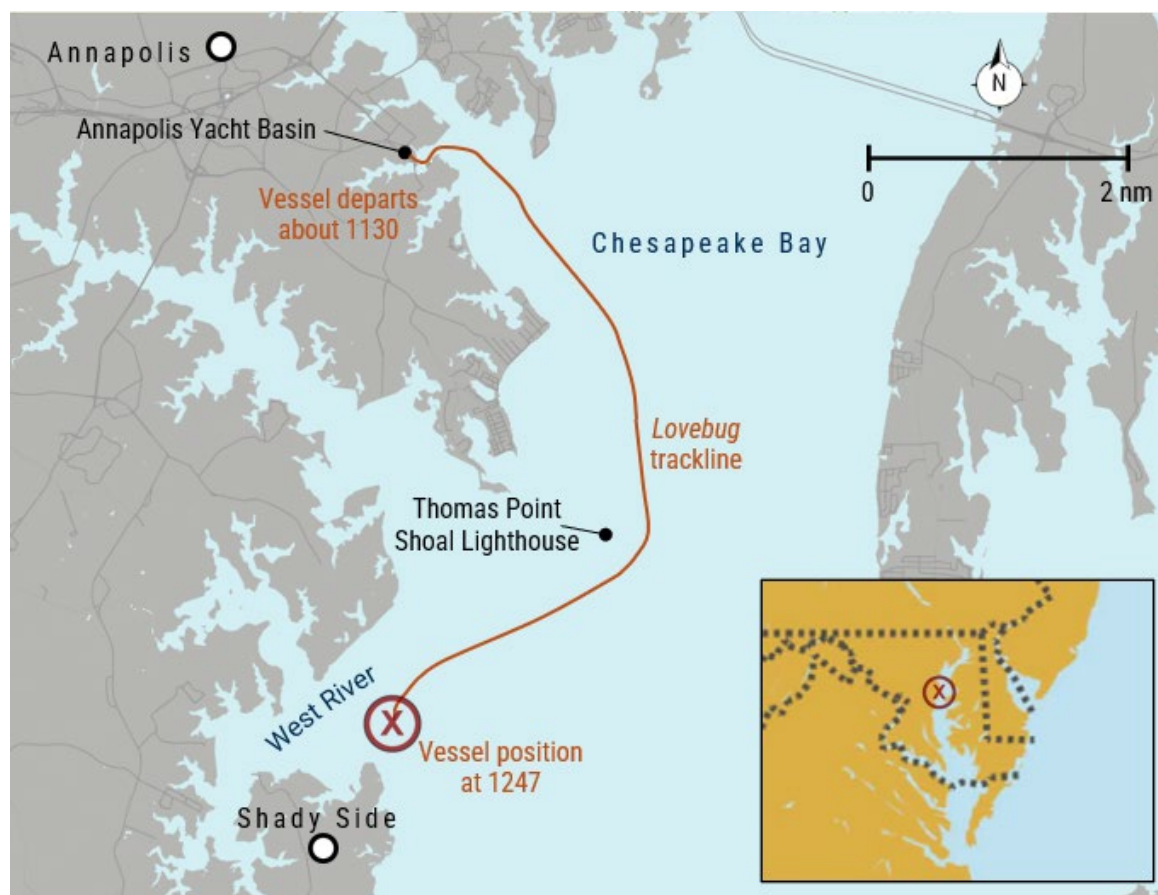
Figure 2. Area where the *Lovebug* partially sank, as indicated by a circled X. The yacht's trackline is orange. (Background sources: Google Maps, Made Smart)

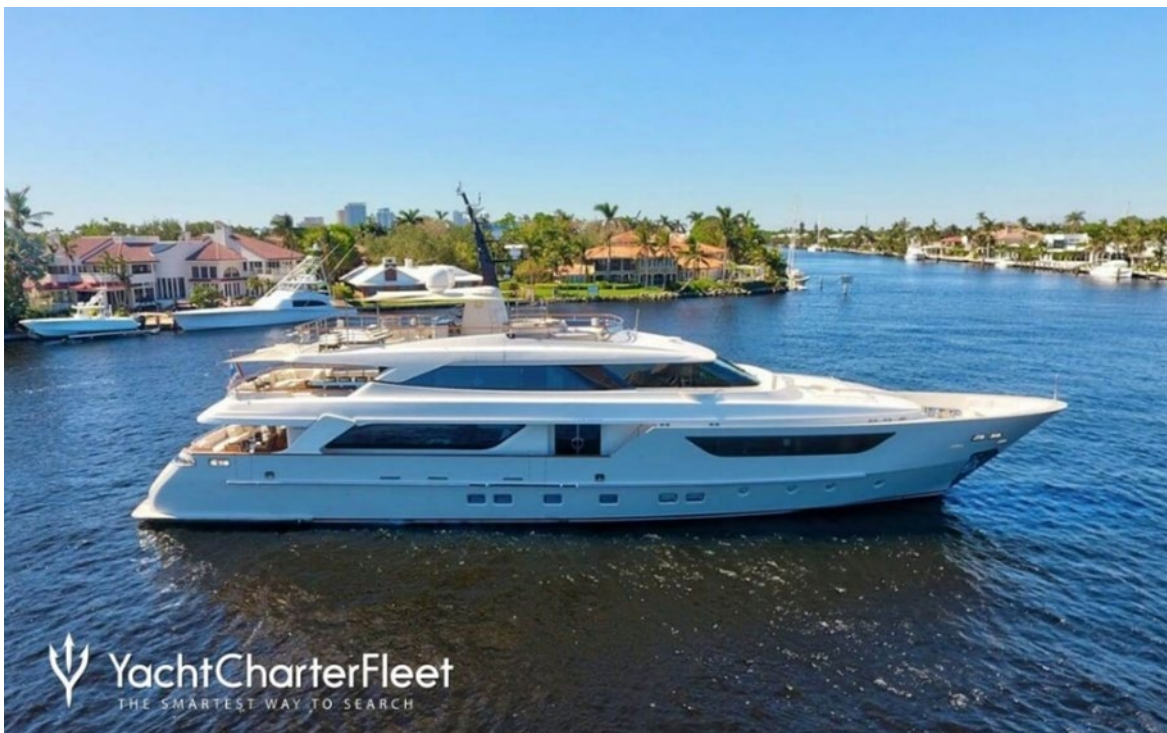
Figure 3. The *Lovebug* on unknown date before the casualty. (Source: YachtCharterFleet)
