July 22, 2025

MIR-25-30

Grounding of Recreational Vessel *6 Saturdays*

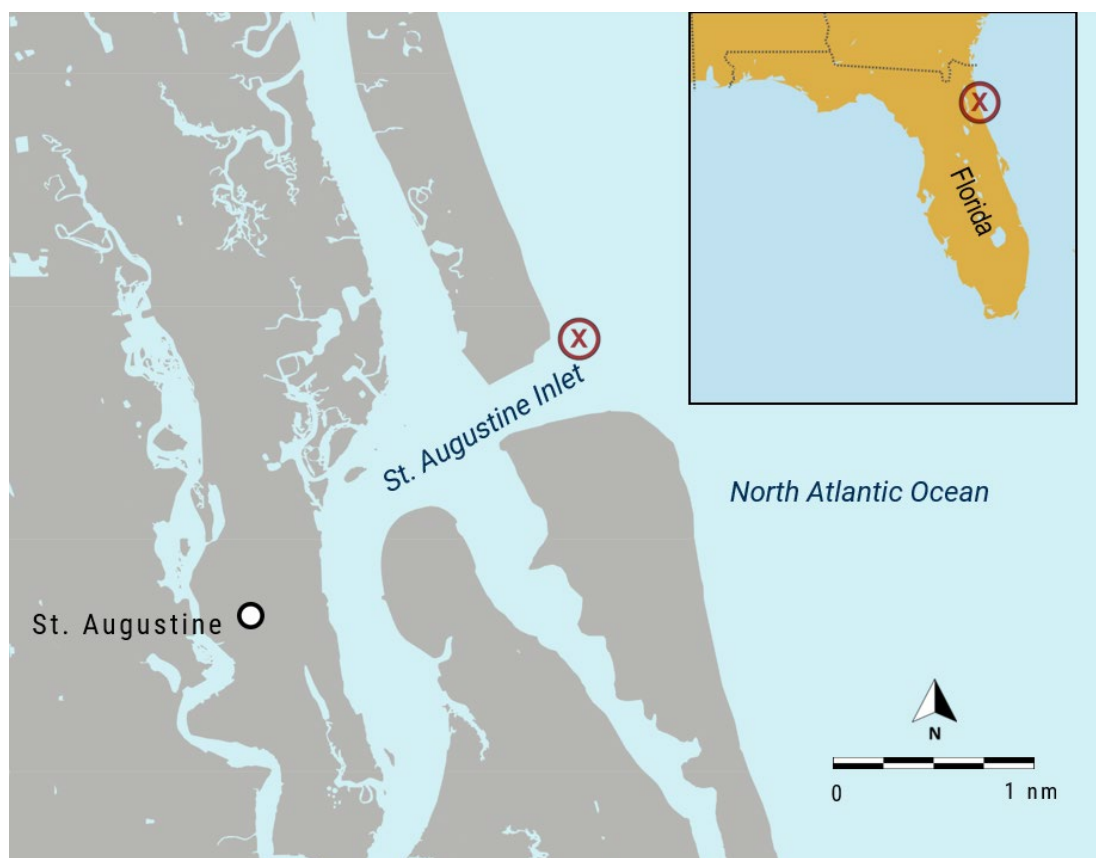
Figure 2. Area where the *6 Saturdays* grounded, as indicated by a circled X. (Background source: Google Maps)

Dangerous and shifting shoals extend one mile seaward. A lighted whistle buoy marks the approach, and buoys mark the channel. These aids are not charted since they are frequently moved with changing conditions to mark the best water. Mariners are advised to seek local knowledge prior to entering.
