Fire aboard Bulk Carrier *Cuyahoga*

On March 15, 2024, about 1315 local time, the bulk carrier *Cuyahoga* was undergoing maintenance while docked in Ashtabula, Ohio, when a fire broke out in a cargo hold where hot work was being conducted (see figure 1 and figure 2).¹ The crew and maintenance personnel on the vessel were unable to extinguish the fire and evacuated to shore. The Ashtabula Fire Department, with assistance from the ship's crew, extinguished the fire. There were no injuries, and no pollution was reported. The vessel was declared a constructive total loss estimated at \$11 million.²

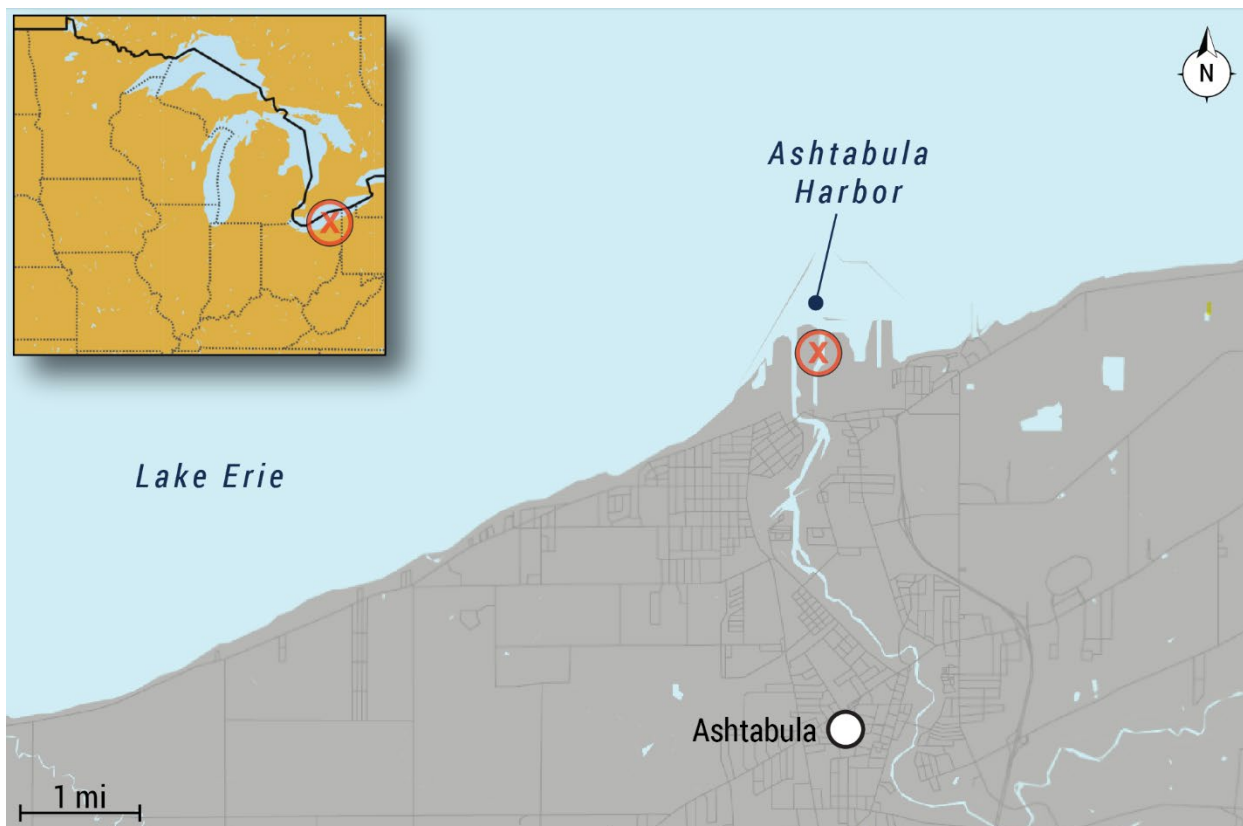
Figure 2. Area where the *Cuyahoga* caught fire, as indicated by a circled X. (Background source: Google Maps)

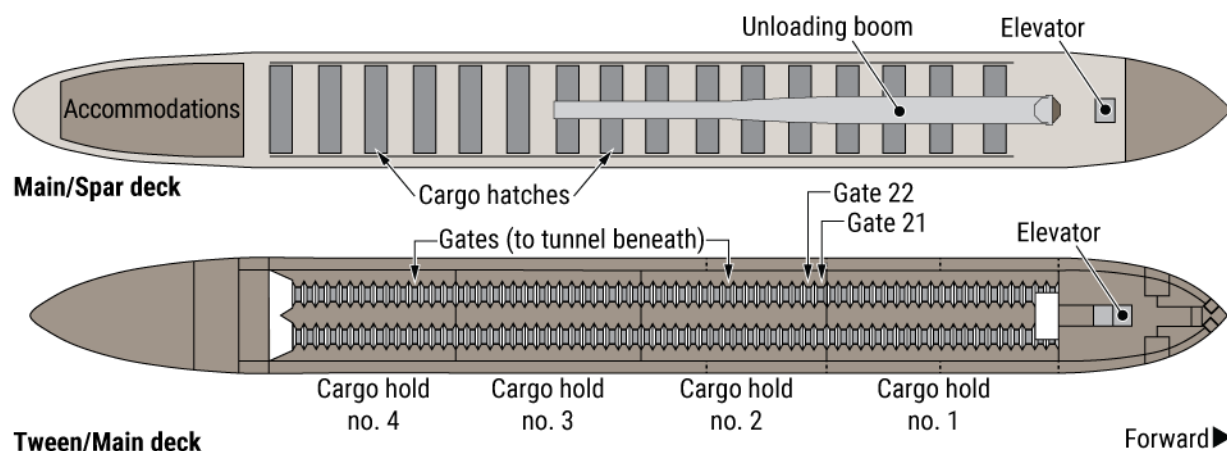
Figure 3. Layout of *Cuyahoga* decks, showing cargo hatches, unloading boom, elevator, gates, and cargo holds.

The South Marine Systems fire watch told investigators that, earlier on the day of the casualty, during cutting operations with an acetylene torch, he had observed the epoxy paint catching fire. He saw this happening on the interior of the slope of the gate to the tunnel below cargo hold no. 2. However, the fire he had witnessed was small and was extinguished with a water canister fire extinguisher. A Lower Lakes Towing employee who was in the cargo tunnel under cargo hold no. 2 informed investigators that before being notified of the fire, he did not see any fire or smoke but did hear a sound similar to small stones or dirt falling onto the gates. Then, as they were evacuating the tunnel, he observed drippings and sparks dropping down into gate 21 (see figure 3).
