October 20, 2025

MIR-25-39

Engine Room Fire aboard Dredging Vessel *Stuyvesant*

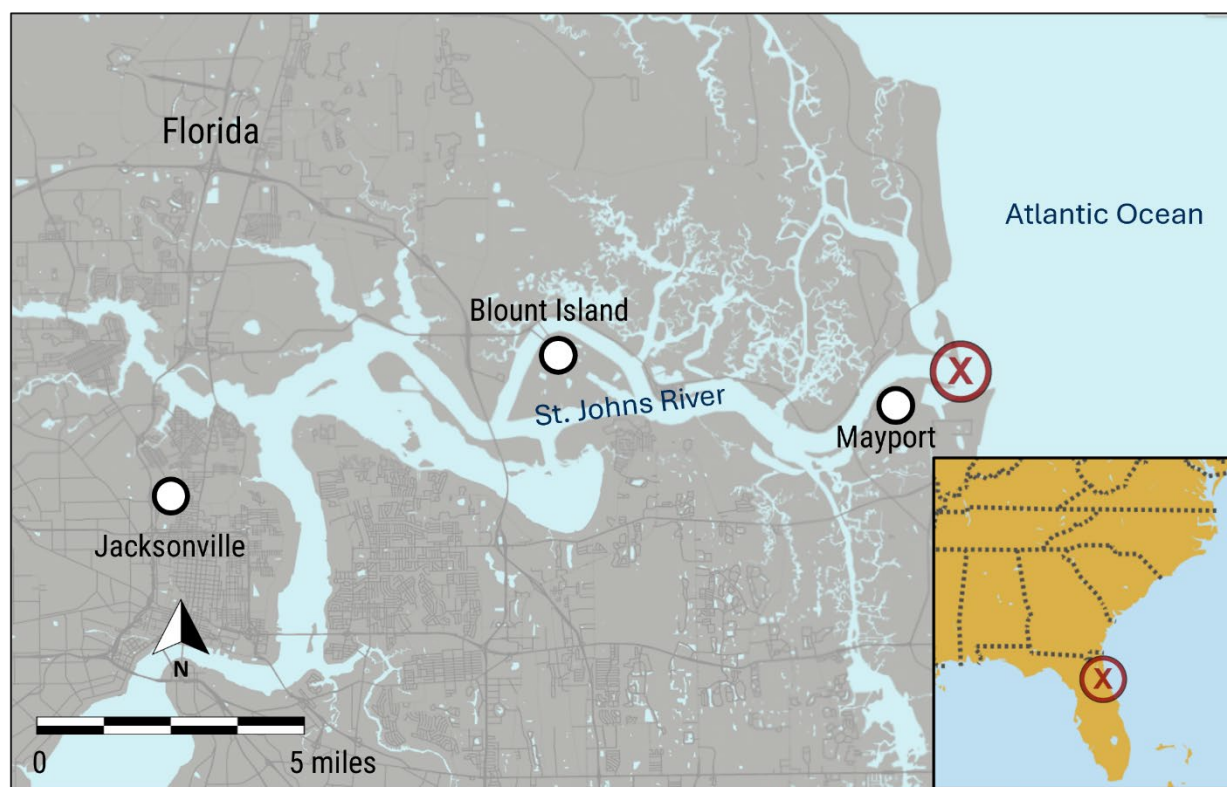
On November 2, 2024, about 1435 local time, the dredging vessel *Stuyvesant*, with a crew of 22, was holding station in the St. Johns River, near Jacksonville, Florida, when a fire broke out in the engine room (see figure 1 and figure 2).¹ Two crewmembers were in the machinery control room when the fire started: one escaped, and the other was removed by the shipboard emergency squad and later pronounced dead at a local hospital. After reporting no active fire and removing the crewmember, the crew verified that the engine room was sealed and released the fixed gas fire extinguishing system. No pollution was reported. Damage to the vessel was estimated at \$18 million.²

Figure 2. Area where the fire broke out aboard the *Stuyvesant*, as indicated by a circled X.
(Background source: Google Maps)

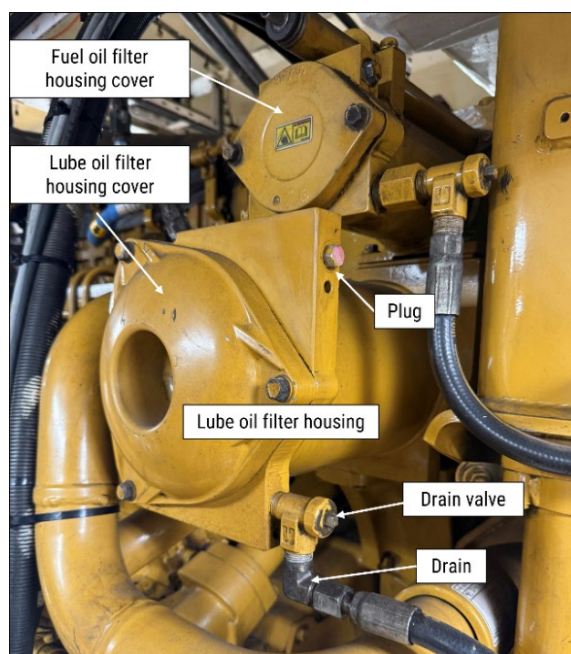
After 1325, the first engineer, oiler, and wiper started the maintenance on the port auxiliary engine. The oiler stated that, prior to performing work on the engine, the first engineer closed the engine start air valve and placed a lock on it as part of the lockout procedure (to safeguard crewmembers from an accidental start command). The crewmembers drained the lube oil from the lube oil filter housing and the engine's sump and removed the lube oil filter's housing cover to access the filter elements (see figure 3). The waste oil from both the lube oil filter housing and the sump drained into a pipe that routed into the dedicated dirty oil tank below the engine. At some point, one of the crewmembers removed the plug from the top of the lube oil filter housing and placed it on a nearby metal storage cabinet.⁶ The oiler told investigators that the first engineer replaced the lube oil filter elements and he believed the wiper reinstalled the lube oil filter housing cover and subsequently changed the fuel oil filters.

Figure 3. Photo of forward end of a Caterpillar 3512C diesel engine, depicting lube and fuel oil filter housings and filter change components. (Background source: The Dutra Group)

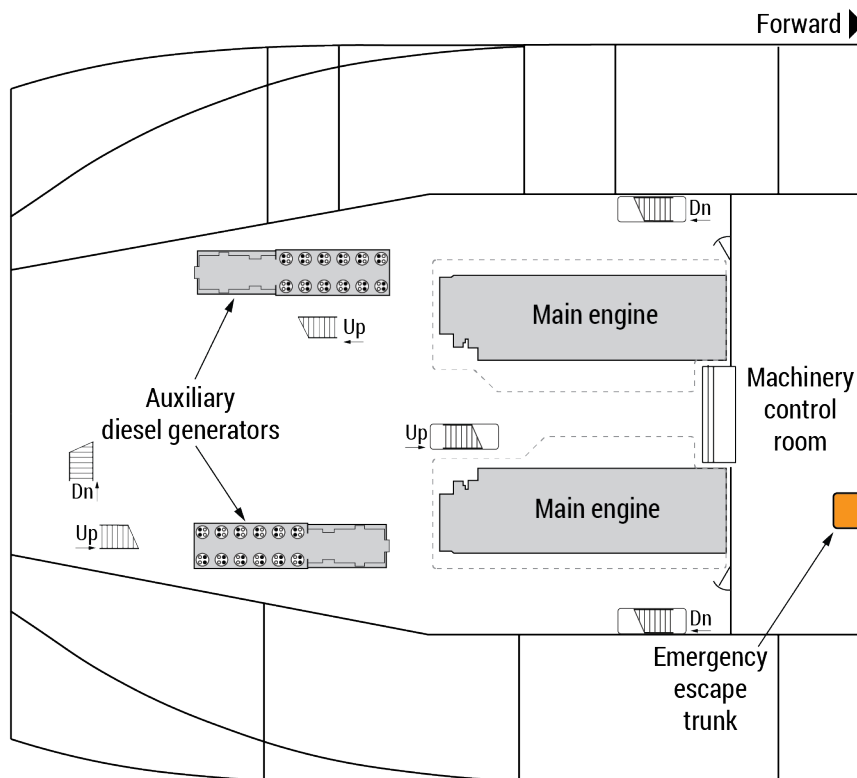
forward bulkhead of the MCR, which led up to the athwartships passageway of the main deck, and then up through a second escape hatch to the poop deck (see figure 4). When he exited the escape hatch, he told the wiper and electrician in the nearby lounge that there was a fire in the engine room.

Figure 4. Layout of the engine room tween deck aboard the *Stuyvesant*. The main engines were located on the deck below.
